ECOLOGICAL CONDITION OF GILL, FISH, AND CAYUGA CREEKS

Niagara Power Project (FERC No. 2216)

New York Power Authority

May 2004

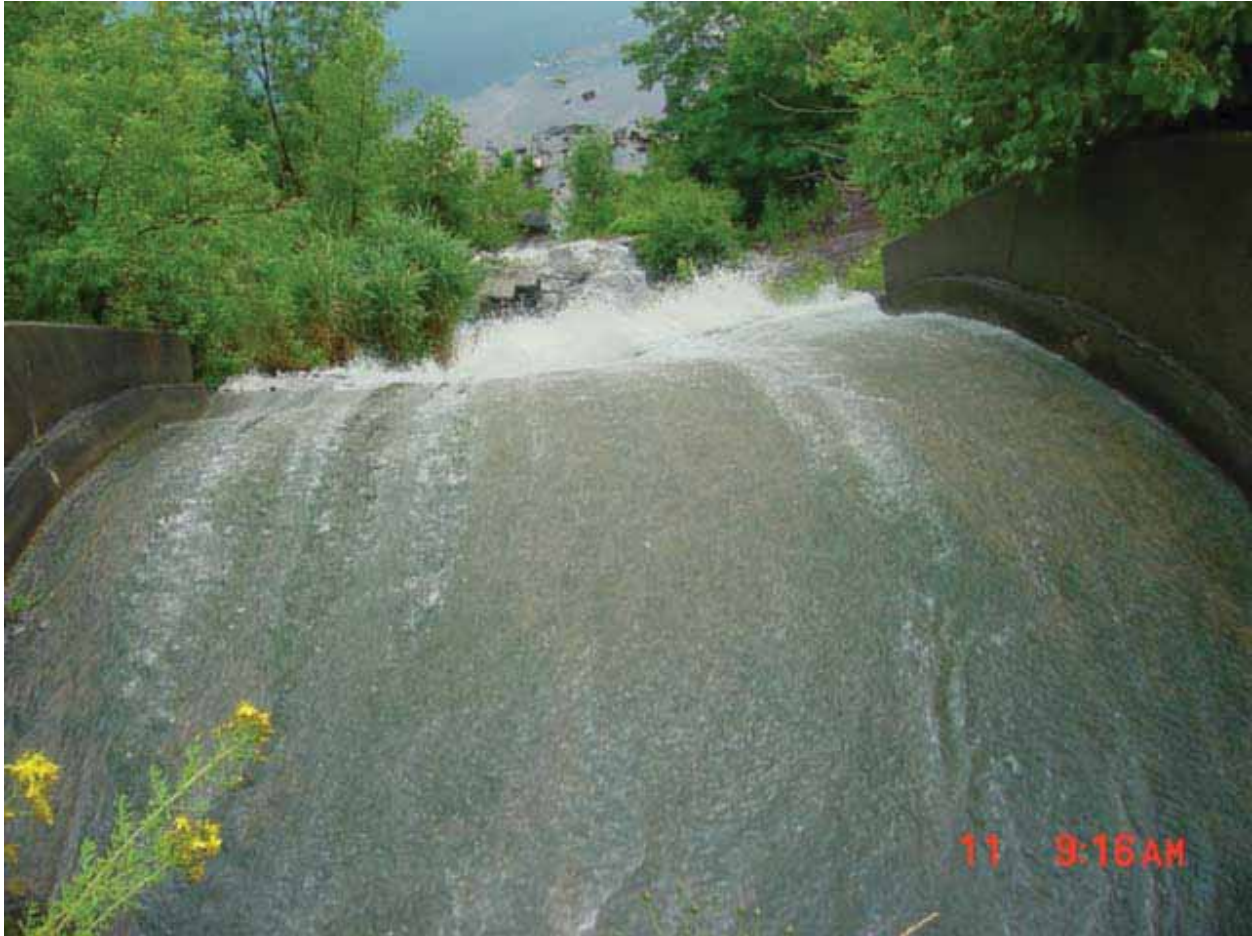
FIGURE 2.5.1-2
SLIME CHUTE AT THE MOUTH OF FISH CREEK

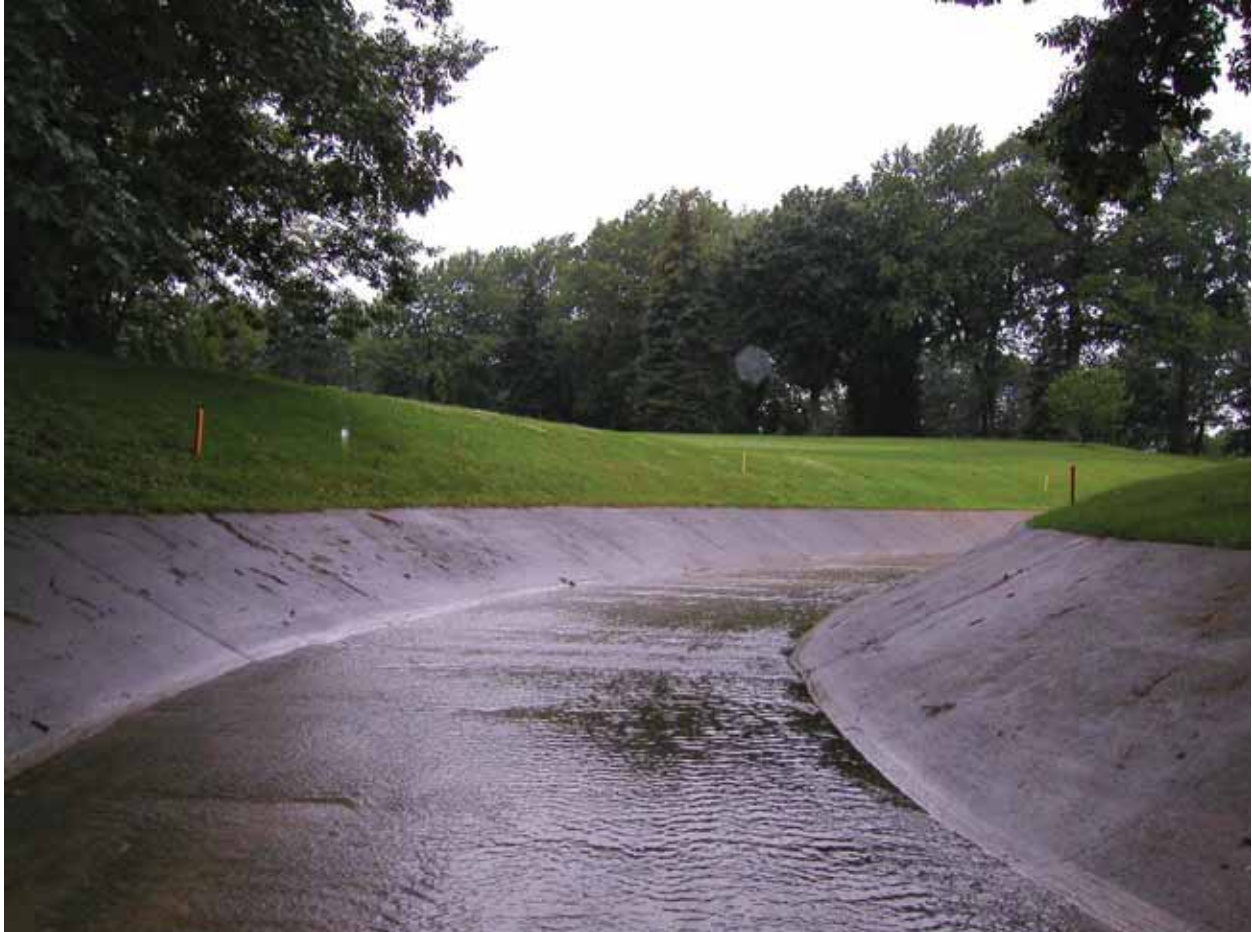
FIGURE 2.5.1-5
CONCRETE LINED STREAM CHANNEL THROUGH THE NIAGARA FALLS COUNTRY CLUB IN REACH F1

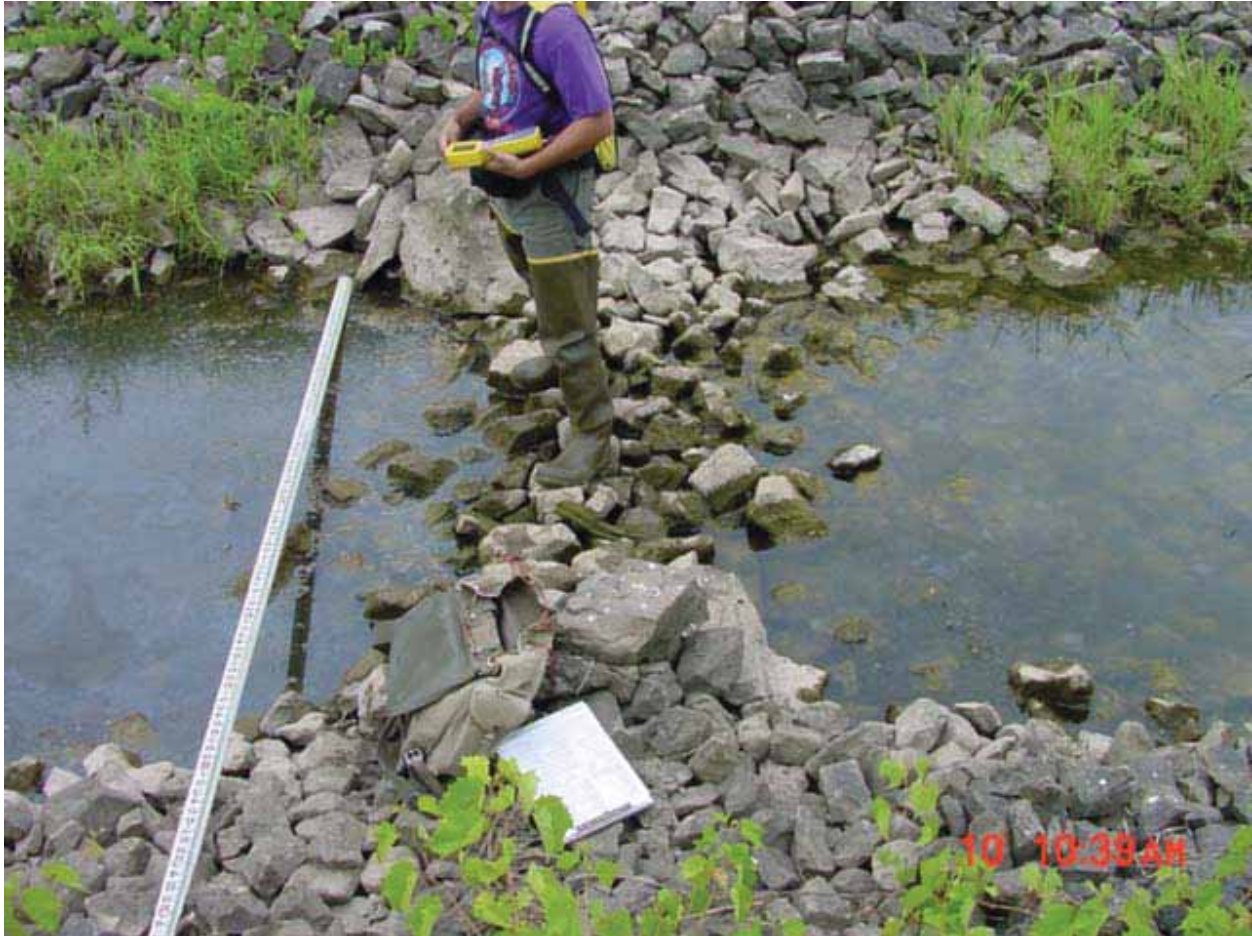
**FIGURE 2.5.1-14
SMALL ROCK DAM ALONG THE LEWISTON RESERVOIR IN REACH F5**

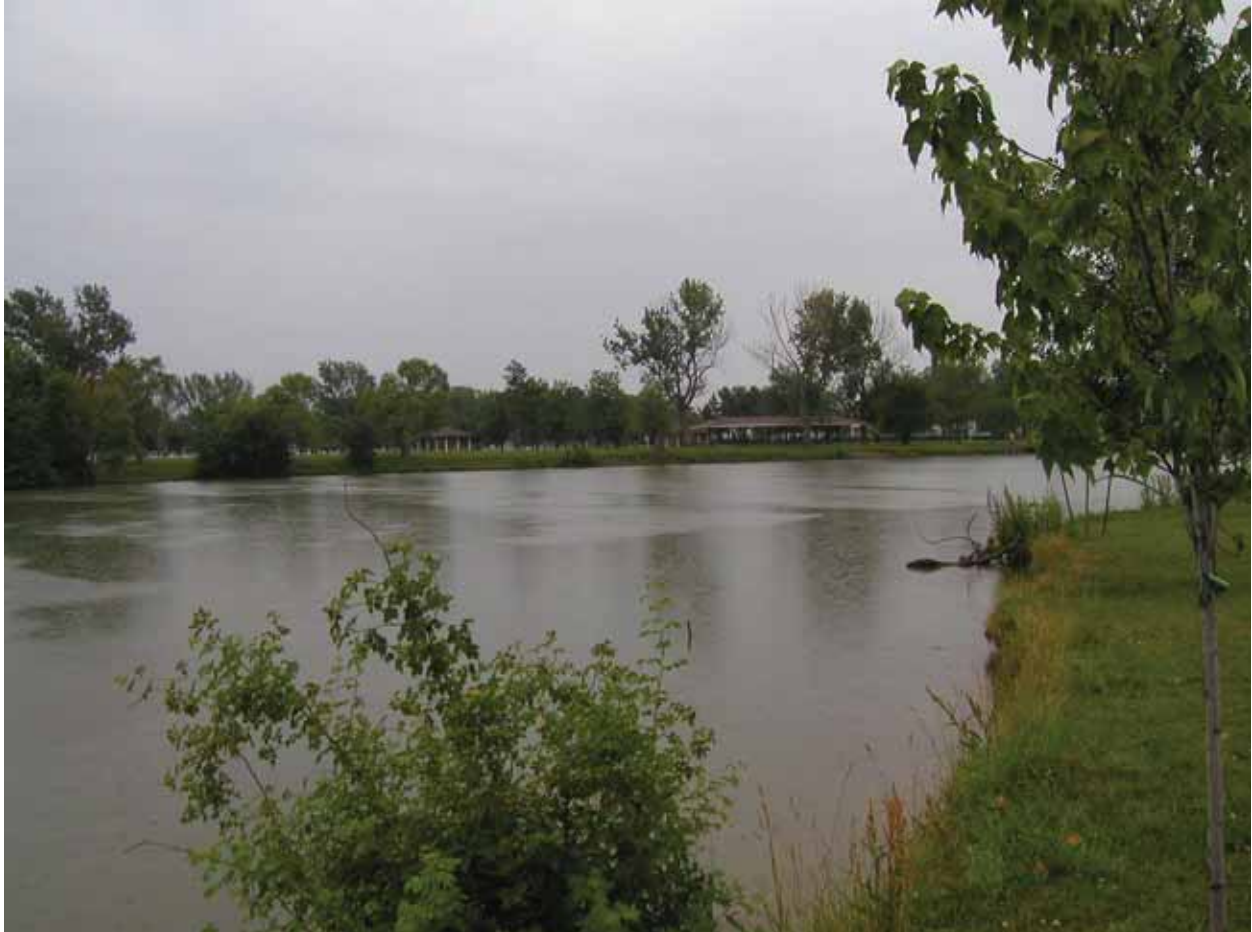
FIGURE 2.5.2-6
A PHOTO OF HYDE PARK LAKE SHOWING THE LACK OF RIPARIAN BUFFERS
SURROUNDING THE LAKE

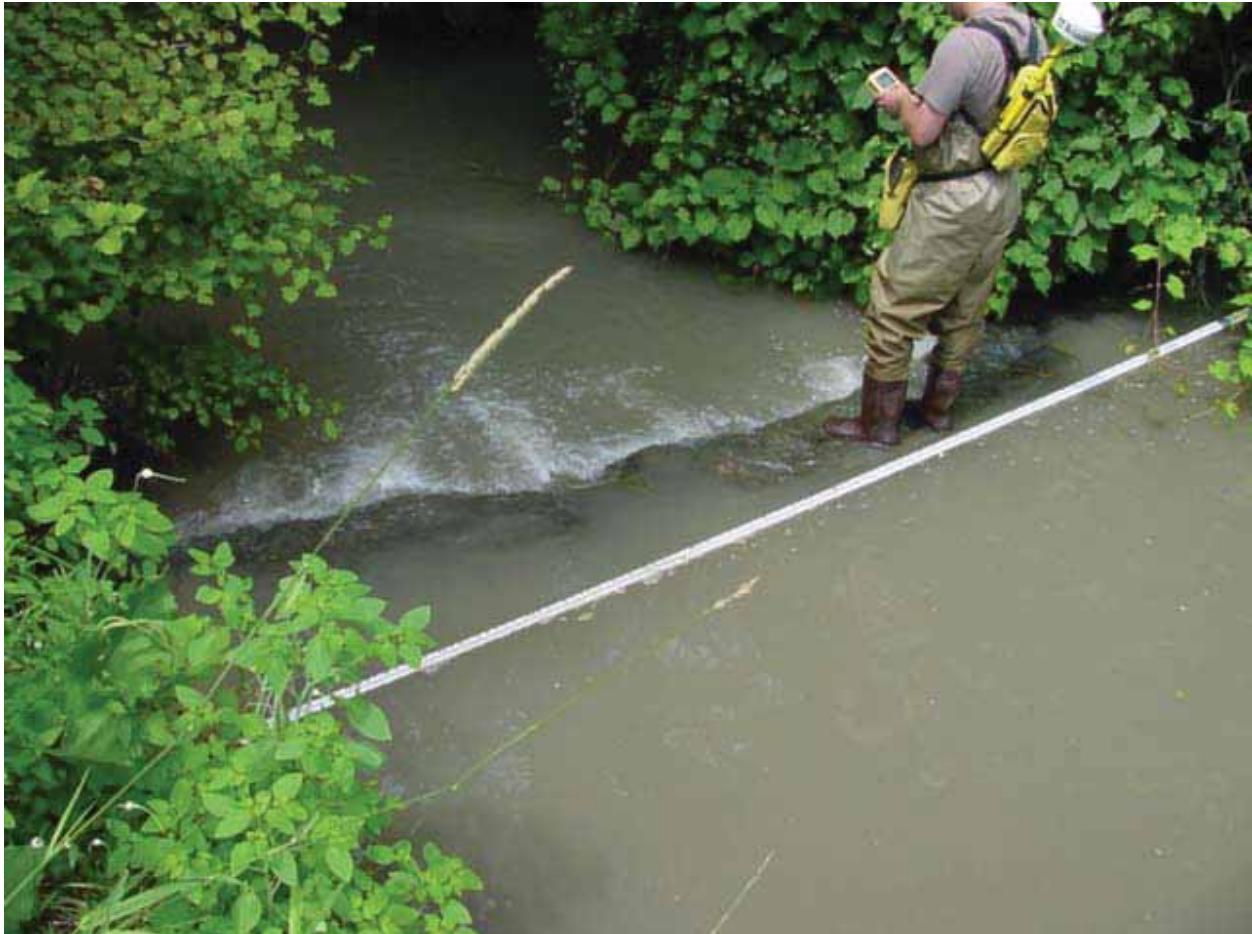
**FIGURE 2.5.2-8
SMALL DAM LOCATED UPSTREAM OF HYDE PARK LAKE IN REACH G4**

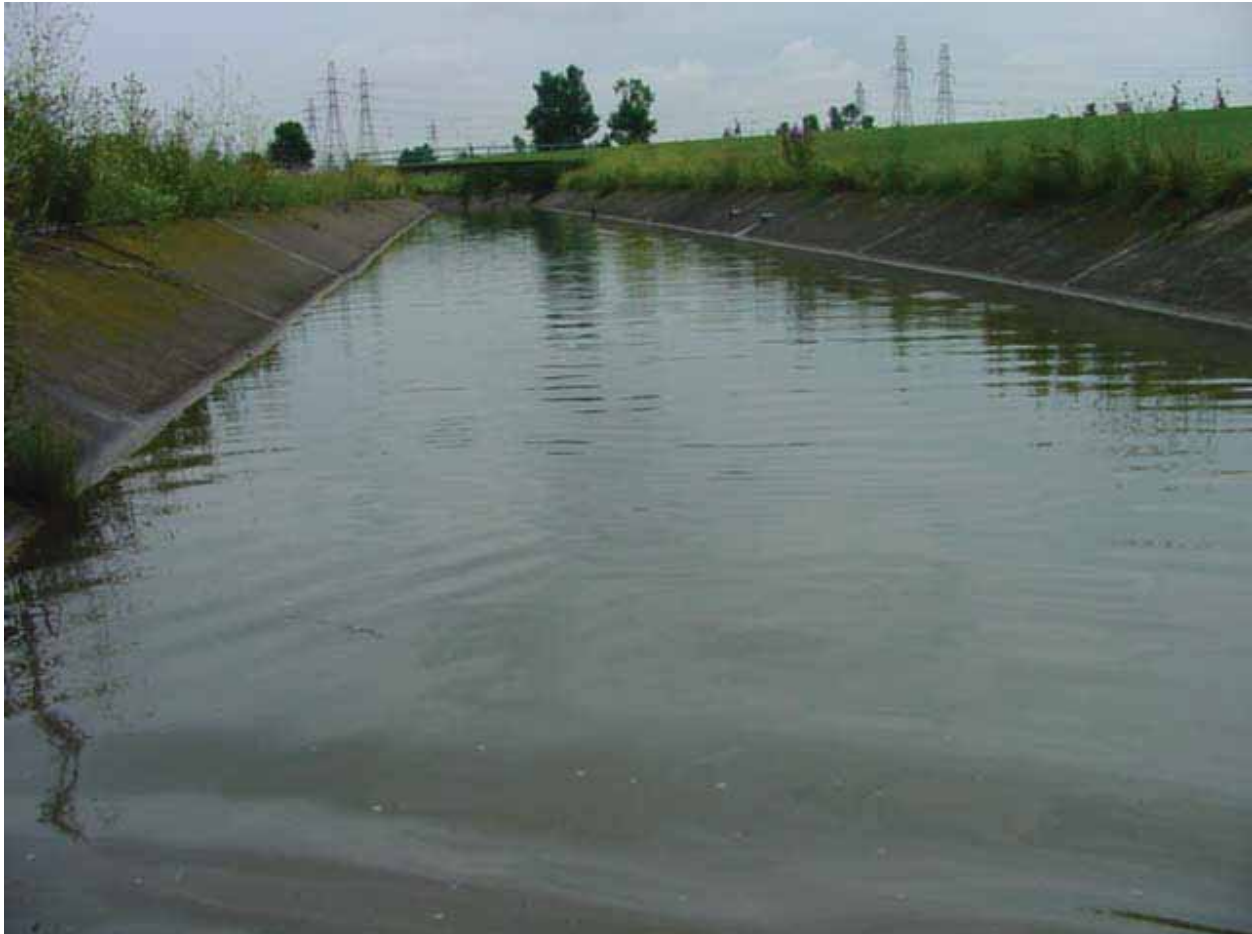
FIGURE 2.5.2-11
CONCRETE LINED PORTION OF STREAM CHANNEL IN THE HYDE PARK GOLF
COURSE

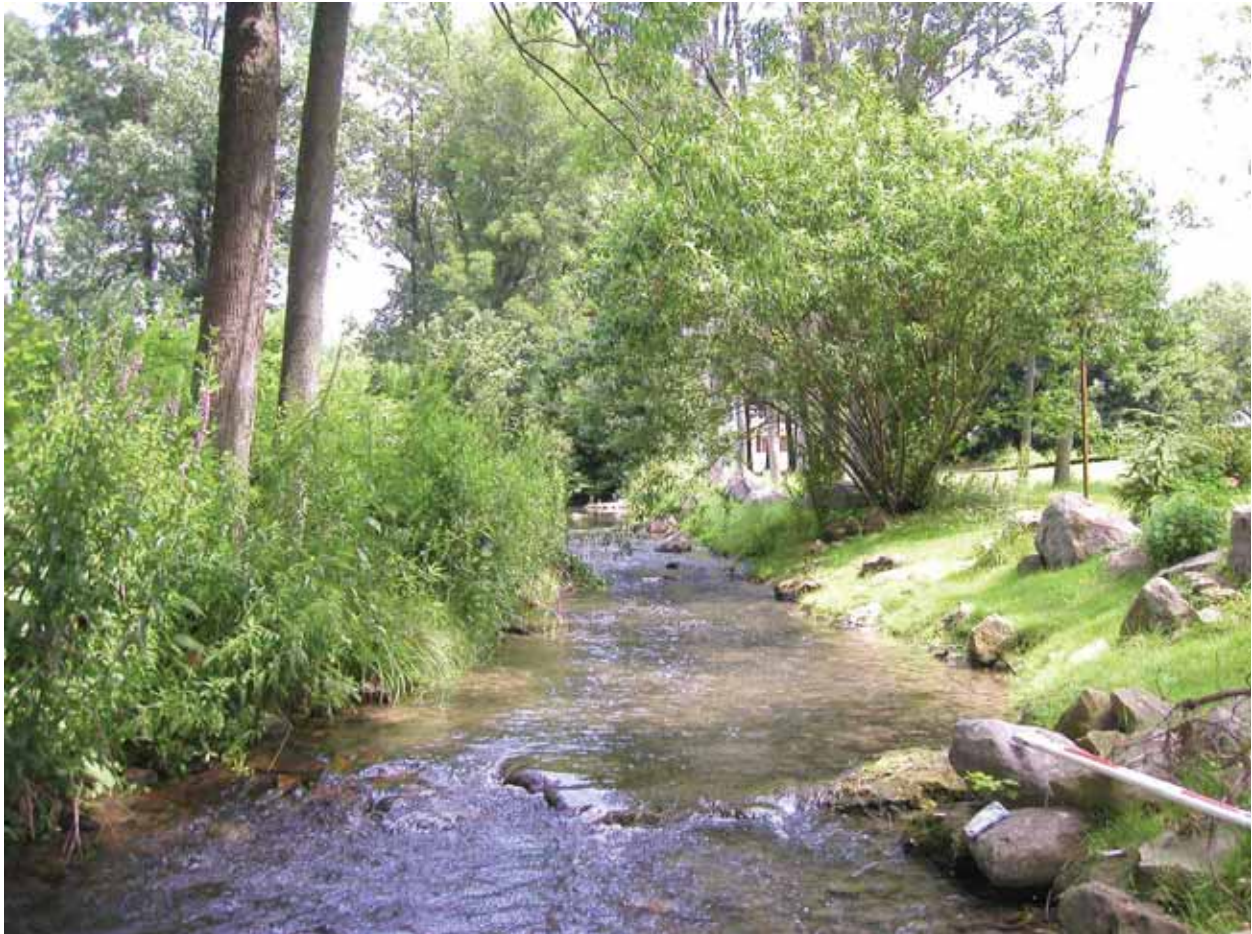
FIGURE 2.5.2-19
MOWED RIPARIAN BUFFERS ALONG RESIDENTIAL SECTIONS OF GILL CREEK IN
REACH G9

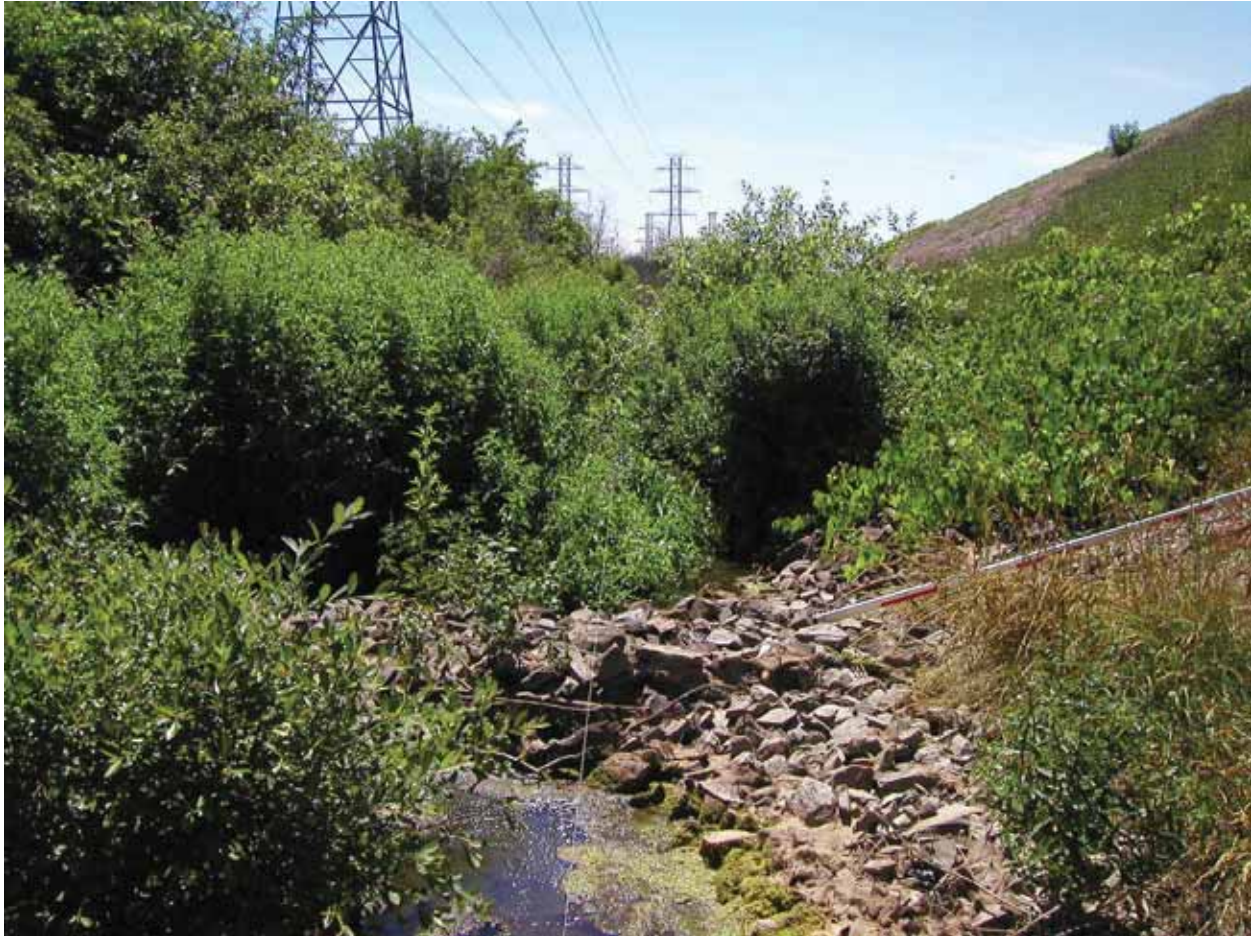
FIGURE 2.5.2-24
SMALL ROCK DAM ACROSS GILL CREEK IN REACH G11

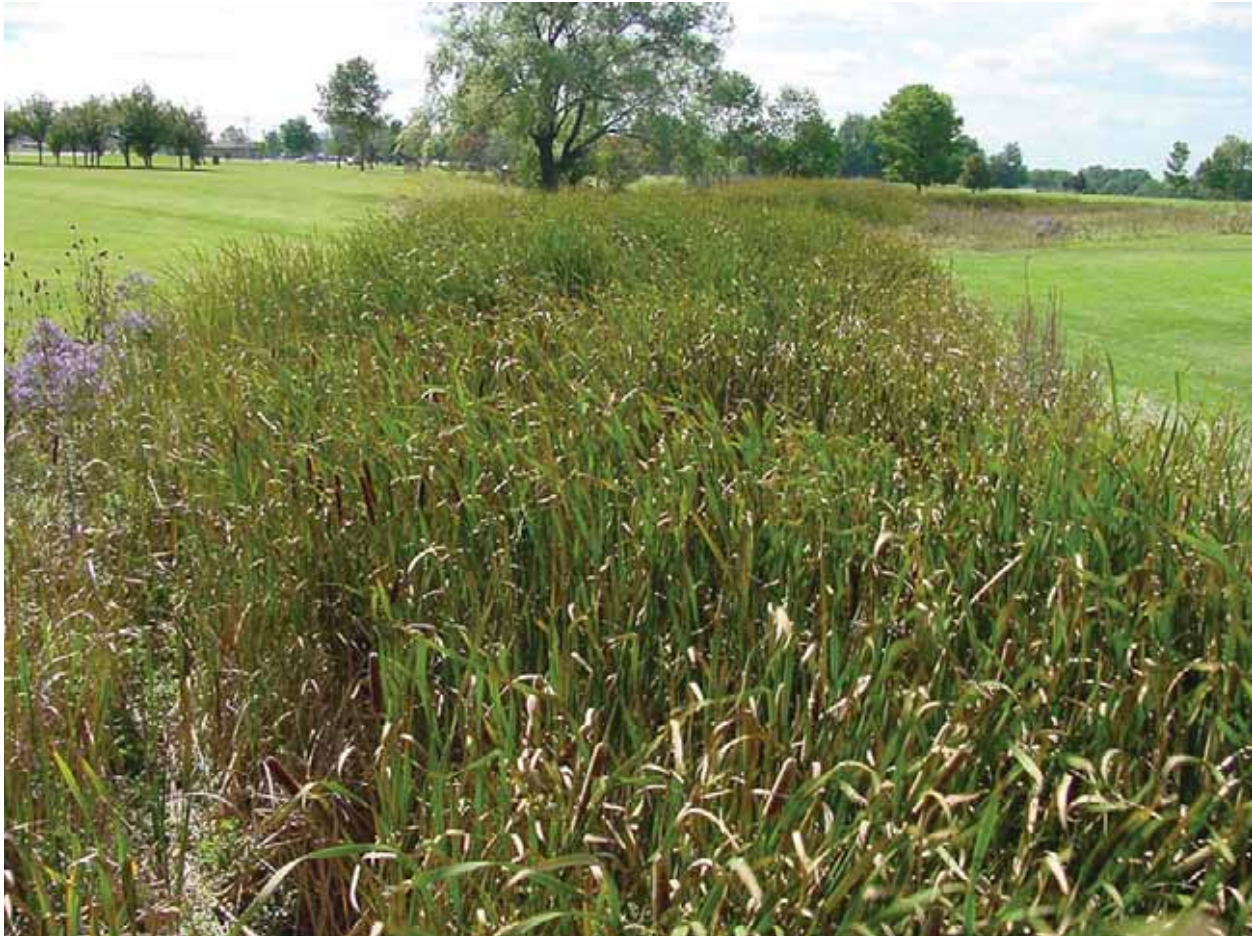
**A SECTION OF THE GILL CREEK TRIBUTARY OVERGROWN WITH BROAD LEAF
CATTAIL**

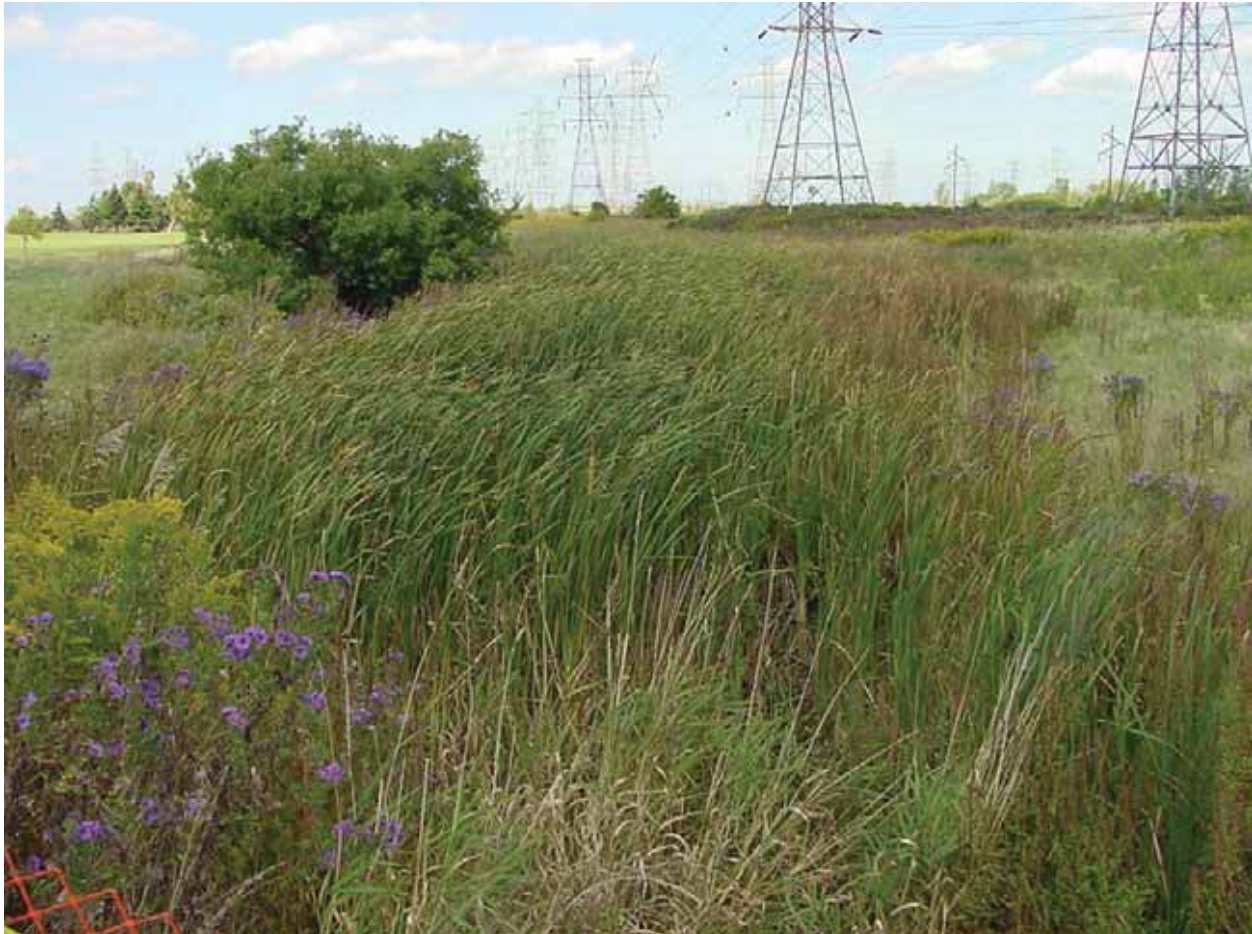
FIGURE 2.5.2-31
A SECTION OF STREAM CHANNEL IN GT2 HEAVILY VEGETATED BY CATTAIL
SPECIES

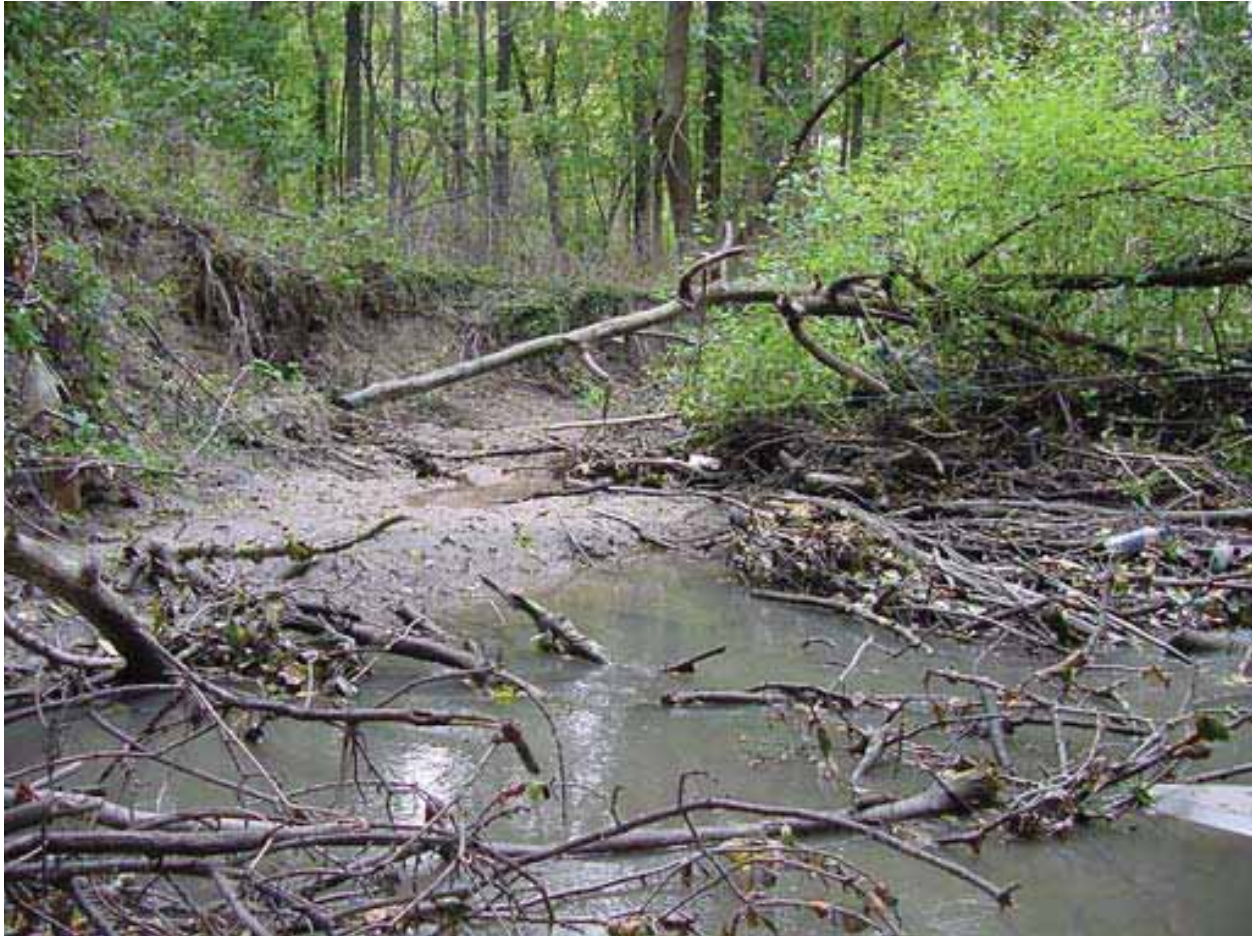
**FIGURE 2.5.3-5
ERODING STREAM BANKS ALONG SECTIONS OF CAYUGA CREEK IN REACH C2**

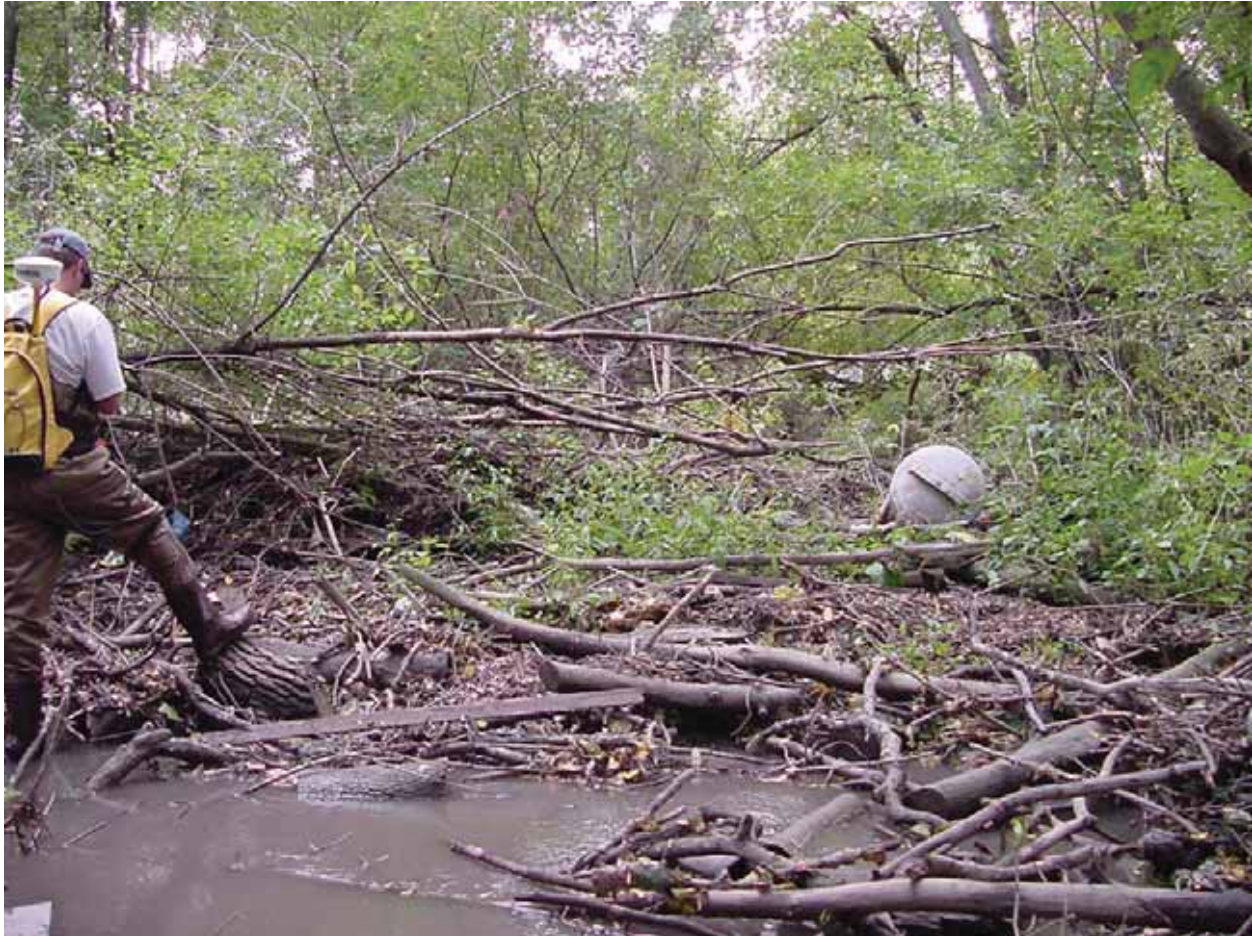
FIGURE 2.5.3-6
WOODY DEBRIS JAM ON CAYUGA CREEK IN REACH C2

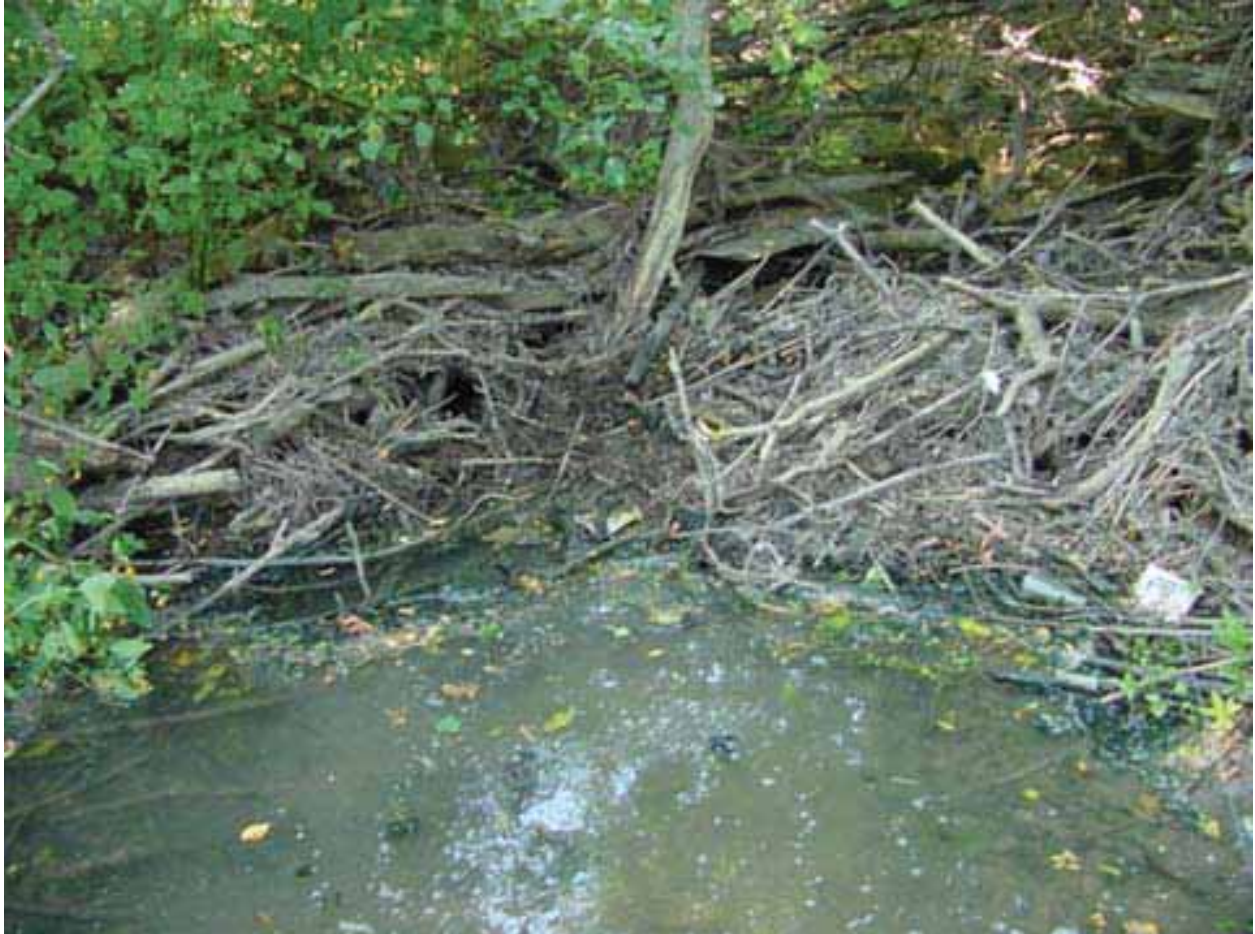
FIGURE 2.5.3-13
ONE OF THREE WOODY DEBRIS JAMS ON CAYUGA CREEK IN REACH C5

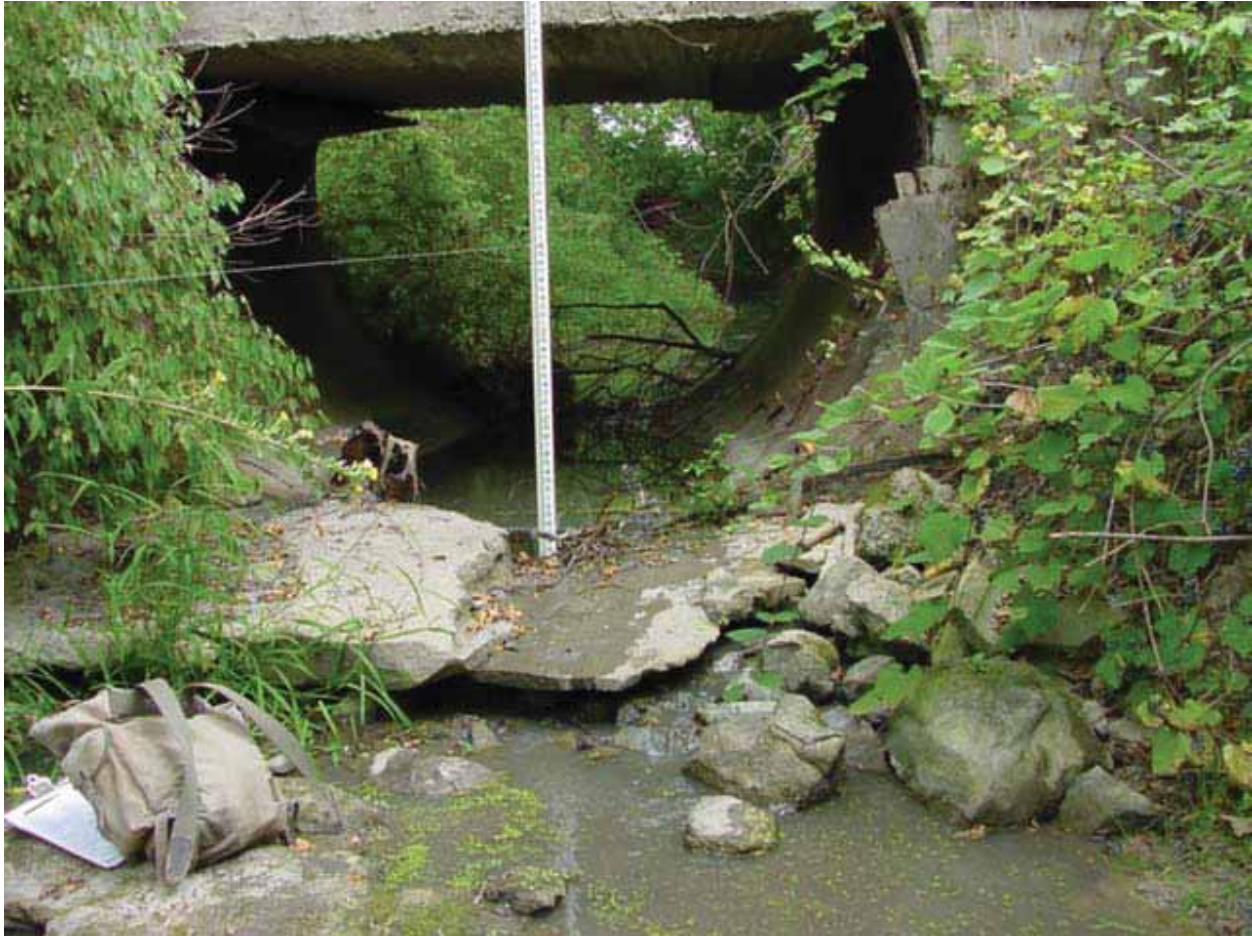
FIGURE 2.5.3-16
HANGING CULVERT ON CAYUGA CREEK IN REACH C6

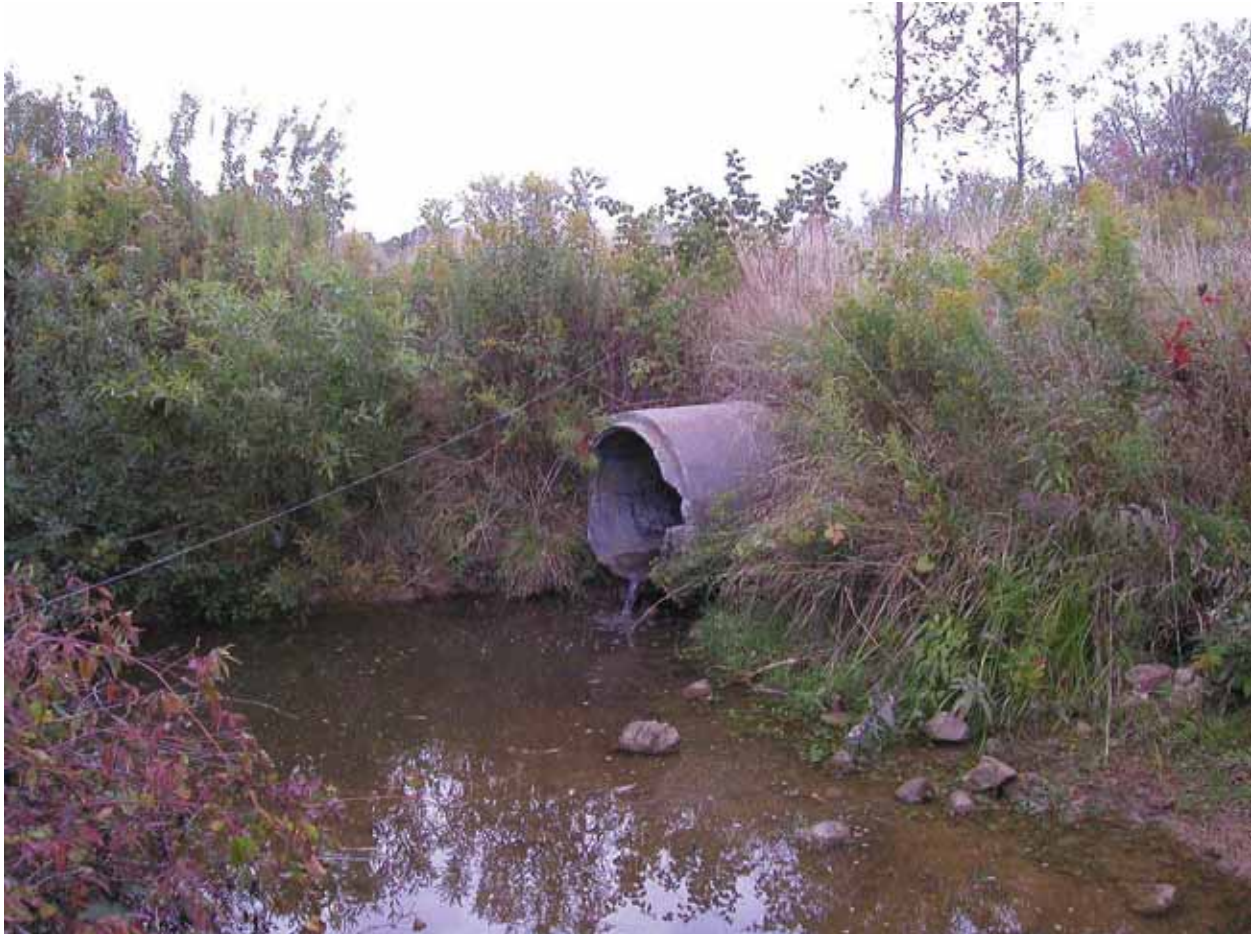
FIGURE 2.5.3-24
HANGING CULVERT ON REACH CET1

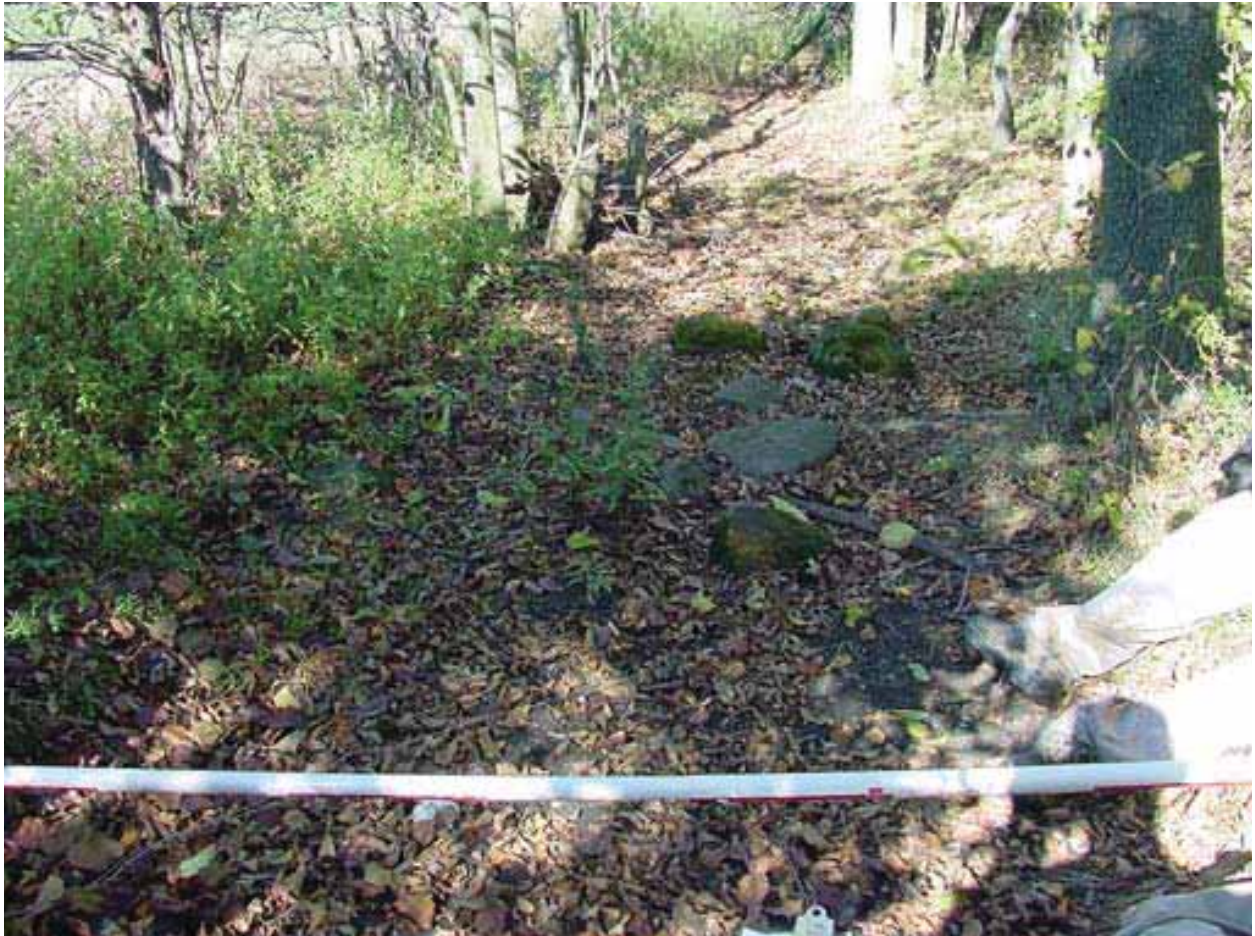
FIGURE 2.5.3-26
DRY STREAM CHANNEL THROUGH A SECTION OF REACH CWT1

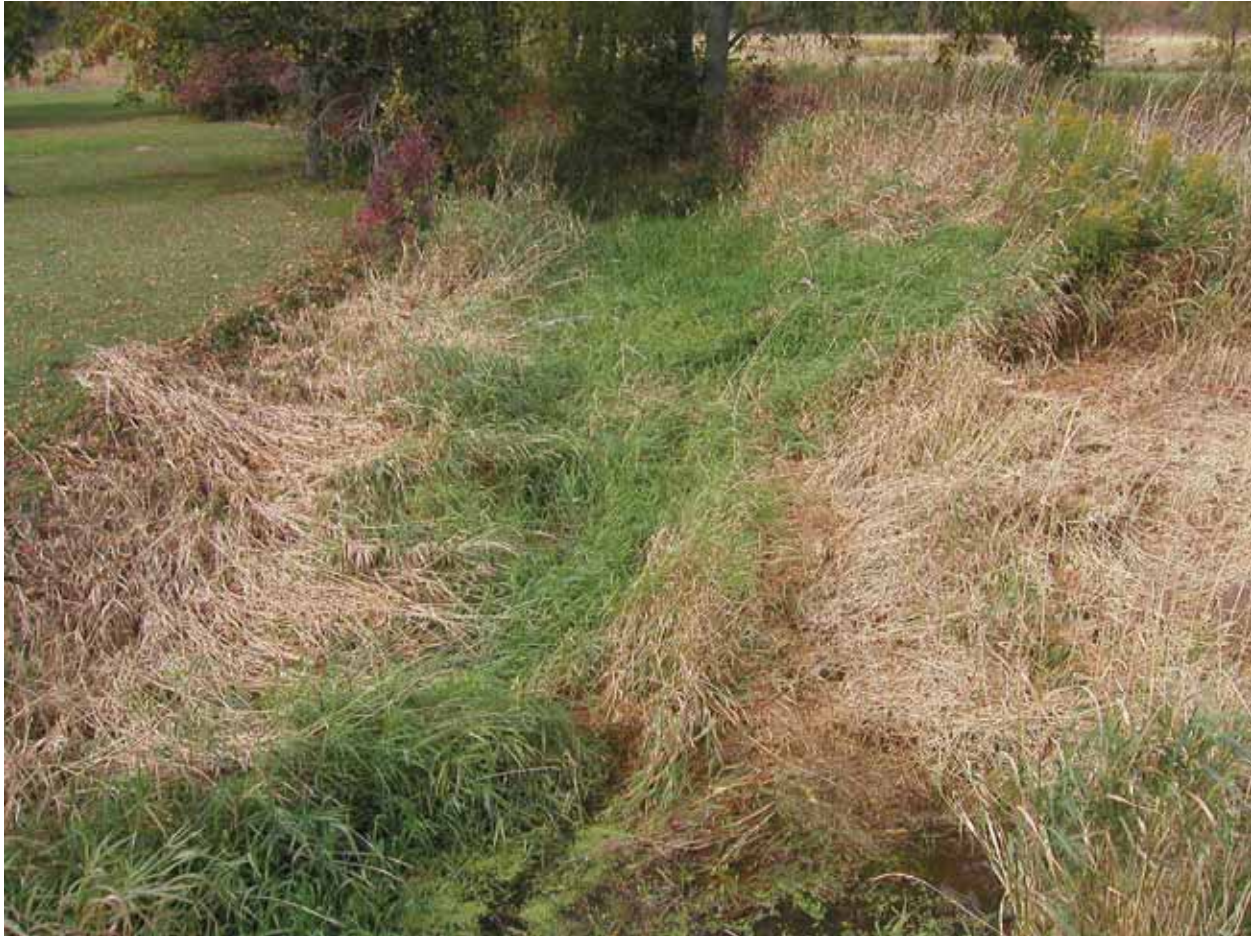
**FIGURE 2.5.3-33
THE UPSTREAM SECTION OF REACH BZ3 OVERGROWN WITH VEGETATION**
