### **Stream Assessments in the Niagara River Greenway**

Prepared by: Dr. Kelly M. Frothingham  
Prepared for: Buffalo Niagara Riverkeeper

January 2014

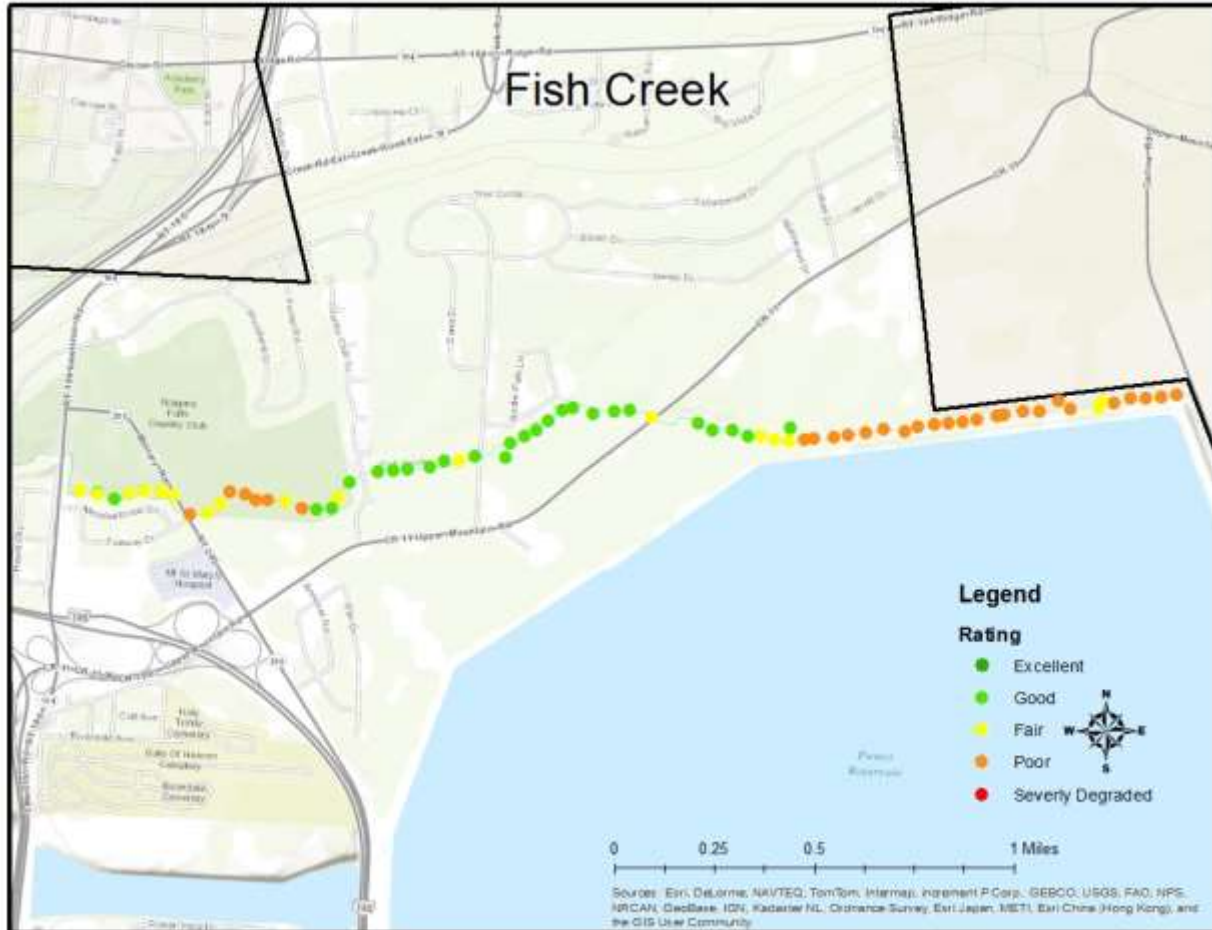
Figure 3 Fish Creek overall SVAP ratings for each reach.

The total number of reaches assessed in Fish Creek was 72 and the average overall SVAP score was 6.0 (Fair) (range 3.5-8.3) (Figure 3). Bed substrate in Fish Creek was silt and clay with gravel and/or cobble (79% of reaches). The physical channel conditions are summarized in Table 2 and Table 3 contains a summary of conditions for each SVAP element.

Channel condition scores were low (2) in the upstream portion of Fish Creek (Reaches 1-26) where the creek was channelized (straightened with riprap) adjacent to the New York Power Authority (NYPA) reservoir. Scores were higher (9.0, on average) in the middle portion of Fish Creek (Reaches 27-55), indicating the presence of a natural channel with established vegetation and little or no evidence of incision or aggradation. Channel condition scores decreased (7-8) in the downstream reaches as the stream flowed through the Niagara Falls Country Club Golf Course (Reaches 56-62) and exhibited evidence of past channelization. Reaches 63 through 72 exhibited channel straightening, hard structures in 50% of the reaches (5 of 10 reaches), and evidence of channel incision.

Like channel condition scores, bank condition scores were low (2) in the upstream portion of Fish Creek (Reaches 1-26) where the banks were stable, but hard structures were present on both banks in all reaches. Bank condition scores indicate moderately stable to stable banks protected by natural vegetation, wood, or rock in Reaches 27 through 55, with the exception of moderately unstable banks in Reaches 39 through 41. Streambanks were also moderately unstable in Reaches 56 through 64 (i.e., through and immediately downstream of the Niagara Falls Country Club Golf Course). Reaches 66

- Riparian zone/canopy cover improvements in the upstream section of the stream adjacent to the NYPA power reservoir (Reaches 1-33) with possible instream habitat restoration opportunities (e.g. bed structure like pools).
- Invasive species (purple loosestrife, Phragmites) removal in the upper and middle portions of the assessed creek (Reaches 1-38).
- Environmental education/outreach and Shoreline Sweep opportunities in the area around Upper Mountain Road (Reaches 34-51) (problems: trash/debris, mowing to streamsides, recreational vehicle paths).
- Riparian zone and bank condition improvement/stabilization in the stream section flowing through the Niagara Falls Country Club (Reaches 56-64).

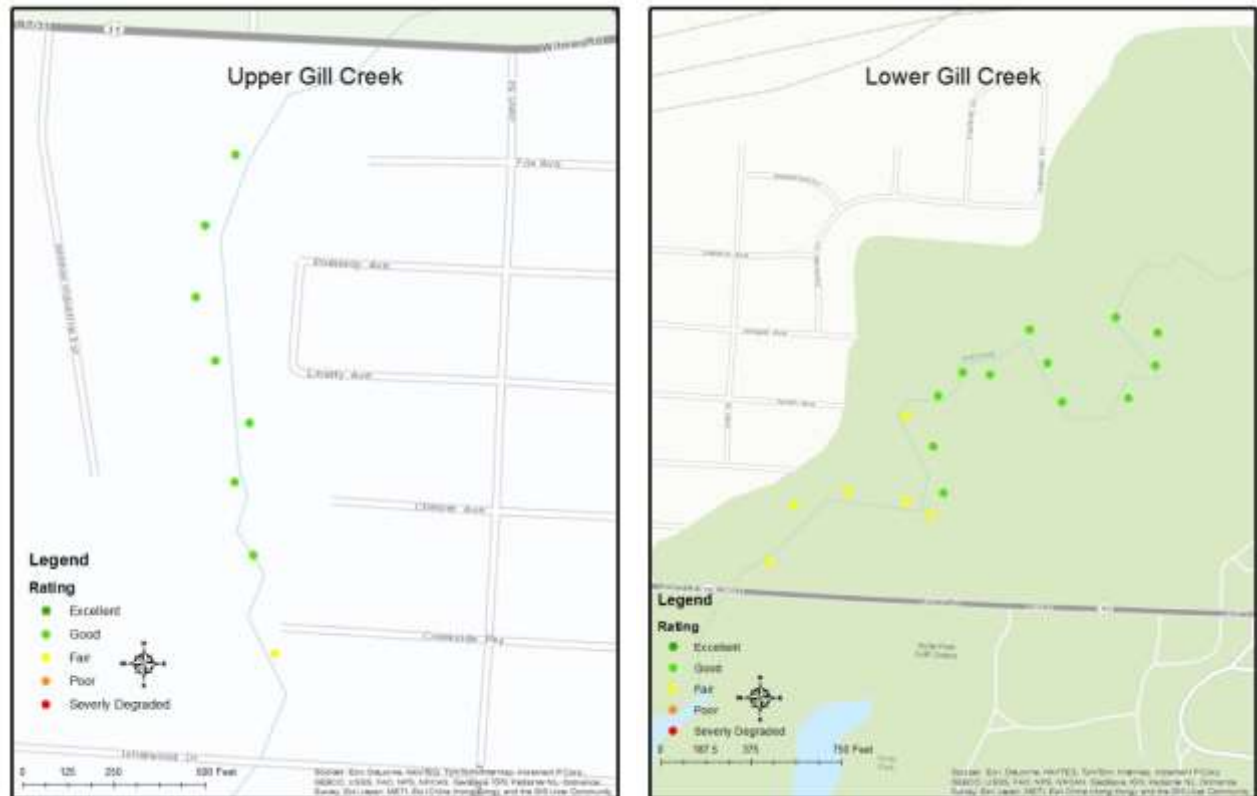
Figure 4 Gill Creek overall SVAP ratings for each reach.

The total number of reaches assessed in Gill Creek was 26 and the average overall SVAP score was 6.9 (Fair) (range 5.0-8.4) (Figure 4). The dominate bed substrate in Gill Creek was silt and clay (65% of reaches); however, coarser substrate (e.g., gravel, cobble, boulders) was noted in Reaches 1 through 8. The physical channel conditions are summarized in Table 4 and Table 5 contains a summary of conditions for each SVAP element.

Channel condition scores were high ( $\geq 6$ ) throughout Gill Creek, indicating the presence of a natural channel with established vegetation and little or no evidence of incision or aggradation (15 of 26 reaches) or a channel with significant recovery from channelization (10 of 26 reaches). Reach 8 had a channel condition score of 2 because the stream was channelized with hard structures to accommodate a road crossing.

All 26 reaches had average bank condition scores indicating moderately stable to stable banks protected by roots, natural vegetation, wood, and natural rock. Limited riprap was noted on at least one bank in six reaches (Reaches 1-4, 8, 25).

- Riparian zone and habitat conservation throughout the assessed creek, but especially in Reaches 1 through 8 between Fox Ave. and Isherwood Dr. Habitat conservation would preserve abundant instream habitat, including pools, and habitat with coarse bed substrate.
- Bank condition/stabilization in Reach 8, as a structure is threatened.
- Riparian zone improvements (e.g., planting to increase width) in the downstream section of the Hyde Park Golf Course (Reaches 24-26).
- Environmental education/outreach in the section between Fox Ave. and Isherwood Dr. (Reaches 1-8) (problems: trails along the streambank; mowing to streamsides in some reaches).
- Shoreline Sweep opportunities between Fox Ave. and Isherwood Dr. (Reaches 1-8) where litter was abundant and included large debris (e.g., shopping cart).
- Potential concrete dam removal in Reach 13 in the Hyde Park Golf Course section of stream.

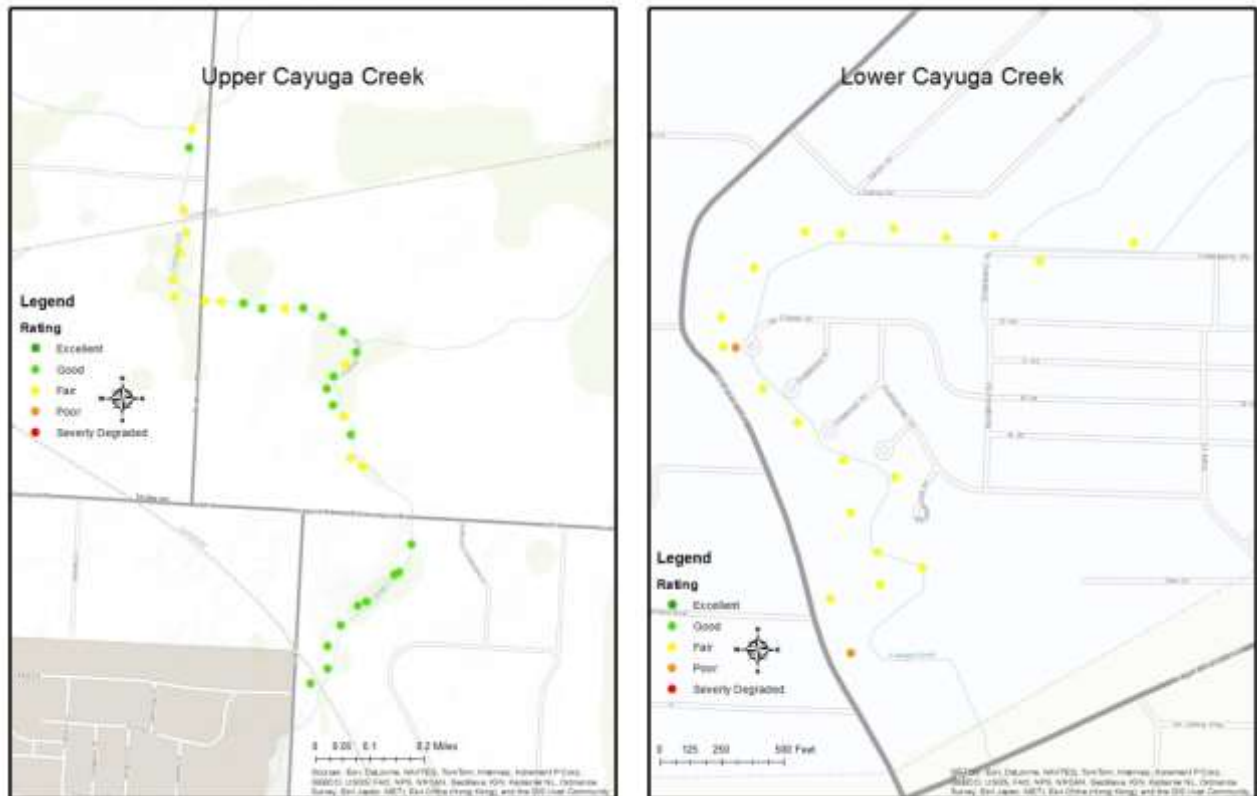
Figure 5 Cayuga Creek overall SVAP ratings for each reach.

The total number of reaches assessed in Cayuga Creek was 56 and the average overall SVAP score was 6.6 (Fair) (range 4.6-8.8) (Figure 5). Bed substrate in Cayuga Creek was a mix of silt and clay (20% of reaches) and silt and clay, plus gravel and/or cobble (50% of reaches). Thirty percent of the reaches are completely gravel, cobble, or boulder. The physical channel conditions are summarized in Table 6 and Table 7 contains a summary of conditions for each SVAP element.

Channel condition scores were high ( $\geq 6$ ) throughout upstream and middle portions of Cayuga Creek (Reaches 1-35), indicating the presence of a natural channel with established vegetation and little or no evidence of incision or aggradation (27 of 35 reaches) or a channel with significant recovery from channelization (8 of 35 reaches). However, channel condition scores dropped in the downstream portion of the creek between Porter Rd. and Niagara Falls Boulevard (Reaches 36-56). The creek was straightened throughout that portion and most of the reaches (13 of 21 reaches) had riprap, concrete, or other hard structures present on the streambanks.

Seventy-nine percent of reaches (44 reaches) had average bank condition scores indicating moderately stable to stable banks protected by roots, natural vegetation, wood, and natural rock or banks with a limited number of bank protection structures. While most (64%, or 36 reaches) of the streambanks were natural (i.e., no hard structures) on both banks, hard structures were observed on one or both sides of the channel in reaches throughout the length of the creek. Hard structures were observed on one or both banks in 23% of the reaches (8 of 35 reaches) in the upper and middle portions of the creek (Reaches 1-35) versus on 57% of the reaches (12 of 21) in the lower portion of the creek (Reaches 36-56).

- Riparian zone improvements (e.g., planting to increase width) in the Walmore Rd. and Cory Dr. section (Reaches 1-8), the Walmore to Lockport section (Reaches 9-25), and the Porter Rd. to Trailer Park and Trailer Park to Niagara Falls Blvd. sections (Reaches 36-56). These improvements would likely improve water quality conditions and, thereby, increase nutrient enrichment scores. Moreover, minimal efforts would enhance a portion of the creek with existing habitat.

- Invasive species (purple loosestrife, Japanese knotweed, Phragmites) removal in the upper and middle portions of the assessed creek (Reaches 1-35).
- Environmental education/outreach and Shoreline Sweep opportunities in the same sections (i.e., Reaches 1-8 and 36-56) (problems: trash/debris, mowing to streambanks,).

- Channel and bank condition improvements (e.g., channel realignment, addition of instream habitat structure) in the section of stream that flows through and downstream of the Cayuga Village Trailer Park (Reaches 32-56).

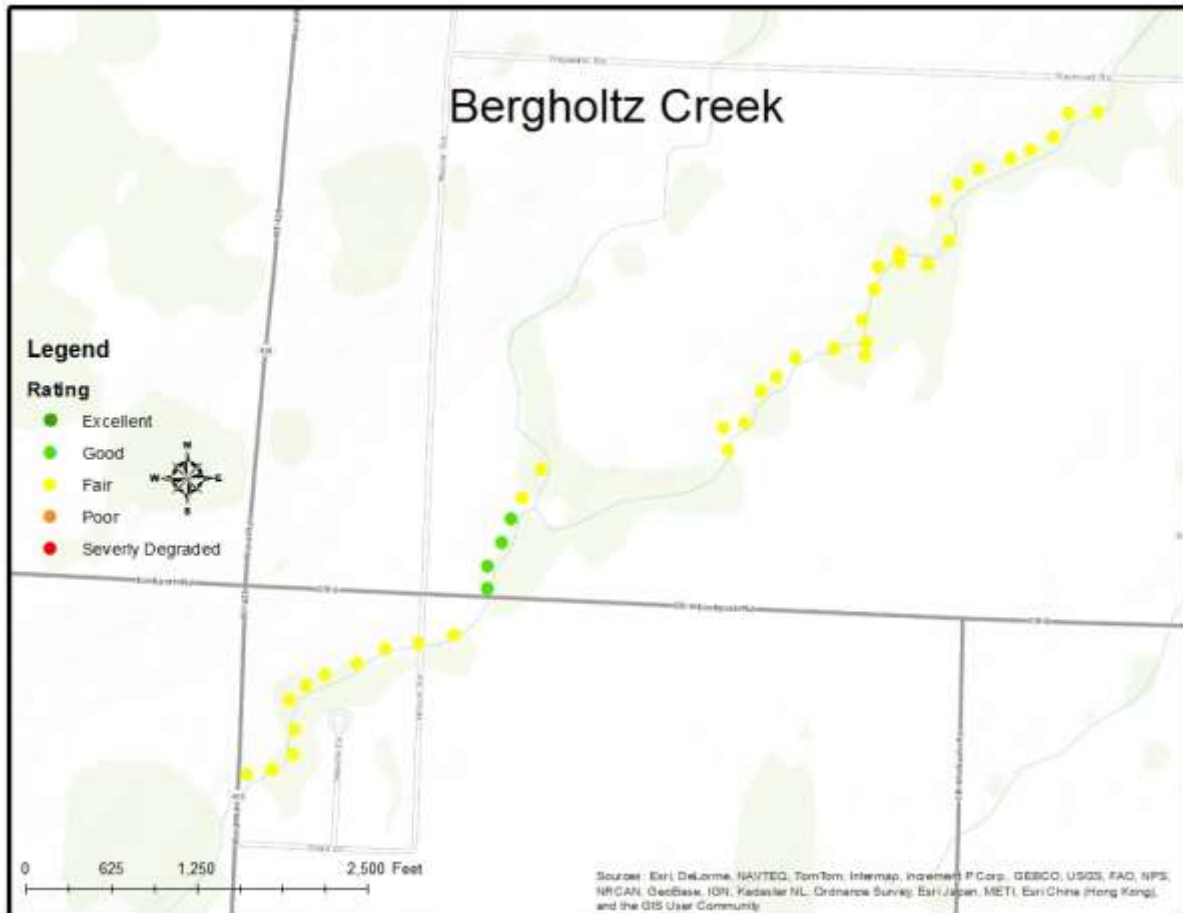
Figure 6 Bergholtz Creek overall SVAP ratings for each reach.

The total number of reaches assessed in Bergholtz Creek was 41 and the average overall SVAP score was 6.2 (Fair) (range 5.1-8.1) (Figure 6). Bed substrate in Bergholtz Creek was silt and clay (49% of reaches) and silt and clay, plus gravel and/or cobble (41% of reaches). The physical channel conditions are summarized in Table 8 and Table 9 contains a summary of conditions for each SVAP element.

Eighty-five percent of reaches (35 reaches) had average bank condition scores indicating moderately stable to stable banks protected by roots, natural vegetation, wood, and natural rock. Bank condition scores were low (3-5), indicating moderately unstable banks, in the section of Bergholtz Creek between Lockport Rd. to Ward Rd. (Reaches 33-39).

Water appearance scores were low (3-4) indicating that the creek is turbid most of the time. This is likely due to the silt and clay bed substrate found throughout the assessed portion of the creek.

- Riparian zone improvements (e.g., planting to increase width) in the section between Lockport Rd. and Ward Rd. (Reaches 29-39).
- Bank condition improvement/stabilization in the section between Lockport Rd. to Ward Rd. (Reaches 33-39). Note: increasing the riparian zone in this section may be all that is necessary to provide increased bank stability to the moderately unstable reaches in this section.

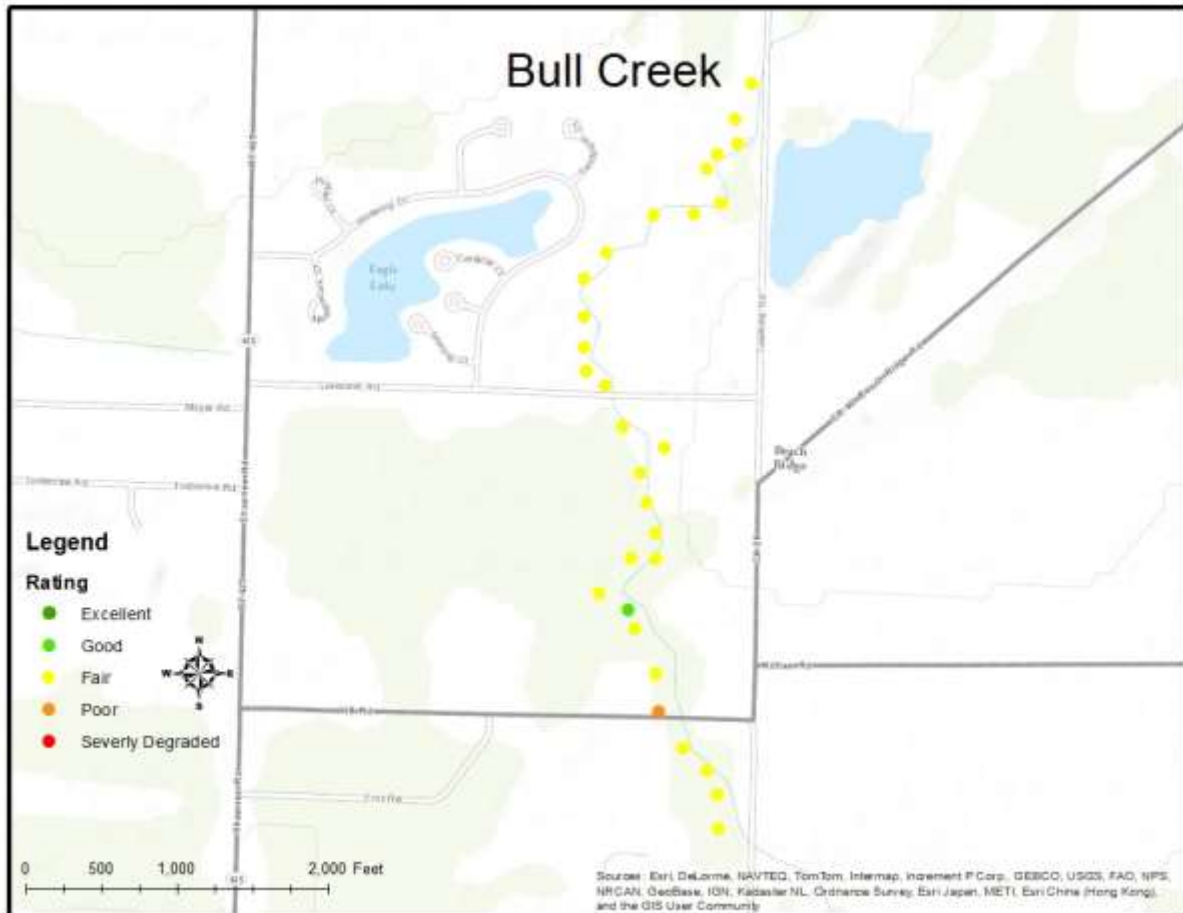
Figure 7 Bull Creek overall SVAP ratings for each reach.

The total number of reaches assessed in Bull Creek was 30 and the average overall SVAP score was 6.0 (Fair) (range 4.8-7.1) (Figure 7). The dominant bed substrate in Bull Creek was silt and clay (77% of reaches). The physical channel conditions are summarized in Table 10 and Table 11 contains a summary of conditions for each SVAP element.

Ninety-seven percent of reaches (29 reaches) had average bank condition scores indicating moderately stable to stable banks protected by roots, natural vegetation, wood, and natural rock. Reach 26 had a bank condition score of 5 indicating moderately unstable banks. Limited riprap was noted on at least one bank in three reaches (Reaches 24, 25, 27).

Water appearance scores were very low (1-2) in all assessed reaches. As noted previously, the dominant bed substrate in Bull Creek is silt and clay and field notes indicated mucky bottom material on several occasions.

- Riparian zone conservation throughout the assessed creek.
- Invasive species (purple loosestrife) removal throughout the assessed creek.
- Riparian zone improvements (e.g., planting to increase width) in the downstream end of the section between Loveland Rd. and Townline Rd. (Reaches 24-26).
- Shoreline Sweep opportunities between Townline Rd. and Loveland Rd. (Reaches 25-30).
- Consider removal of debris jam in Reach 10 in the Townline Rd. to Loveland Rd. section.

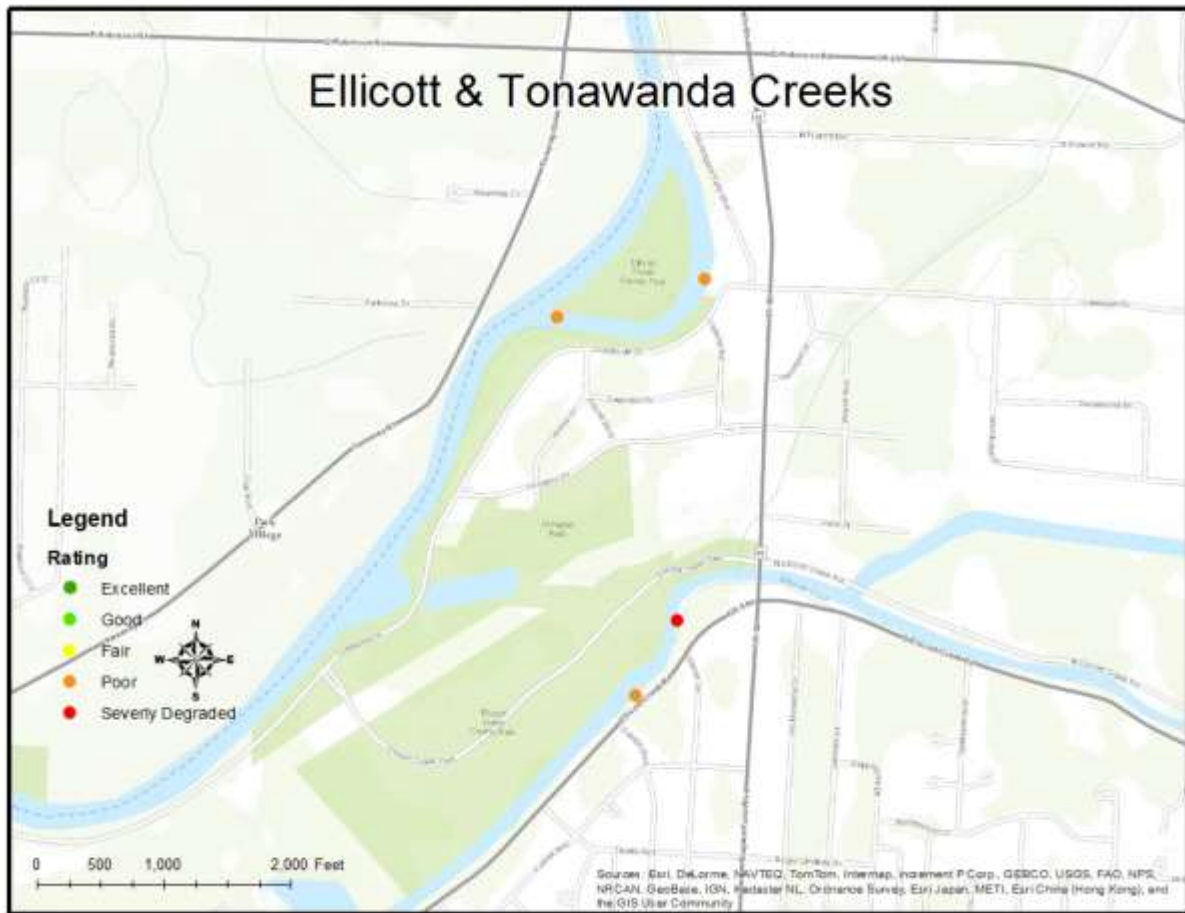
Figure 8 Ellicott and Tonawanda Creeks overall SVAP ratings for each reach.

Two reaches were assessed on both Ellicott Creek and Tonawanda Creek. The average overall SVAP score for Ellicott Creek was 3.1 (Poor) and the average overall SVAP score for Tonawanda Creek was 3.3 (Poor) (Figure 8). The dominant bed substrate in both creeks is silt and clay. The physical channel conditions are summarized in Table 12 and Table 13 contains a summary of conditions for each SVAP element.

Channel condition scores were low (2) in both reaches on both creeks because the creeks are channelized (straightened with riprap).

Bank condition scores were low (1.5-3.0) in all reaches, as riprap and other structures dominated the banks.

- Invasive species (purple loosestrife and Phragmites) removal.
- Riparian zone improvements (e.g., planting to increase width).
- Shoreline Sweep opportunities.

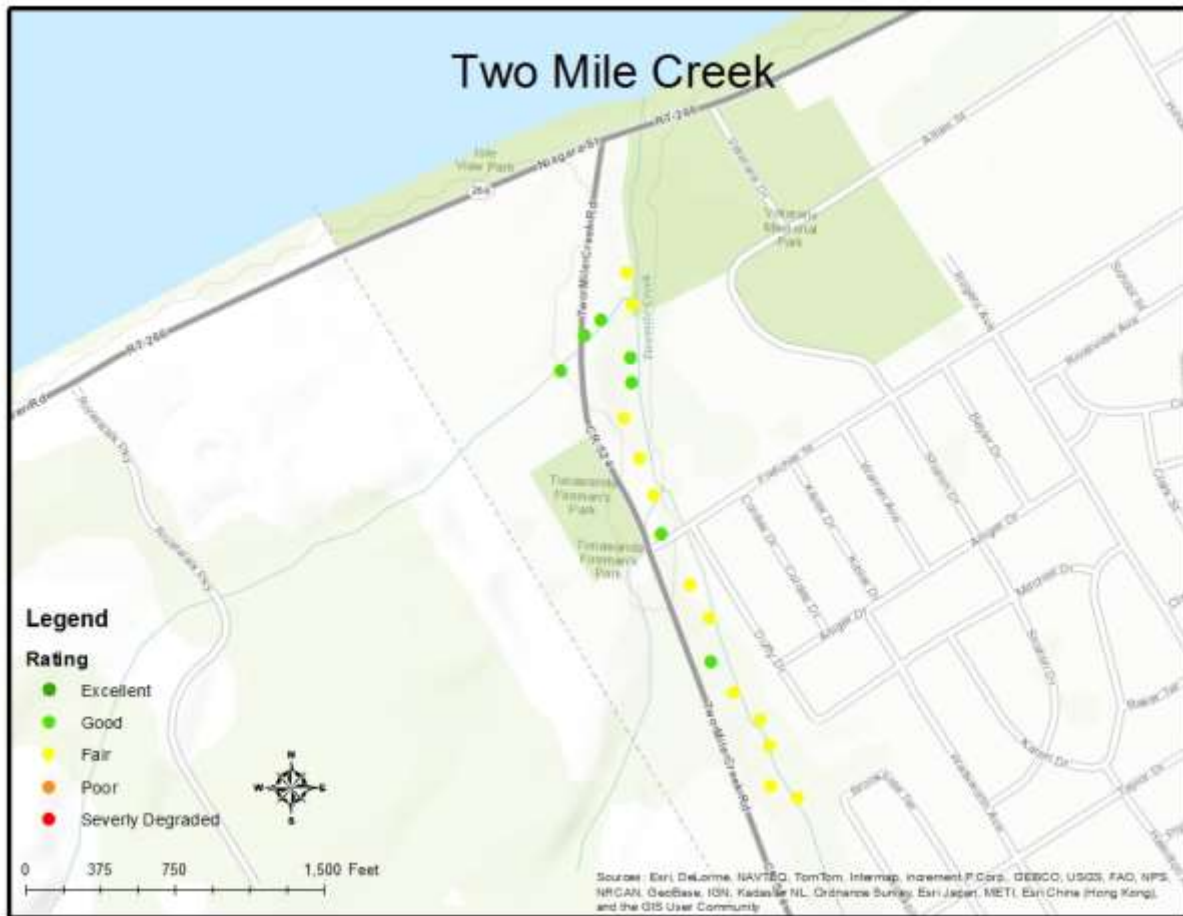
Figure 9 Two Mile Creek (and tributary) overall SVAP ratings for each reach.

The total number of reaches assessed in Two Mile Creek was 19 and the average overall SVAP score was 6.9 (Fair) (range 5.4-8.4) (Figure 9). Bed substrate in Two Mile Creek was mix of primarily sand and gravel (11 of 19 reaches) with some smaller sediment (clay/silt) and larger sediment (cobble). The physical channel conditions are summarized in Table 14 and Table 15 contains a summary of conditions for each SVAP element.

Channel condition scores were high ( $\geq 6$ ) throughout most of Two Mile Creek, indicating the presence of a natural channel with established vegetation and little or no evidence of incision or aggradation (five of 19 reaches) or a channel with significant recovery from channelization (10 of 19 reaches). However, channel condition scores were lower in the upstream portion of the assessed stream along Two Mile Creek Rd. (Reaches 1-5) where channel incision was noted.

Average bank condition scores were low (2.0-5.5), indicating moderately unstable to unstable banks, in the upstream portion of the assessed creek where channel incision was noted (Reaches 2-5). Average bank condition scores in the other 15 reaches indicated moderately stable to stable reaches. Limited riprap was noted on at least one bank in two reaches (Reaches 6 and 7).

- Riparian zone and habitat conservation throughout the assessed creek. Habitat conservation would preserve abundant instream habitat, including deep pools, and habitat with coarse bed substrate.
- Invasive species (Phragmites, Japanese knotweed, and purple loosestrife) removal throughout the assessed portion of the creek.
- Bank and channel condition improvement/stabilization in the upstream stream section along Two Mile Creek Rd. (Reaches 1-5) to address channel incision and unstable bank conditions.
- Riparian zone improvements (e.g., planting to increase width) in the upstream end of the section between Fletcher St. and River Rd. (Reaches 9-11).
- Shoreline Sweep opportunities throughout the assessed stream.

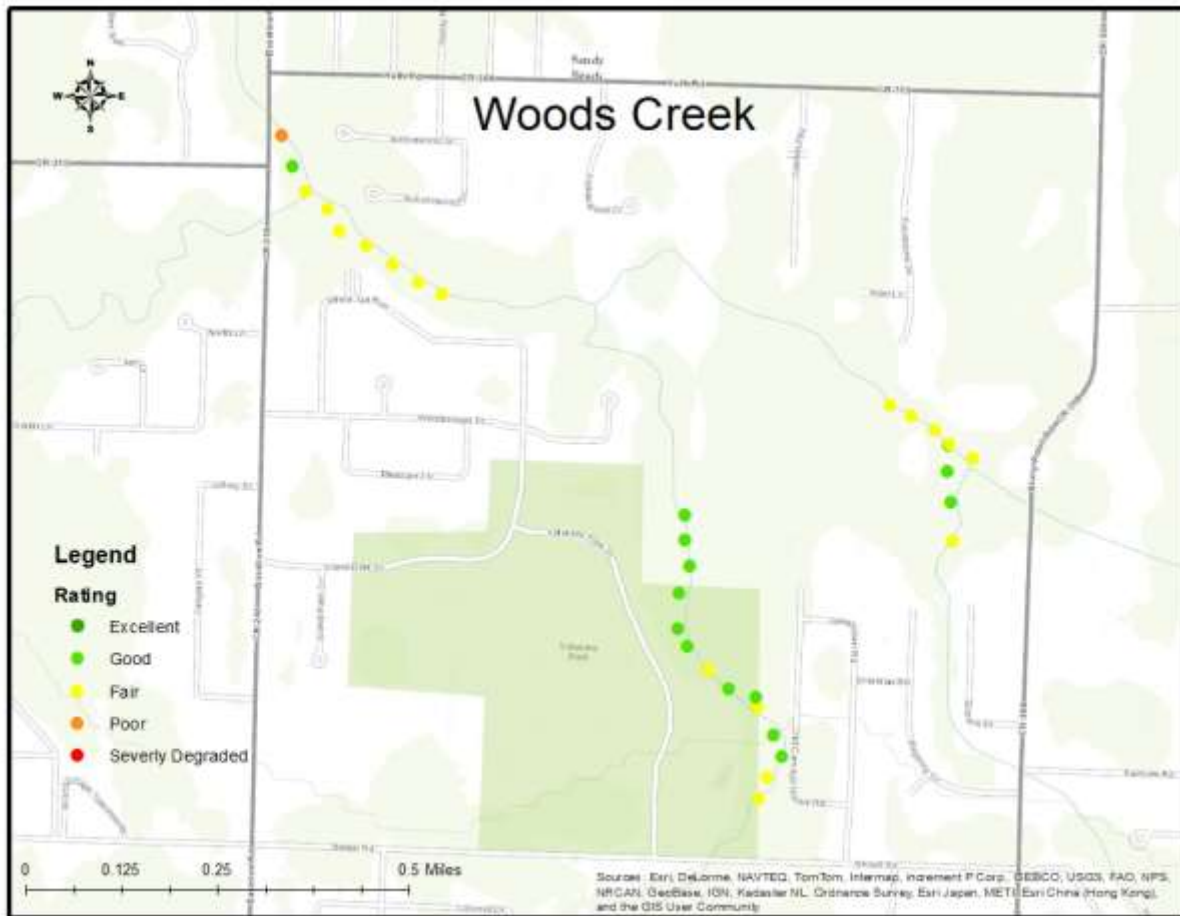
Figure 10 Woods Creek (and tributaries) overall SVAP ratings for each reach.

The total number of reaches assessed in Woods Creek was 32 and the average overall SVAP score was 6.7 (Fair) (range 4.8-8.1) (Figure 10). Dominant bed substrate in Woods Creek was silt/clay (66% of reaches) with some coarser substrate (e.g., gravel, cobble) found in the remaining 11 reaches. The physical channel conditions are summarized in Table 16 and Table 17 contains a summary of conditions for each SVAP element.

Channel condition scores were high (8-10) throughout most of Woods Creek, indicating the presence of a natural channel with established vegetation and little or no evidence of incision or aggradation (28 of 32 reaches) or a channel with significant recovery from channelization (three of 32 reaches). However, minimal channel incision was noted in seven reaches, six of which were located between Autumnwood Dr. and Baseline Rd. (Reaches 10-15) and one was located between Queens Dr. to Fieldstone Dr. (Reach 3). Riprap or other hard structures were not observed in any reaches.

All but one reach had high ( $\geq 6$ ) average bank condition scores, indicating stable to moderately stable banks that were protected by roots, natural vegetation, wood, and naturally occurring rock. Reach 3 scored a 5, indicating moderately unstable banks.

- Riparian zone and habitat conservation throughout the assessed creek. Habitat conservation would preserve existing instream habitat, especially in the natural areas of Veterans Park.
- Invasive species (purple loosestrife) removal, especially in the Bedell Rd. to Veterans Park section of the creek.
- Riparian zone improvements (e.g., planting to increase width) in the upstream end of the section between Fletcher St. and River Rd. (Reaches 9-11).

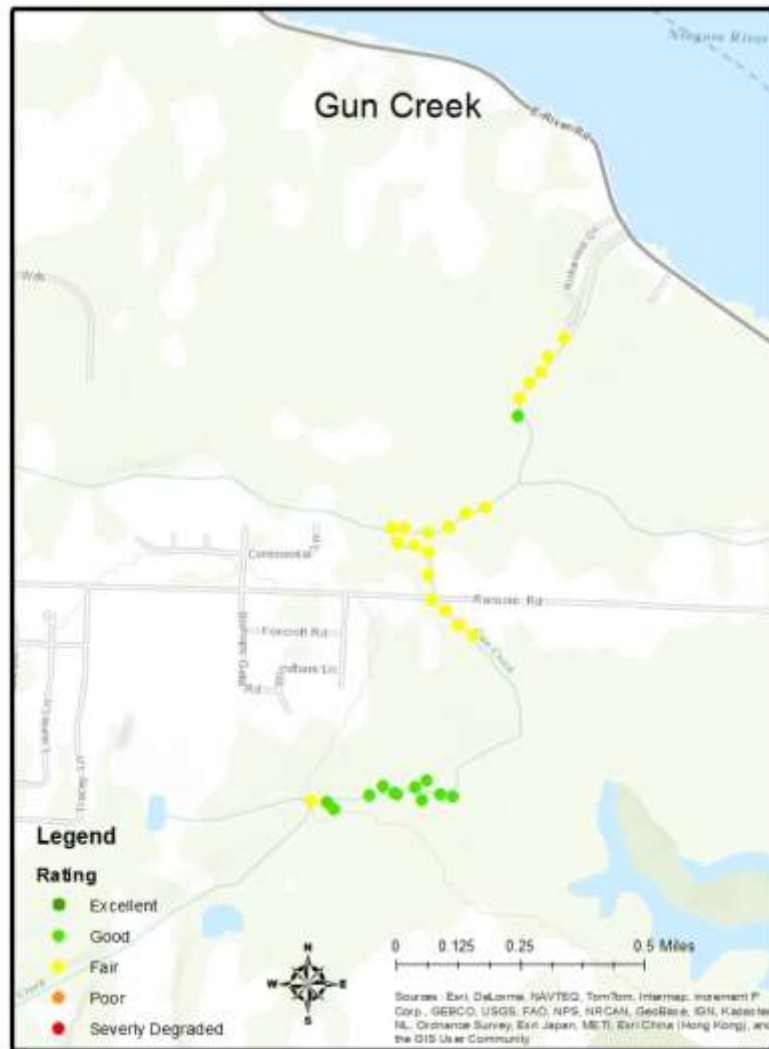
Figure 11 Gun Creek overall SVAP ratings for each reach.

The total number of reaches assessed in Gun Creek was 32 and the average overall SVAP score was 6.6 (Fair) (range 5.0-8.3) (Figure 11). Dominant bed substrate in Gun Creek was silt/clay (88% of reaches) with some coarser substrate (e.g., gravel) found in the remaining four reaches. The physical channel conditions are summarized in Table 18 and Table 19 contains a summary of conditions for each SVAP element.

Channel condition scores were high ( $\geq 6$ ) throughout most of Gun Creek, indicating the presence of a natural channel with established vegetation and little or no evidence of incision or aggradation (10 of 32 reaches) or a channel with significant recovery from channelization (17 of 32 reaches). However, minimal channel incision was noted in three reaches (Reaches 24-26) and minimal aggradation was noted in four reaches (Reaches 20-22 and 24), all of which were in the Ransom Rd. to Kirkwood Dr. stream section. Riprap or other hard structures were not observed in any reaches.

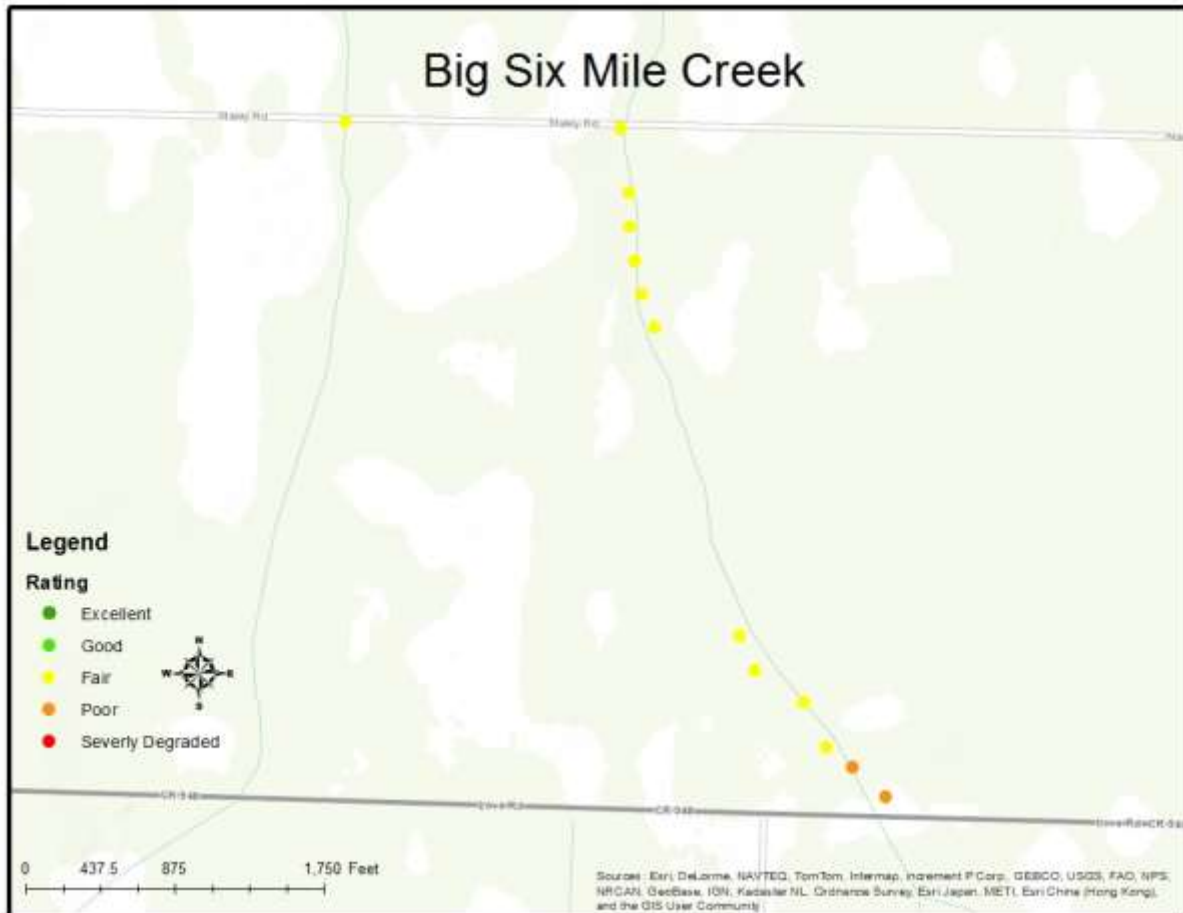
Figure 12 Big Six Mile Creek (and tributary) overall SVAP ratings for each reach.

The total number of reaches assessed in Big Six Mile Creek was 13 and the average overall SVAP score was 6.0 (Fair) (range 4.5-6.9) (Figure 12). Dominant bed substrate in Woods Creek was silt/clay (100% of reaches). The physical channel conditions are summarized in Table 20 and Table 21 contains a summary of conditions for each SVAP element.

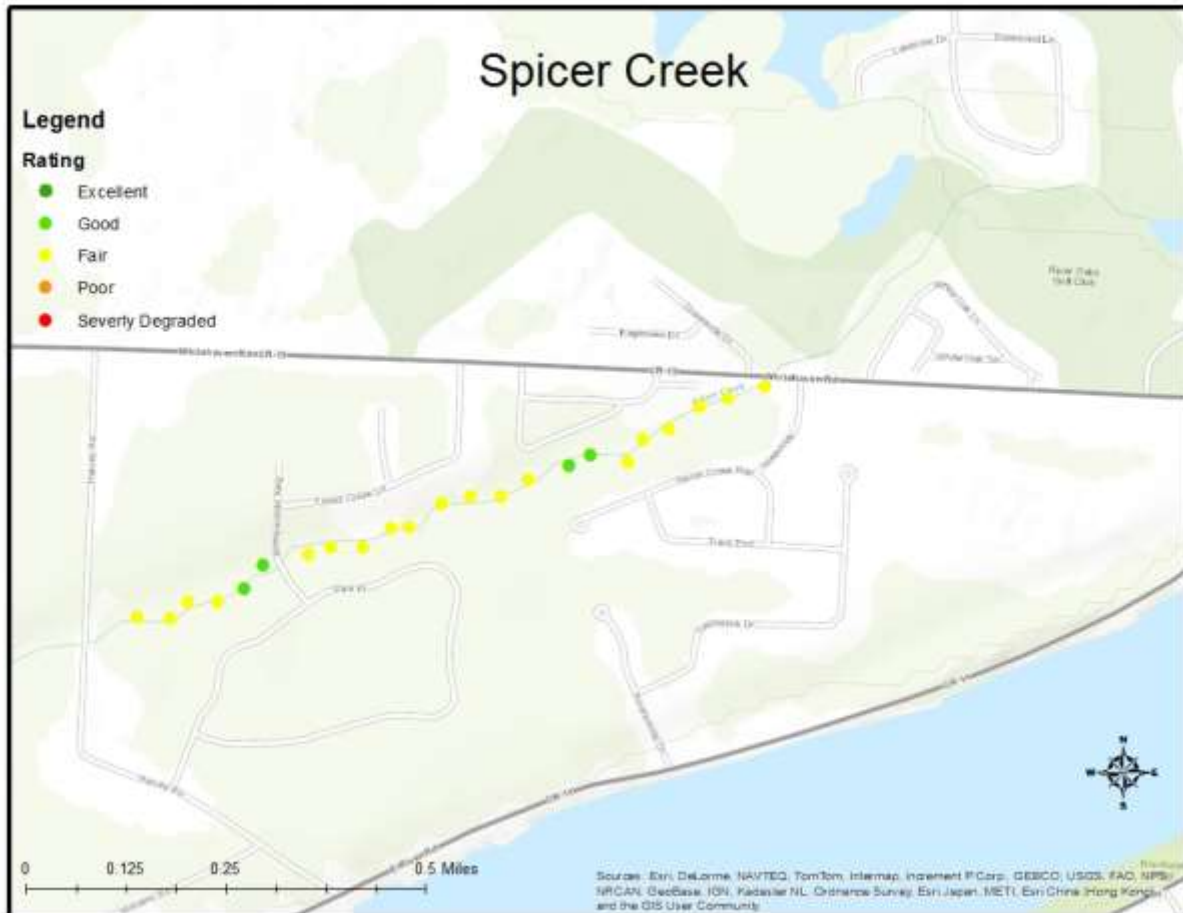
Figure 13 Spicer Creek overall SVAP ratings for each reach.

The total number of reaches assessed in Spicer Creek was 23 and the average overall SVAP score was 6.5 (Fair) (range 5.5-7.4) (Figure 13). Bed substrate in Spicer Creek is silt/clay (52% of reaches) or silt/clay with gravel or cobble (48% of reaches). The physical channel conditions are summarized in Table 22 and Table 23 contains a summary of conditions for each SVAP element.
