Chapter 3: Buffalo River

REGIONAL NIAGARA RIVER/LAKE ERIE WATERSHED MANAGEMENT PLAN (Phase 2)

Sub-watershed Implementation Plans

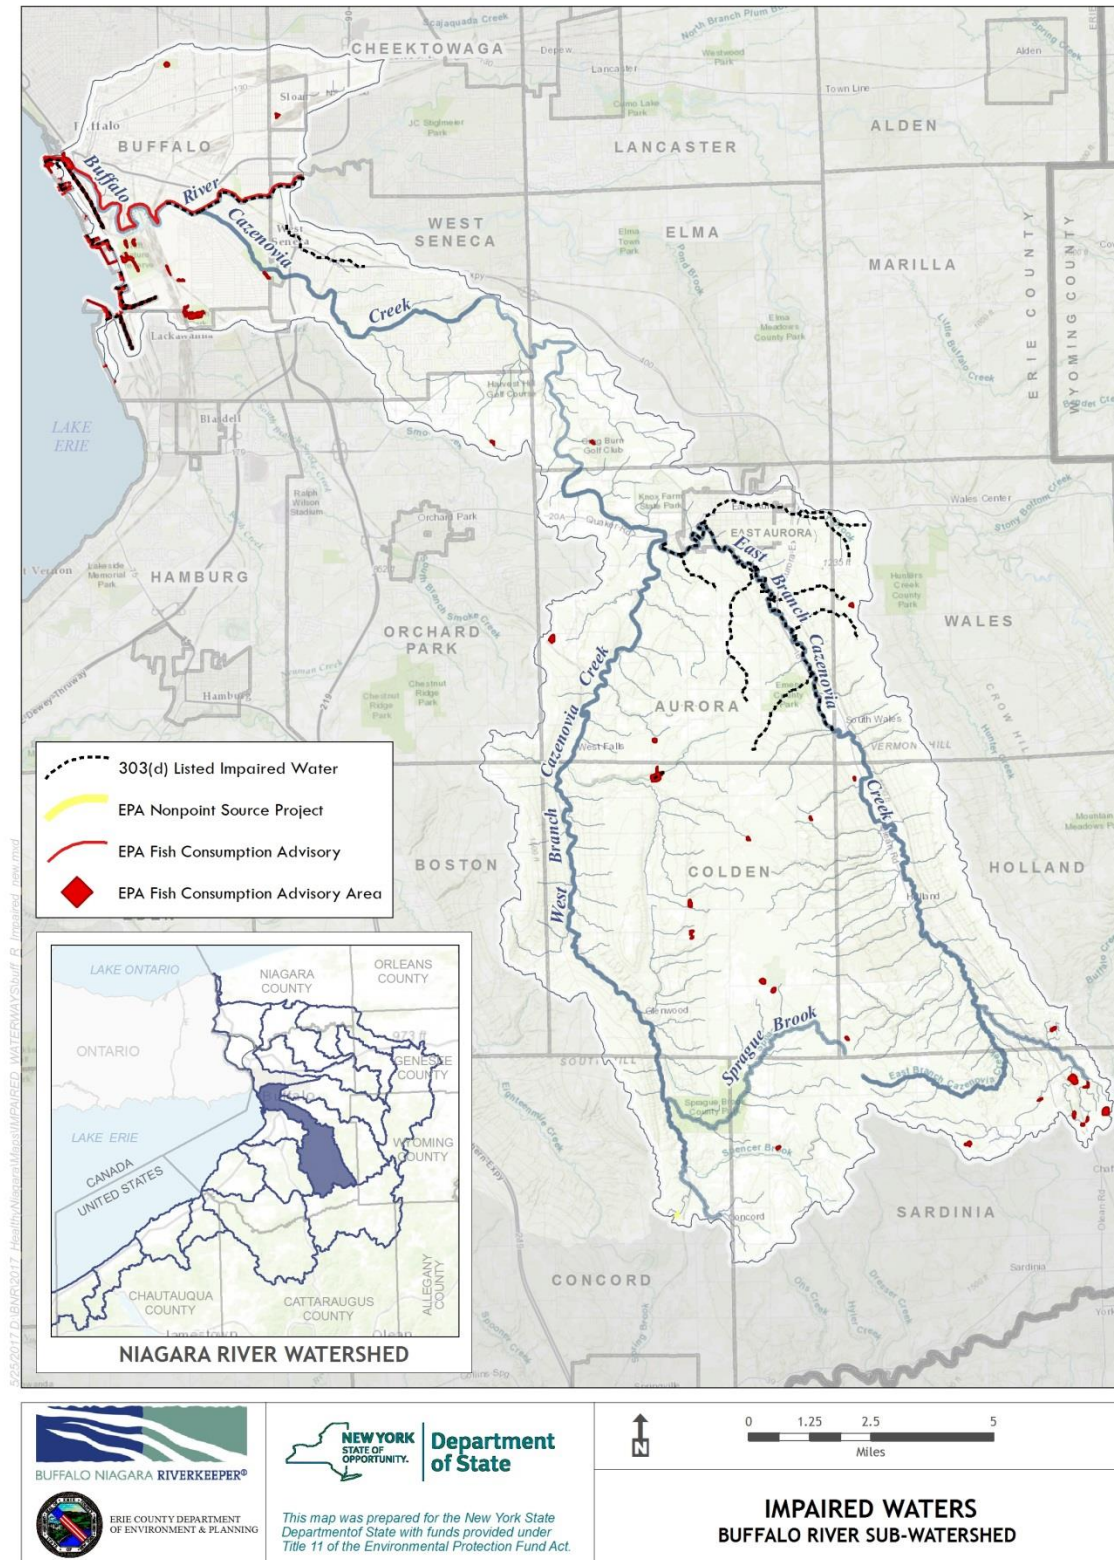
As depicted in Map 3.5, many of the sub-watershed’s streams including the Buffalo River, the East Branch Cazenovia Creek, and the Outer Harbor are listed on the 303(d) list, another indication of impaired waterways. Waterways in this sub-watershed may additionally be listed as EPA Fish Consumption Advisory Areas, or as part of the EPA Nonpoint Source Project, a program instituted by the EPA to provide funding opportunities through Section 319 of the Clean Water Act and administered by the NYS DEC to “control pollution from nonpoint sources to the waters of the state and to protect, maintain and restore waters of the state that are vulnerable to, or are impaired by nonpoint source pollution.”⁹

Map 3.5: Buffalo River Sub-watershed Impaired Waterways

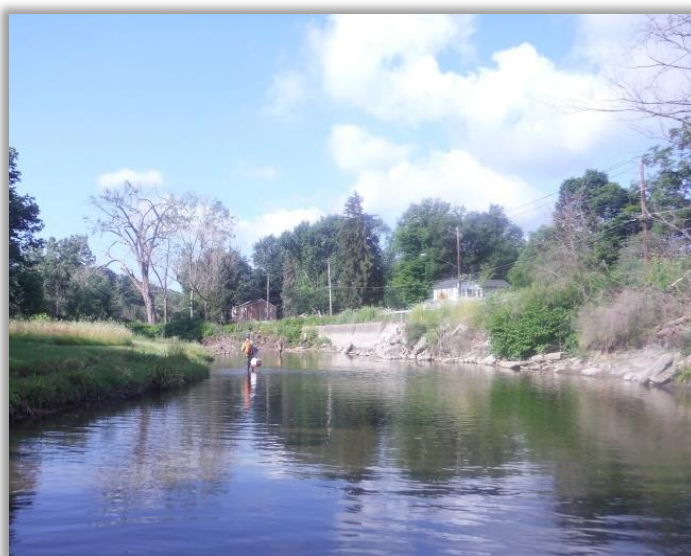
All waterbodies assessed were found to have average channel condition scores of 'good' to 'excellent' (8.1-9.8). Assessed stream channels were generally un-altered with limited channelization or use of rip-rap. This lack of modification has a positive impact on wildlife and overall stream health. Areas of channel alteration were concentrated around areas of development or where infrastructure was located near streams, as seen in Figure 3.2. While channel conditions skewed towards good, many problems related to erosion in this area exist, as shown by inspections and erosion control projects undertaken by the Erie Wyoming County Joint Watershed Board. These areas are concentrated in the East Branch from Savage Road in Holland to East Aurora, and in the West Branch from Glenwood to Jewett Holmwood Road, among

**Figure 3.2: Altered Stream Channel east of Orchard Park
 - Cazenovia Creek West Branch (BNR)**

various other sites in the main stem such as intersections with Northrup Road and Union Road. Additionally, heavily modified stream and fish barriers such as Legion Dam in East Aurora further degrade stream channels in BR.

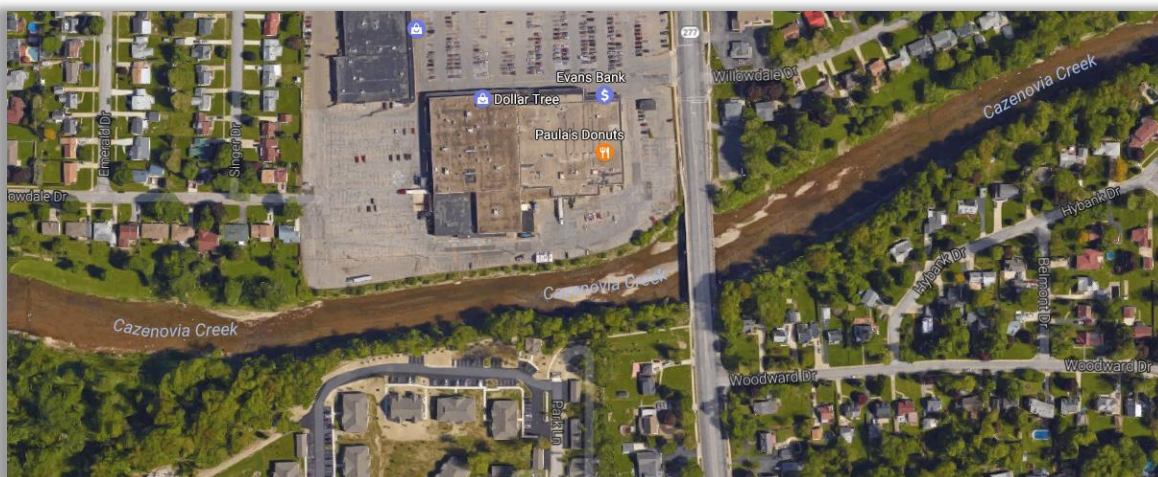
The riparian zone, or area of natural vegetation bordering waterbodies, along assessed stretches of Cazenovia Creek, excluding the Main Stem, received average scores of ‘good’ to ‘excellent’ (8.4+). The Main Stem of Cazenovia Creek received the lowest average riparian zone score of ‘fair’ (7.3). As Cazenovia Creek flows toward the city of Buffalo, it meanders through many suburban areas with heightened residential and commercial development. In these areas, riparian vegetation along the creek is often compromised or removed as seen below in Figure 3.3. In these areas, the potential for urban stormwater runoff is elevated.

Figure 3.3: Compromised riparian vegetation along Cazenovia Creek, Main Stem (Google Maps)

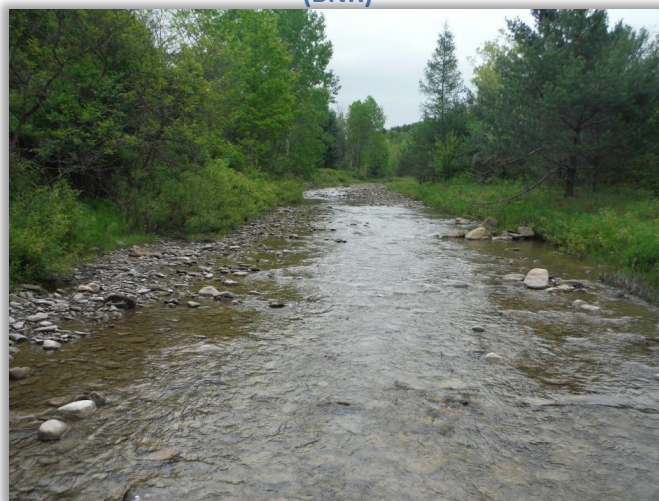
Figure 3.4: Riparian vegetation along Sprague Brook (BNR)

In areas closer to the headwaters, further removed from the pressures of development, riparian vegetation remains well intact. A segment of Sprague Brook over three miles long was assessed within the limits of Sprague Brook County Park. This segment received the highest average score for riparian zone within the entire sub-watershed of ‘excellent’ (9.9). This waterbody was characterized by extensive riparian vegetation, as

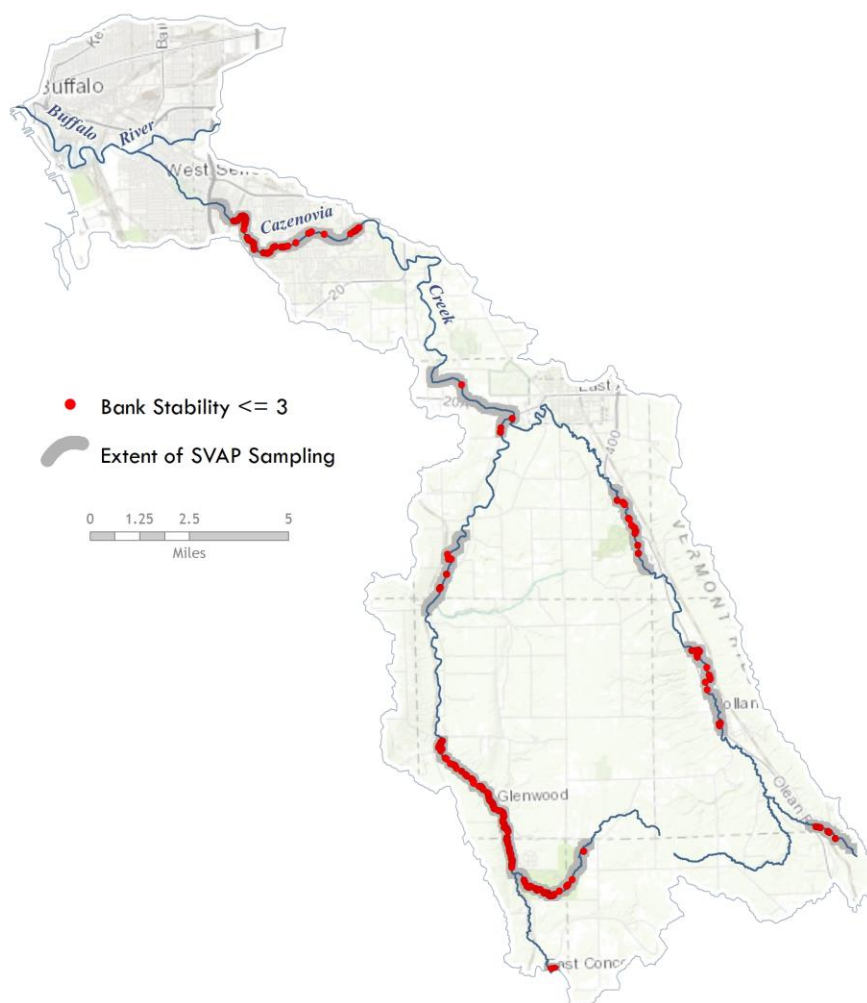
Map 3.7: Bank Stability Score 1-3

Bank stability within the sub-watershed recorded an average score of ‘fair’ (7.2). Bank stability scores can be impacted by the height of stream banks, current evidence or lack of erosion, and presence or absence of rip-rap. Bank stability was variable from reach to reach with 44% of reaches assessed recorded an ‘excellent’ score and 31% of reaches recorded a ‘poor’ score. Bank stability scores under 3 for the sub-watershed are shown in Map 3.7 below. A score of 3 indicates that “banks are moderately unstable, typically high, actively eroding at bends; ~50% rip-rap; excessive erosion” while a score of 1 represents “Unstable high banks, actively eroding at bends throughout; dominated by rip-rap.” As noted prior, inspections and ongoing active bank management projects by the Erie Wyoming County Joint Watershed Board show heavy erosion at locations in the sub-watershed that may be masked by thick growths of invasive plants.

Future Goal: Work with communities, agencies, and municipalities to implement stream bank stabilization programs at actively eroding sites.

Target: Stream stabilization at reaches scoring 3 and below in SVAP Bank Stability (Map 3.7).

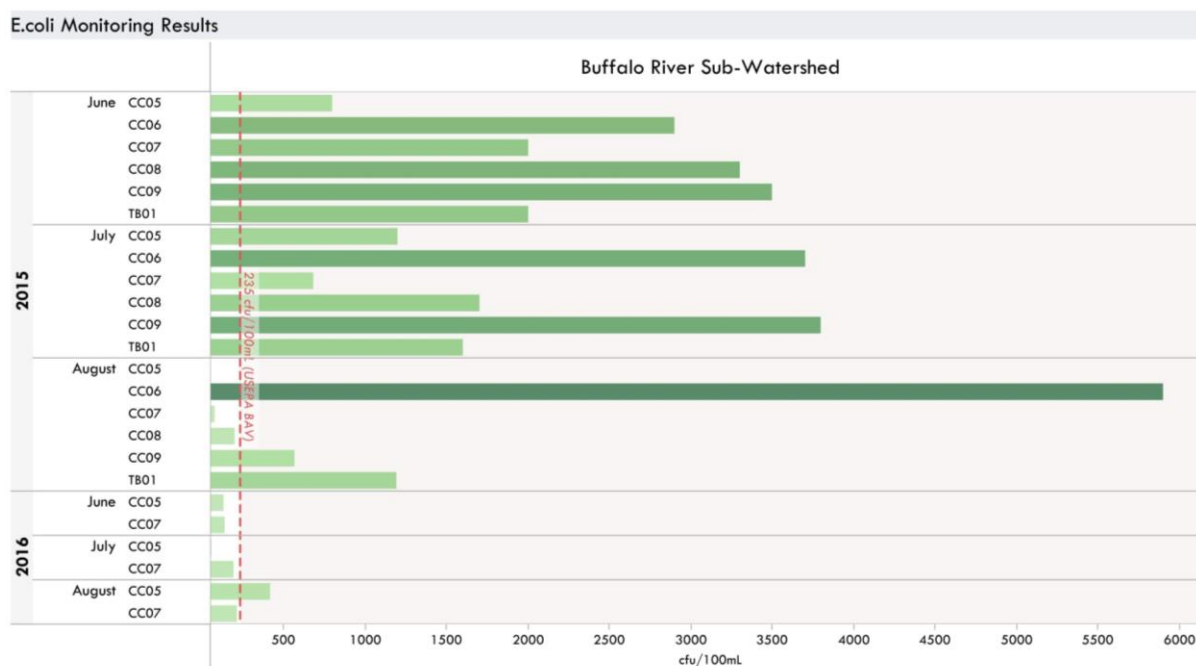
Escherichia coli (*E. coli*) samples were collected within BR at six sites during 2015 and two sites during 2016. Results were frequently above the USEPA Beach Action Value (BAV) of 235 cfu/100mL as seen in Figure 3.5. The BAV is a tool often used to assist in making beach notifications and closures.²⁹ Extremely high *E. coli* levels seen at CC06 may be due to septic leakage from a nearby trailer park. The site is also downstream of the Town of Holland WWTP.

Figure 3.5: *Escherichia coli* Monitoring Results
