Cayuga Creek

Watershed Restoration Road Map

The Cayuga Creek Watershed Restoration Roadmap

March 2009

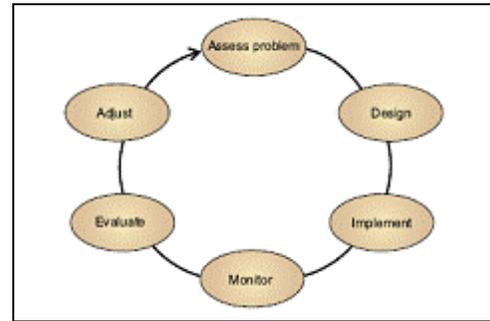
Adaptive Management Process

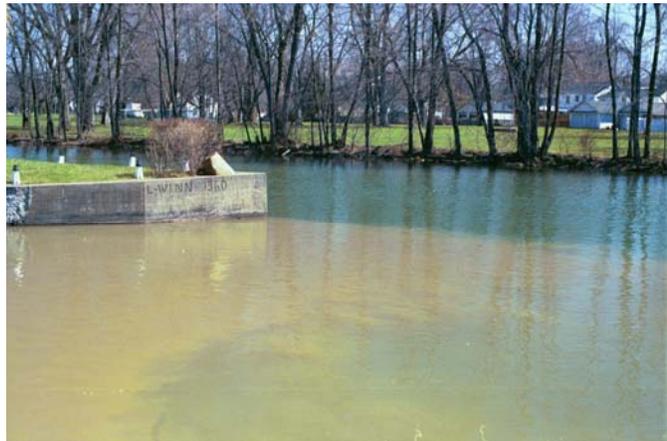
water in the upper portions of the creek. In the lower watershed, poor bank stability, and a lack of a natural riparian corridor are common. One study found that bank erosion and instability threatens structures. Fallen trees and other debris, including appliances and other garbage, have caused jams and worsened stream-bank erosion problems on occasion.

Erosion and sedimentation degrade aquatic and riparian habitat, degrade water quality, and negatively impact the quality of recreational experiences.

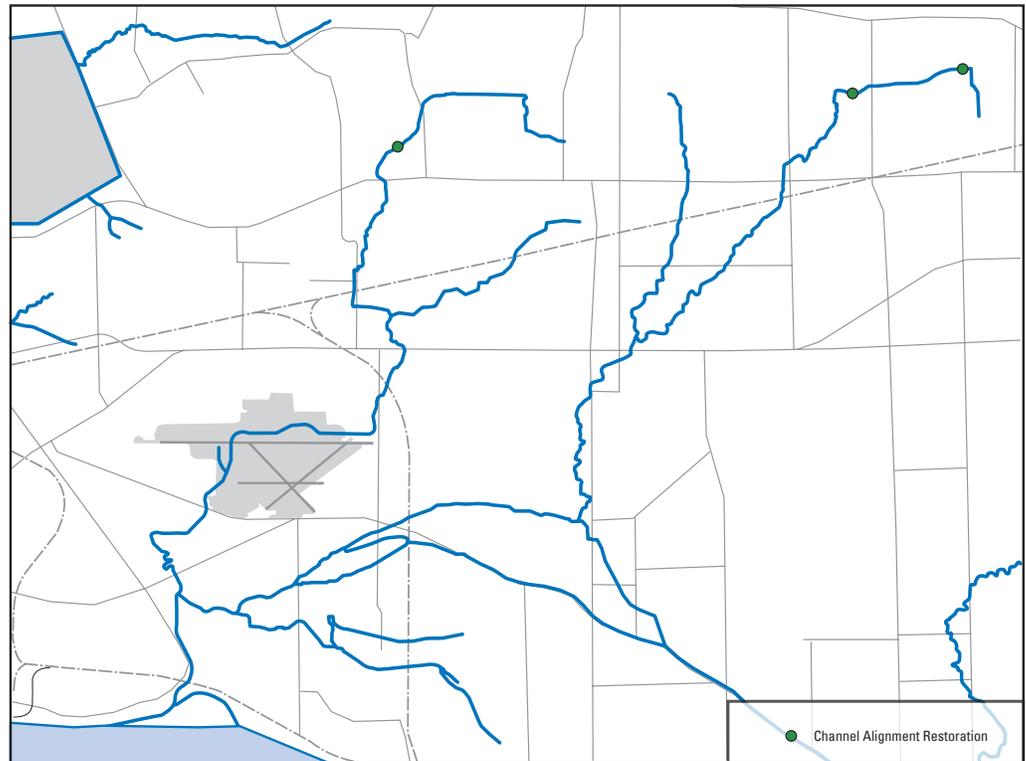
Potential Project Locations

An initial list of locations has been identified based upon existing channel straightness, lack of development in the immediate vicinity of the stream channel, and larger parcel sizes/reduced number of property owners. Ultimately, landowner agreement will need to be secured. Work at each project location will include field work, modeling, determination of upstream/downstream effects, and design prior to construction.

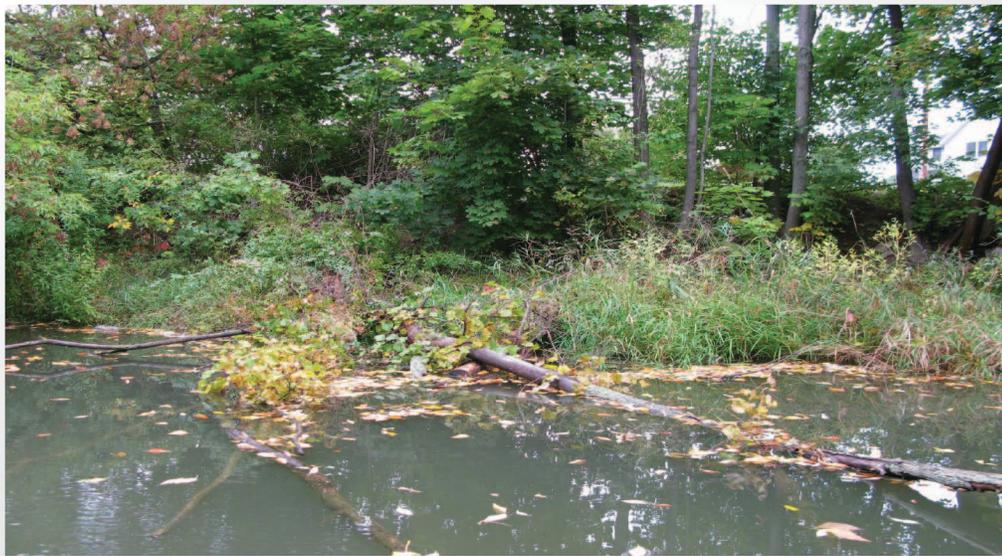
Locked Log for Shade and In-channel Habitat Diversity

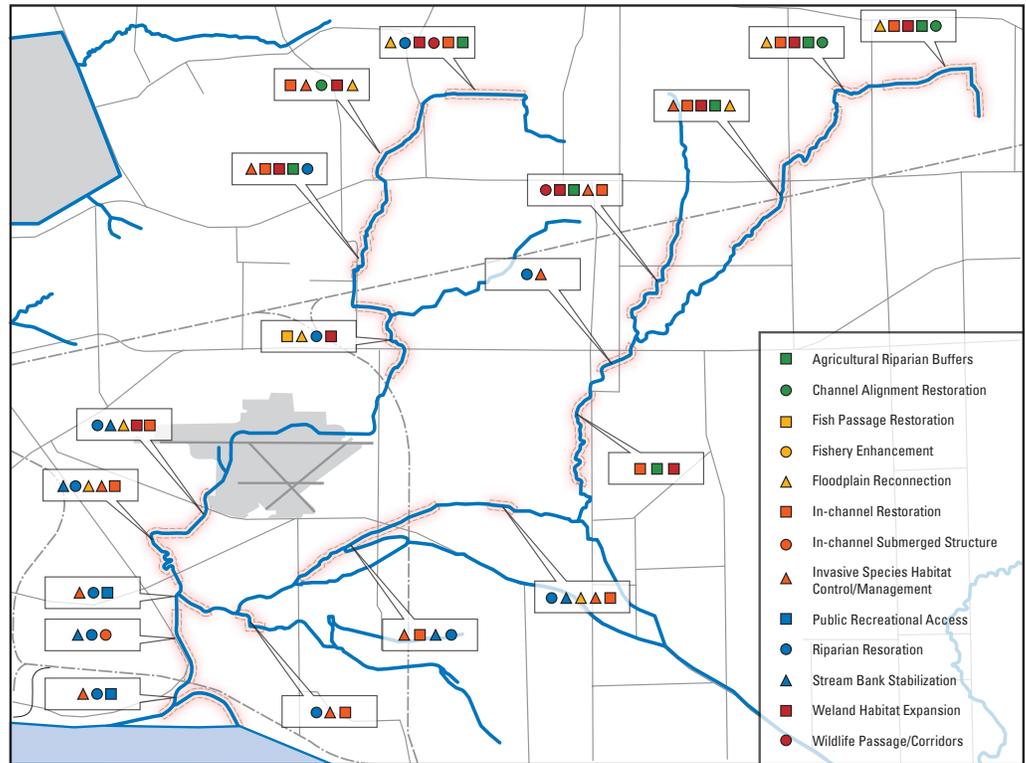
Potential Project Locations

Areas identified include: upstream from the confluence of Cayuga Creek with Little Niagara River; adjacent to Jayne Park on Little Niagara River; Cayuga Creek downstream from confluence with Bergholtz Creek; and Bergholtz Creek upstream of confluence with Cayuga Creek.

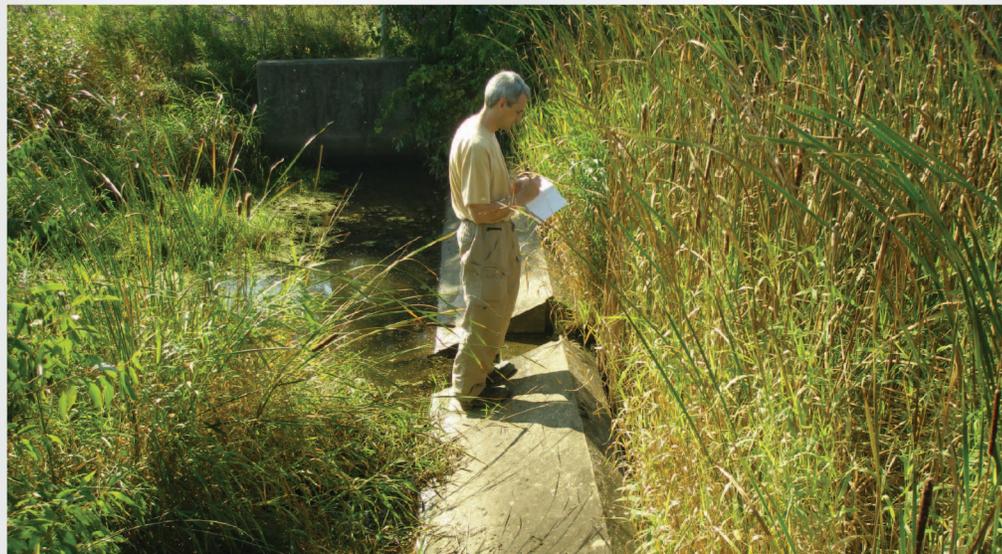
Fish passage barriers have been located in Cayuga Creek

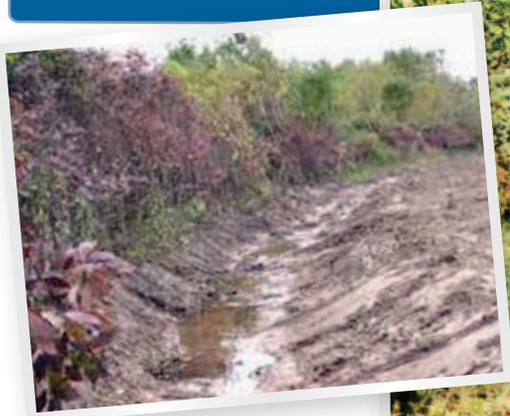
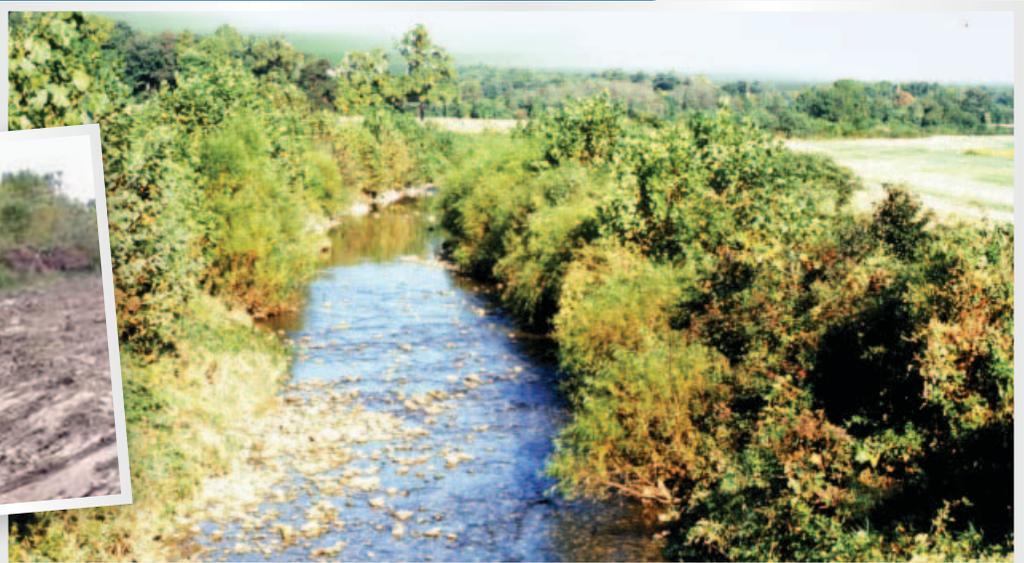
Sediment and nutrient loading tend to be high in active farming landscapes that do not have established riparian buffers.

As the percentage of roots in stream banks and shorelines increases, erosion decreases.

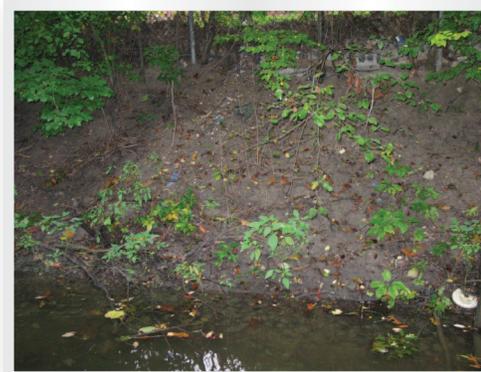
Erosion and unstable stream banks have been identified as a serious impairment and an impediment to improving water quality, restoring riparian corridors, and creating

conditions suitable for a healthy watershed. Stream bank erosion may contribute to elevated turbidity levels and bank instability. Some stream banks between Porter Road and Niagara Falls Boulevard are eroding excessively (Baird 2005); some banks are undercut. Agricultural, residential, and commercial land uses have all contributed to stream channel and bank alterations, and reduction in riparian zones. Erosion in the

lower portion of the watershed may be caused at least in part by daily fluctuations in water stage due to operation of the NYPA power project. Unstable and eroding stream banks contribute to increased sediment loading, reducing filtering capacity of banks and riparian zones, tree falls, property loss, unsafe access, loss of transition habitat (buffer between stream and upland), and modifications to channel cross-sections.
