# Flood Effects on Road–Stream Crossing Infrastructure: Economic and Ecological Benefits of Stream Simulation Designs

study of the survival and failure of road–stream crossings was conducted in the upper White River watershed and the Green Mountain National Forest in Vermont following record flooding from Tropical Storm Irene in August 2011. Damage was largely avoided at two road–stream crossings where stream simulation design was implemented and extensive at multiple road–stream crossings constructed using traditional undersized hydraulic designs. Cost analyses suggest that relatively modest increases in initial investment to implement stream simulation designs yield substantial societal and economic benefits. Recommendations

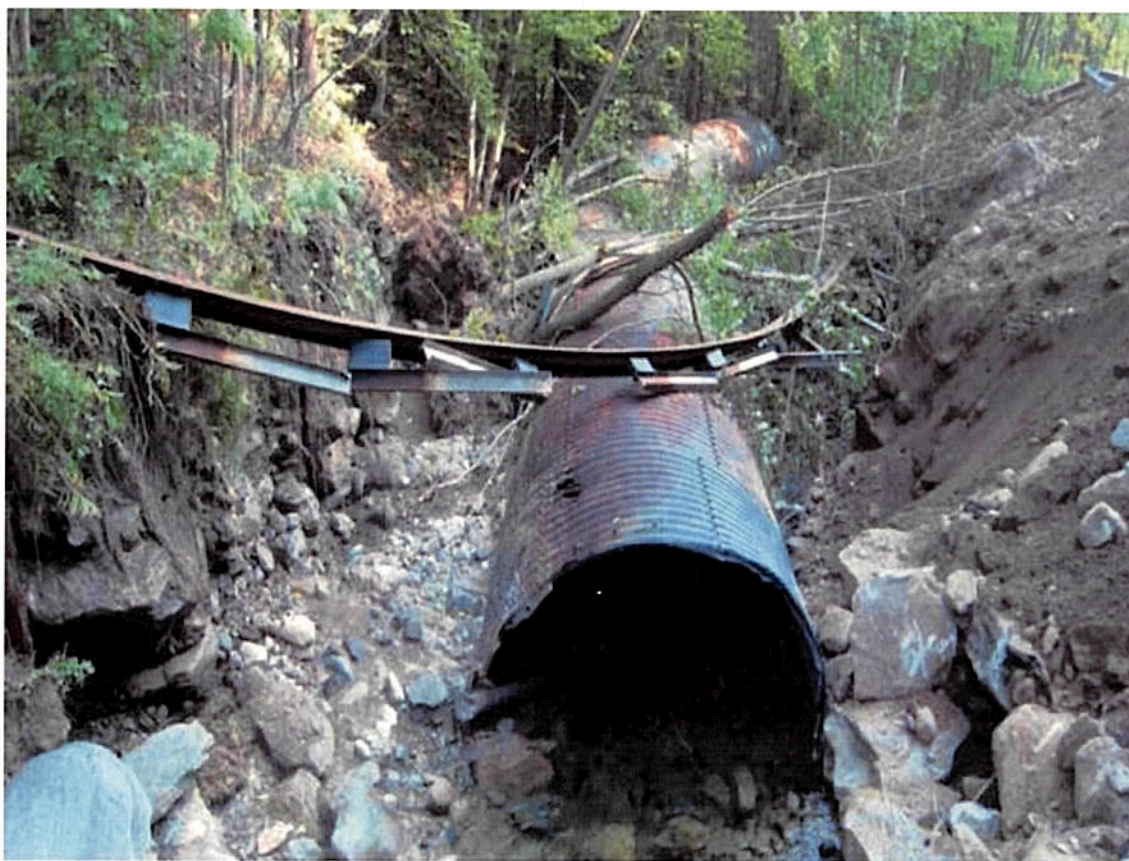
Figure 1. Road failure at a 3-m culvert placed within a 6-m bankfull width stream, Green Mountain National Forest. Photo credit: Dan McKinley, Green Mountain National Forest.

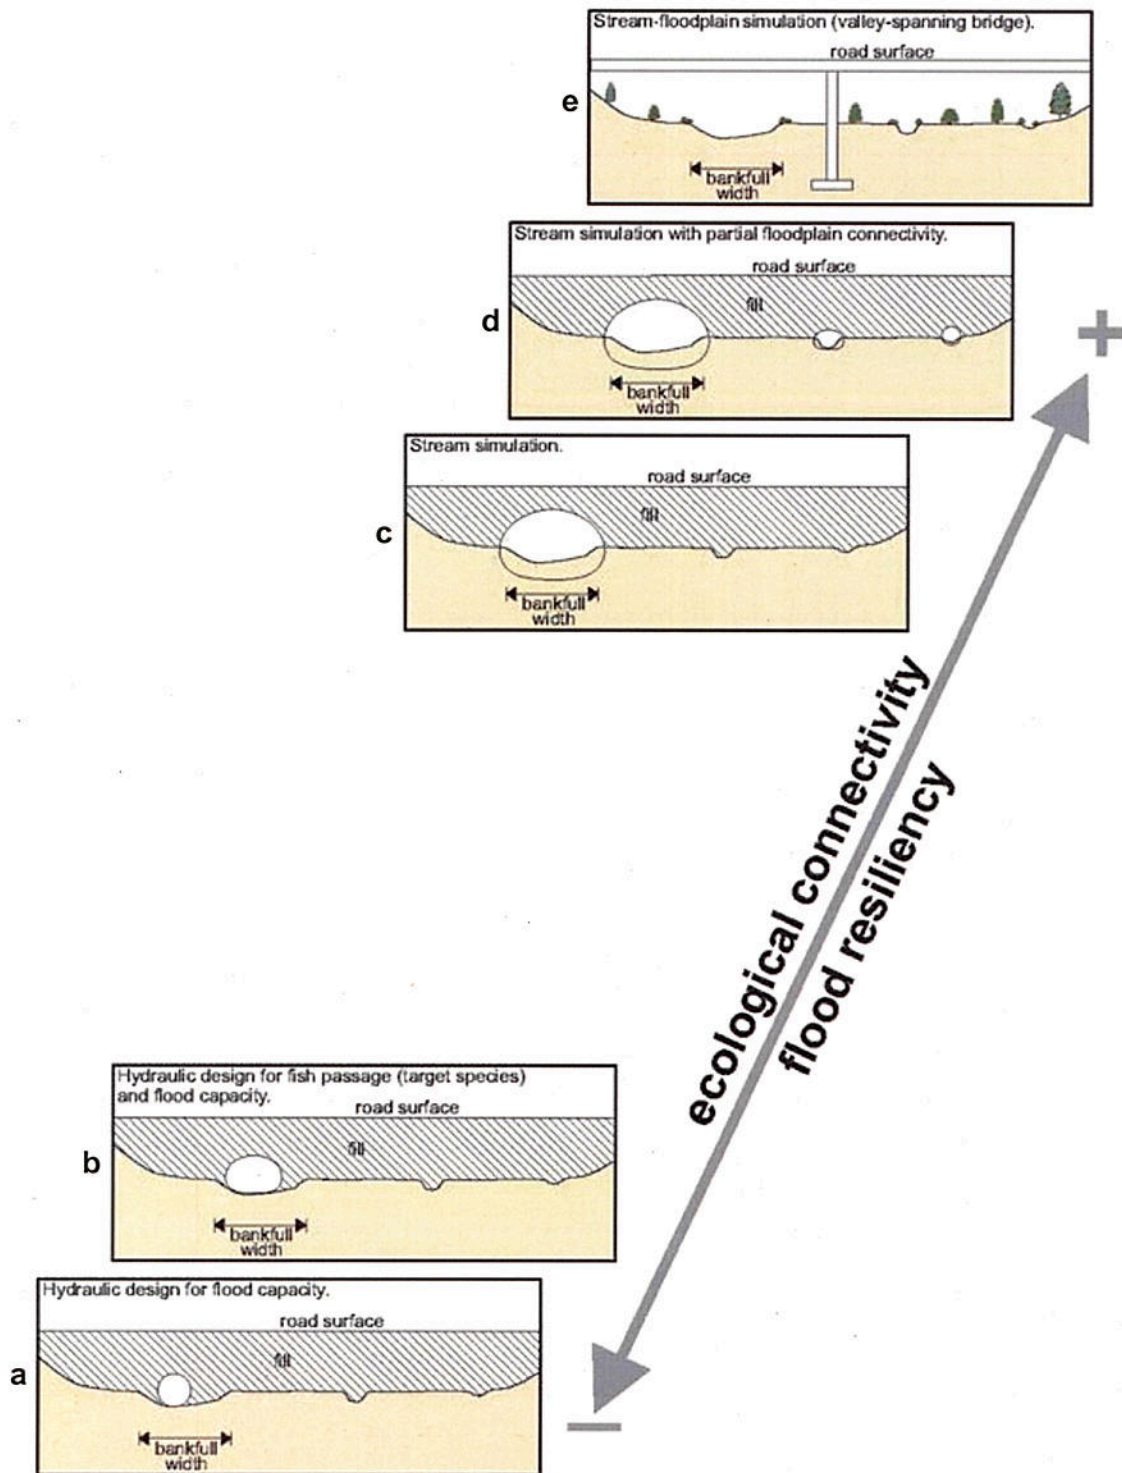
Figure 2. An ecological connectivity and flood resilience continuum for different design approaches at road-stream crossings (adapted from SSWG, 2008). The stream-floodplain simulation design (top graphic) provides passage for all aquatic and terrestrial species all at flow levels and minimal interference of stream and floodplain processes, resulting in greater ecological connectivity and flood resiliency. The stream simulation design (middle graphic) provides for fully functioning floodplain processes, passing floodwater, sediment and woody debris and all aquatic species for a broad range of flows. The hydraulic design for flood capacity (bottom graphic) only provides for partial functioning of stream processes, impedes passage of some floodwaters, sediment, and woody debris during high flows, and impedes passage of most aquatic species for most flows, consequently providing low ecological connectivity and flood resiliency.

and Washington (Orsborn et al. 2002; Clarkin et al. 2005). Prior to the 1970s, a hydraulic design approach to road–stream crossings focused on efficiently conveying flood flows with minimal or no concern for the movement and habitat needs of fish (Figure 2a). In the 1970s and 1980s, hydraulic design structures were modified to create hydraulic conditions that allowed for passage of adult fish including fishways, baffles, and weirs (Figure 2b; Cenderelli et al. 2011). Structures substantially narrower than the width of the adjacent natural channel, however, were only partially successful in allowing passage for the targeted adult fish species, and they did not address the passage needs of multiple species occupying the stream corridor at different life stages and flow conditions. Into the 1990s, hydraulic engineers continued to study and provide design advice to agency fisheries biologists. As Endangered Species Act listings for Pacific Coast salmonids increased in the 1990s and understanding of river and stream geomorphology among agency staff improved, inventories of road system crossings and design improvements to provide passage of all aquatic species, not just adult salmon and trout, increased. Recognizing the limitations of hydraulic design approaches for meeting the passage needs of multiple species occupying the stream corridor at different life stages and flow conditions, a stream simulation design approach was developed (Figures 2c–2e).

Long-term maintenance and replacement costs should also be considered. Hydraulic designs (Figures 2a and 3) that constrict the stream channel can incur a yearly maintenance cost from debris removal and pose a greater risk of unexpected replacement costs from failure during large magnitude floods (Furniss et al. 1997). In contrast, stream simulation designs that span the bankfull channel (Figures 2c–2e and 4) have demonstrated minimal or no annual maintenance costs and are flood resilient and are likely to last longer than their projected service life (Long 2010). Galvanized steel culverts installed using the stream simulation design method have an anticipated service life of 50 to 75 years because the constructed stream channel

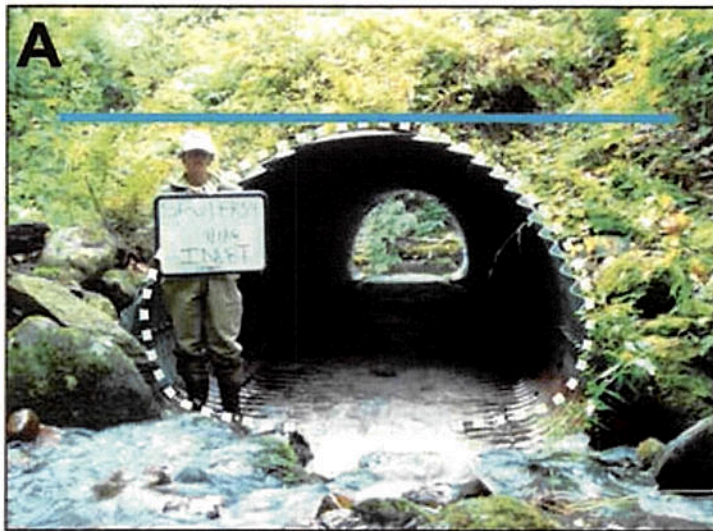
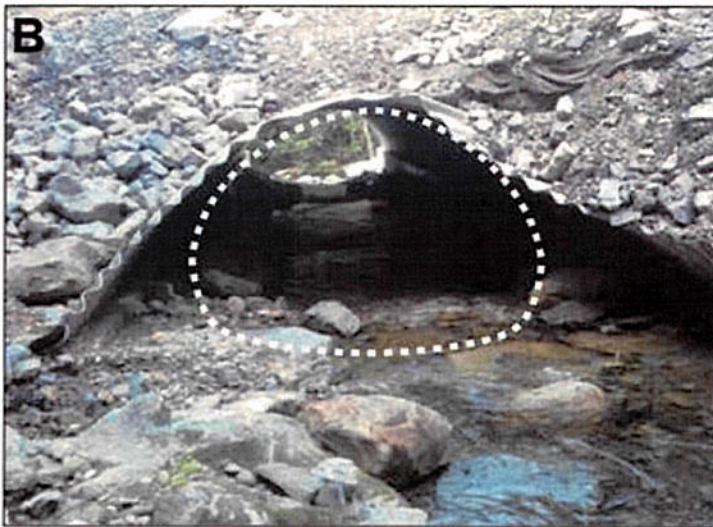
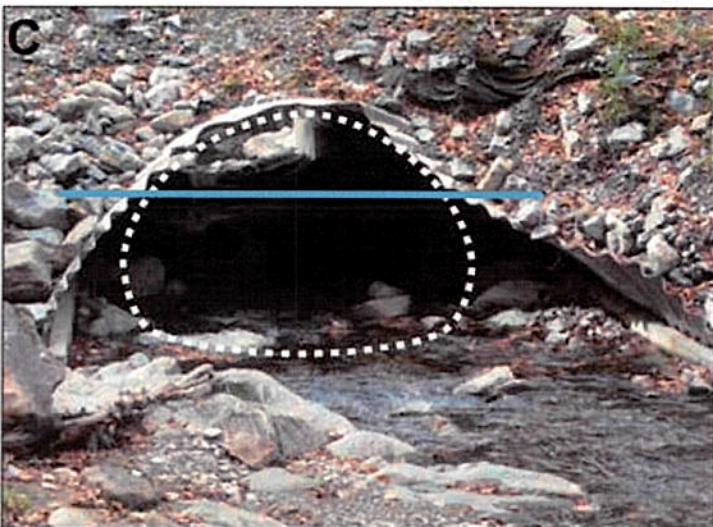
Figure 3. Sparks Brook road-stream crossing located on the Green Mountain National Forest, showing (a) original hydraulic design pipe-arch built in late 1960's, with a 2.5 m span and 1.9 m rise; (b) stream simulation design open-bottom arch structure built in 2010 with 4.5 m span, 1.62 m rise and footers extending 2.7 m below channel bed; (c) replacement structure after Irene flood. The blue line illustrates the actual peak flood water-surface elevation as well as the estimated peak flood elevation if the original culvert had been in place. Photo credit: Dan McKinley, Green Mountain National Forest.

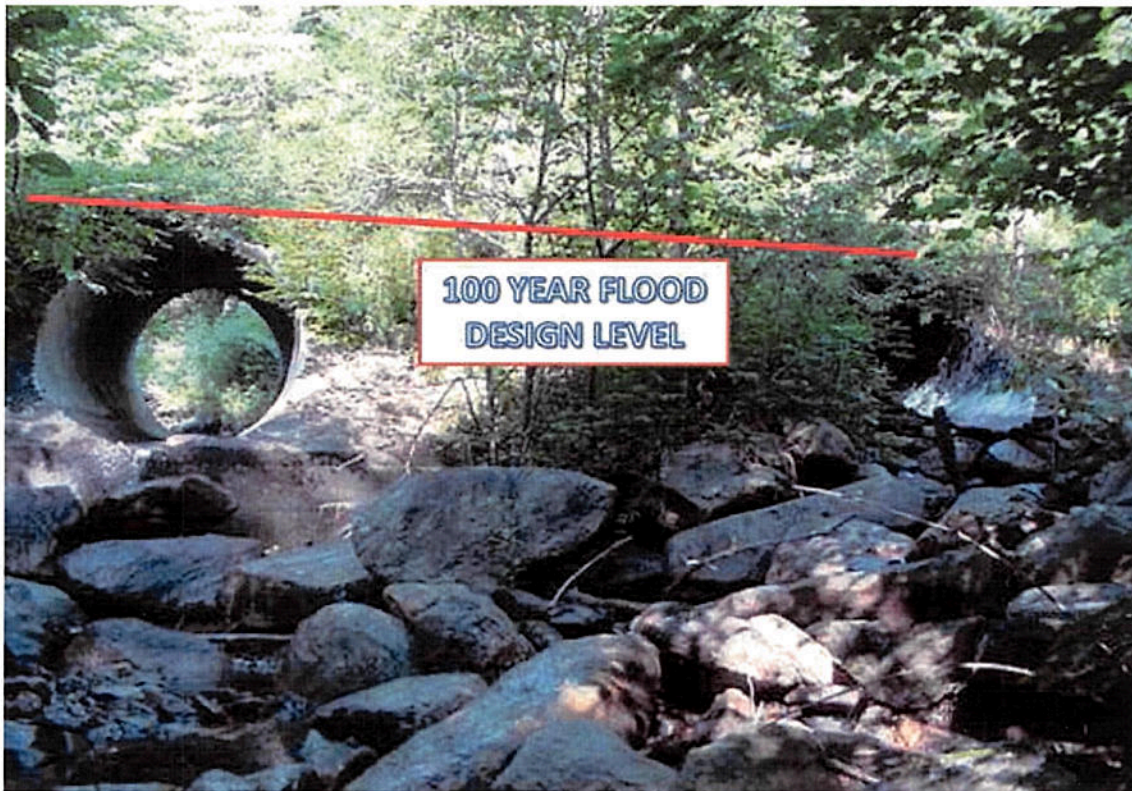
Figure 4. Typical hydraulic design double culvert over Jenny Coolidge Brook, May 2010. Green Mountain National Forest showing estimated height of 100-flood design discharge in red. Photo credit: Brian Austin, Green Mountain National Forest.

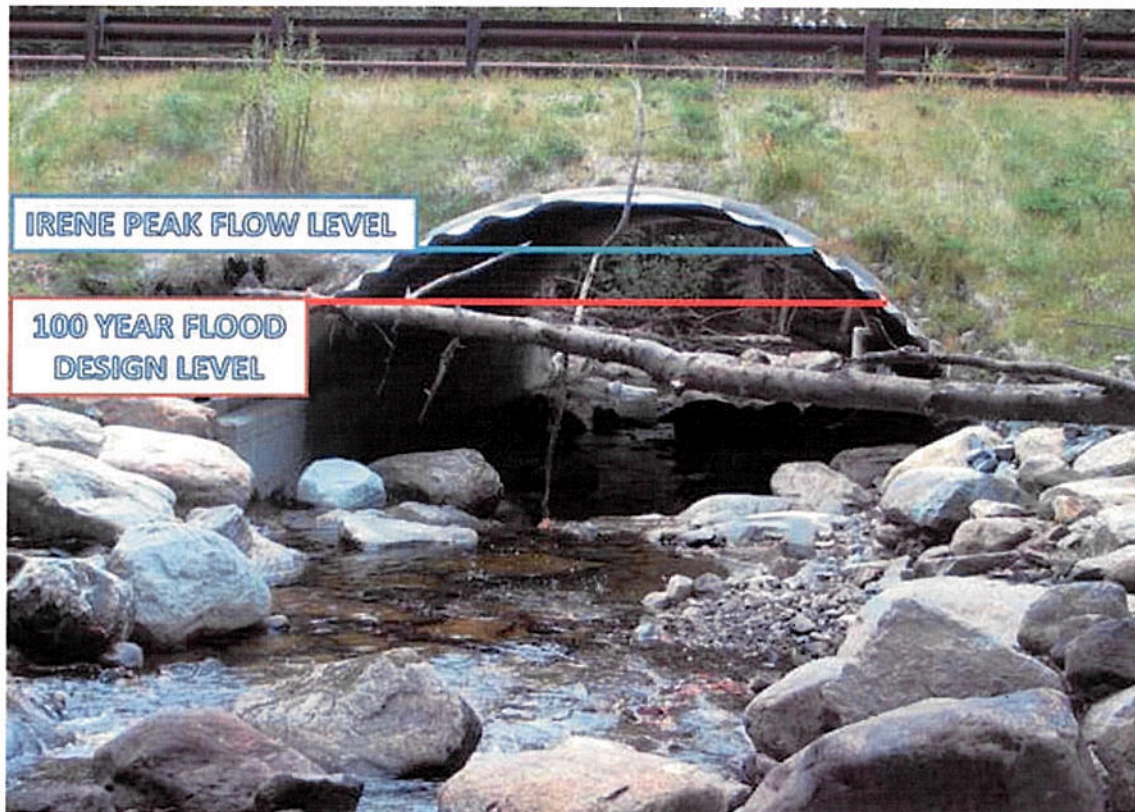
Figure 5. Stream simulation design culvert at Jenny Coolidge Brook, installed in June 2010, showing height of 100-year design discharge in red and height of Tropical Storm Irene flood level in blue. Photo credit: Brian Austin, Green Mountain National Forest.

The hydraulic capacity design method differs from the stream simulation design method in fundamental ways (Figure 5). Stream simulation design determines the size of the structure based on the physical dimensions of the natural channel first and foremost and evaluates hydraulic capacity as a secondary check to ensure sufficient conveyance of the 100-year flood with additional clearance for debris transport. In contrast, traditional hydraulic design methods give no consideration of the actual physical dimensions of the natural channel when sizing the road-stream crossing structure. Hydraulic design structures are sized to pass a design flood (e.g., Q10 flood, Q25 flood, Q100 flood) with headwater-to-depth ratios typically at 1.0 or greater (Hotchkiss and Frei 2007). Design flood discharge estimates are usually determined using regional regression equations that typically have standard error estimates greater than 40%. Additionally, regional regression equations used to predict design discharge were typically developed for larger drainages and are not necessarily applicable to small drainages, which add to the uncertainty of the discharge estimates. Recent analyses and predictions under a changing climate suggest that the set of return interval floods underlying hydraulic capacity designs are no longer valid. In New England, trends in measures of precipitation intensity (Huntington et al. 2009) and frequency of larger precipitation events increased by 85% since 1948 (Madsen and Wilcox 2012), and the recent record-breaking storm events such as Tropical Storms Irene, Lee, and Sandy (Douglas and Fairbank 2011) and the projected increases in total annual precipitation (Intergovernmental Panel on Climate Change 2007) and rain on snow events (Douglas and Fairbank 2011) strongly suggest the need for changing flood discharge estimates.
