# Existing Conditions Report

## OHIO STREET BOAT LAUNCH AND OLD BAILEY WOODS

*Buffalo, NY*

JULY 2016

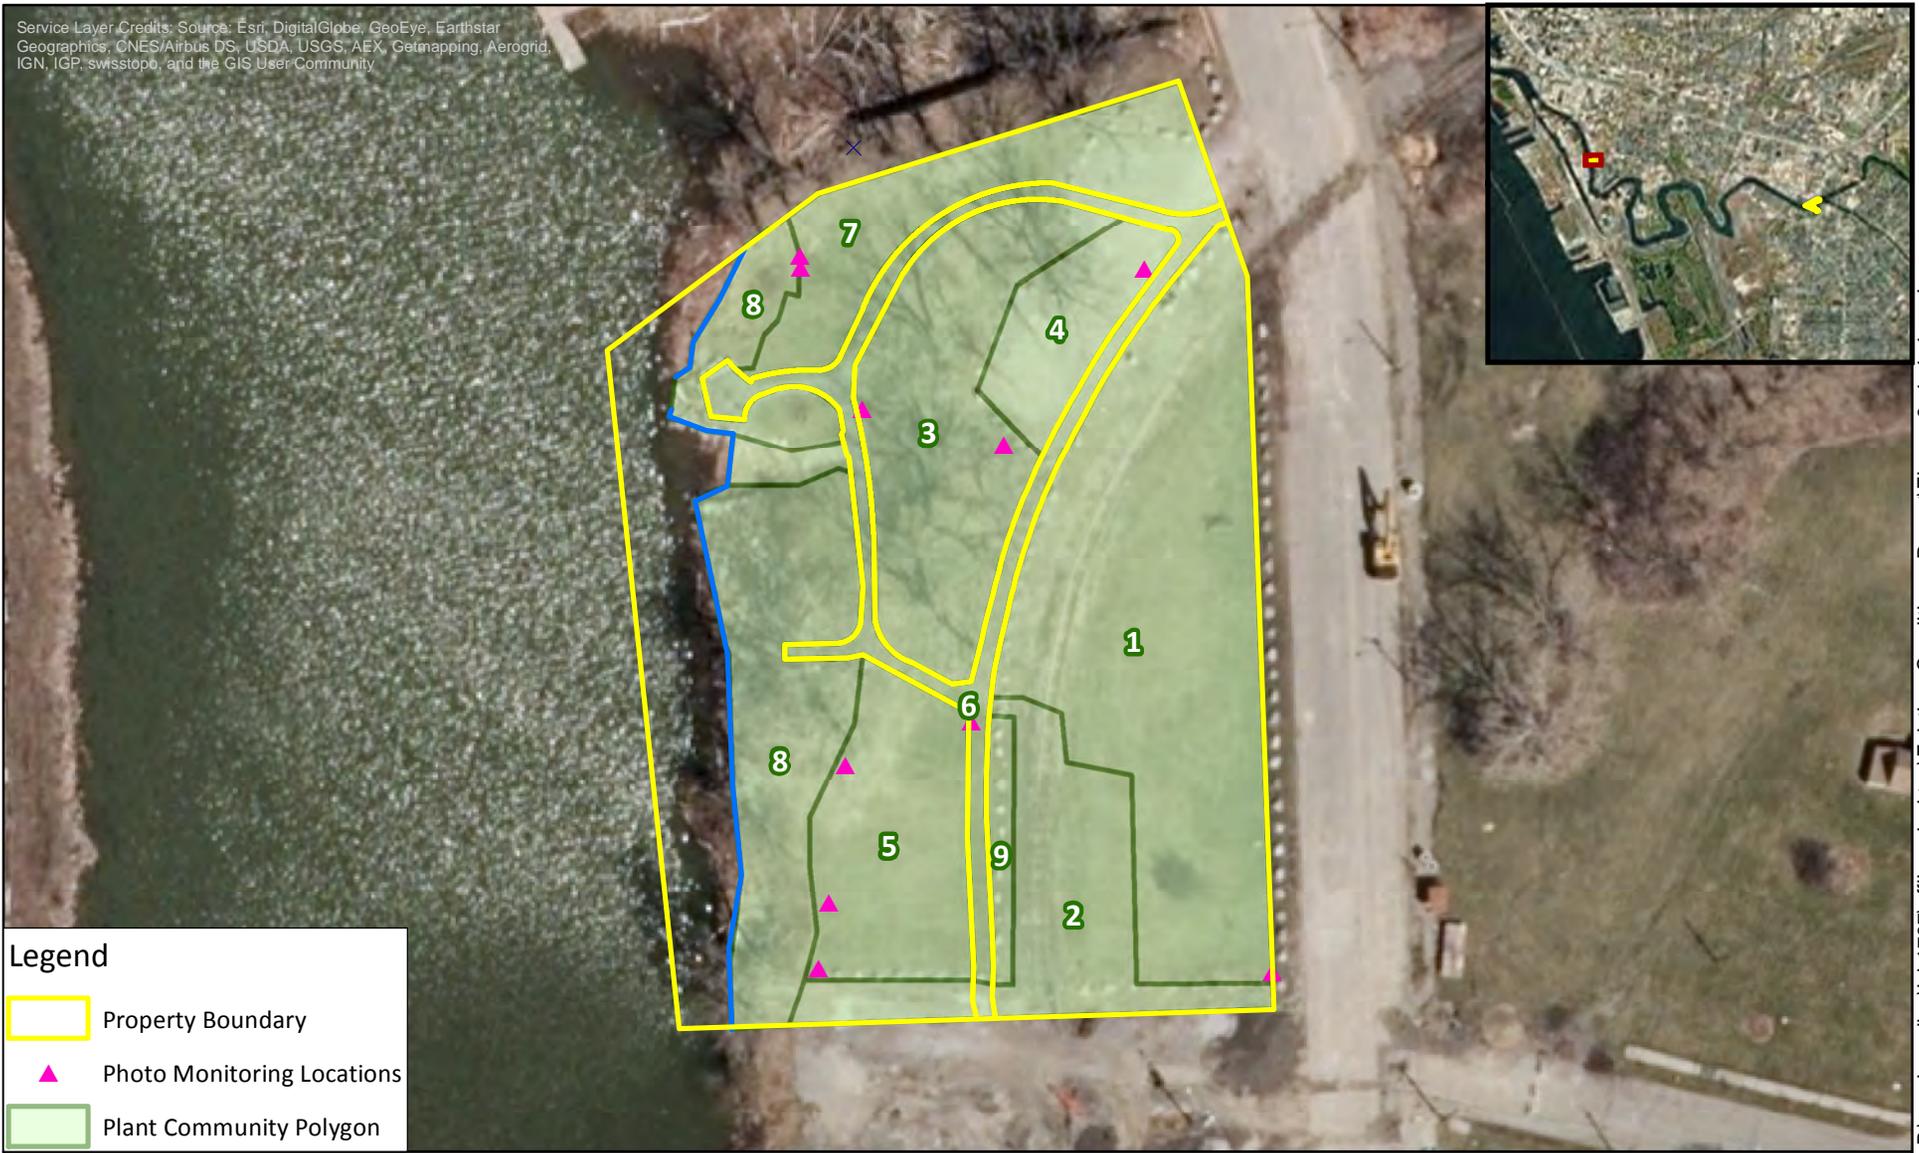
**Figure 3.1.1-1. NYSDEC Ohio Street Boat Launch Project Area**

The land area within the surveyed property boundary encompasses 1.62 acres. Eleven cover type polygons were mapped at the Ohio Street Boat Launch site (Figure 3.1.1-1). These polygons are summarized in Table 3.1.1-1.

Area 1 is a natural herb dominated cover type and category, Grasses and Lawns, which covers 0.45 acres. There were 14 plant taxa identified in this area, with unidentified lawn grasses being the dominant taxa. Note that the grassy areas are mowed regularly and had been mowed prior to the field crew’s visit. This prevented identification even to genus. Lawns are typical dominated by cultivated members of the genera *Poa* (bluegrass), *Festuca* (fescue) and *Agrostis* (bent grass). Five of the taxa in area 1 were native species, and five were non-native. One invasive species, *Artemisia vulgaris* (mugwort) was listed as an occasional plant in Area 1. This invasive plant was only growing near the landscape boulders.

Area 2 is a parking lot with no vegetation. This area covers 0.16 acres. No changes will be made to this area.

Area 3 is a natural wooded cover type in the category Upland Wooded, encompassing 0.22 acres. The upland wooded area at the site is an area of mowed lawn with an overlapping canopy of cottonwood (*Populus deltoides*) trees. The dominant herbaceous species were unidentified lawn grasses, the understory was generally populated by species commonly found in lawns and abandoned areas. Seven taxa were identified. Two are native species; four are not native. Nativity of the lawn grass was not available. No listed species were found.

Area 4 is a natural herbaceous cover type in the category Grasses and Lawns, which covers 0.07 acres. This area covers where the Ohio Street Boat Launch parking area used to be before the most recent landscape improvements. The grass here was planted and is the only plant taxa in the area.

Area 5 is a natural herbaceous cover type in the category Grasses and Lawns, occupying 0.15 acres. Grasses were the dominant taxa, with common lawn weeds narrow leaved plantain (*Plantago lanceolata*) and common dandelion (*Taraxacum officinale*) occurring abundantly. Both of the taxa identified to species are non-native. No listed species were found.

Area 6 is the paved area comprised of paved paths, a sitting area and the boat launching ramp. The total area was 0.14 acres. Visitors to the site walk on these paths; however, they also walk along the lawns. The boat launching ramp is used frequently by kayakers, picnickers, and dog walkers, and also provides easy access to the upland for wading birds and animals.

Area 7 is also a natural herbaceous cover type in the category Grasses and Lawns. The dominant plants in this 0.15-acre area are lawn grasses and lawn weeds. There is also a line of mature cottonwood trees along the northern boundary of the property. These trees show signs of herbivory by beaver, but otherwise appear healthy. There is a single linden tree (*Tilia americana*) species that was planted.

The only riparian wooded area on the site is Area 8, an area of 0.26 acres which borders the Buffalo River on the west side of the site. The riparian area includes cottonwood and willow trees, as well as shrubs and herbaceous plants. It is dominated by invasive European buckthorn (*Rhamnus cathartica*).

Area 9 is a small area of 0.02 acres that borders the parking lot. Most of this area is taken up by landscape boulders that prevent cars from driving on the lawns or walking paths. There is sparse grass growing around the boulders.

Area 1: There are five non-native species in this area, and one invasive plant. The native trees and shrubs should be retained. The population of mugwort should be treated. Islands of native shrubs could be created in this almost half acre area. Species could include common winterberry (*Ilex verticillata*), red-osier dogwood (*Cornus sericea*), or New Jersey tea (*Ceanothus americana*). To maximally increase native diversity, the removal of the non-native species should be considered. The grassy areas dominated by non-native lawn species could be removed and replaced with a mix of native grasses and forbs. A mix might include Indian grass (*Sorghastrum nutans*), little bluestem (*Schizachyrium scoparium*), switchgrass (*Panicum virgatum*), butterfly weed (*Asclepias tuberosa*), bee-balm (*Monarda punctata*), smooth blue aster (*Symphotrichum leave*), blackeyed Susan (*Rudbeckia hirta*), early goldenrod (*Solidago juncea*) or other meadow species.

Area 2: The parking area is not within the scope of this project and therefore no improvements are planned.

Area 3: The main ecological need for this area is to increase diversity and structural complexity.

Area 4: This area has thin soil over an old parking lot. The main ecological need is to improve conditions for plant growth by bringing in additional topsoil, and planting native grass, meadow and shrub species.

Area 5: A meadow similar to that described for Area 1 could be installed here.

Area 6: The trail system has generally good pavement and any proposed changes to the trail or boat ramp area will be first discussed with RIVERKEEPER.

Area 7: This area is mowed lawn with cottonwoods, a linden, and a hawthorn planted near the south side. The space could offer improved habitat, particularly for birds, by replacing areas of the lawn with native grass and meadow plant species, as well as adding clumps of shrubs to offer food, nesting and shelter habitat for birds. Native virburnums, hollies, and elderberries all attract a variety of passerine birds with their fruits. When planted in clumps separated by meadow species, they also offer shelter and nesting cover. Bird boxes (suitable for bluebirds, swallows, and other species) might be installed. Bat boxes might also be installed. These are best placed on free standing poles, rather than attached to tree trunks.

Area 8: The Buffalo River shoreline in this riparian area shows little evidence of erosion, and appears largely intact. There is a fair amount of driftwood along the shore. This material should be carefully removed to allow planting and other activities. The non-native glossy buckthorn and other non-native and invasive species should be cut and the stems removed. They will be replaced by native riparian trees and shrubs. Along steeper portions of the bank, native thorny shrubs such as Virginia rose (*Rosa virginiana*), devil's walking stick (*Aralia spinosa*), common blackberry (*Rubus allegheniensis*) or purple flowered blackberry (*Rubus odoratus*) might be planted near locations where the bank is steep and potentially unsafe for walking.

Area 9: This is a small area of mowed lawn planted around landscape boulders. The non-native flora here should be removed and replaced with native upland grasses, herbs and shrubs. Species could be chosen from the list provided for Area 1.

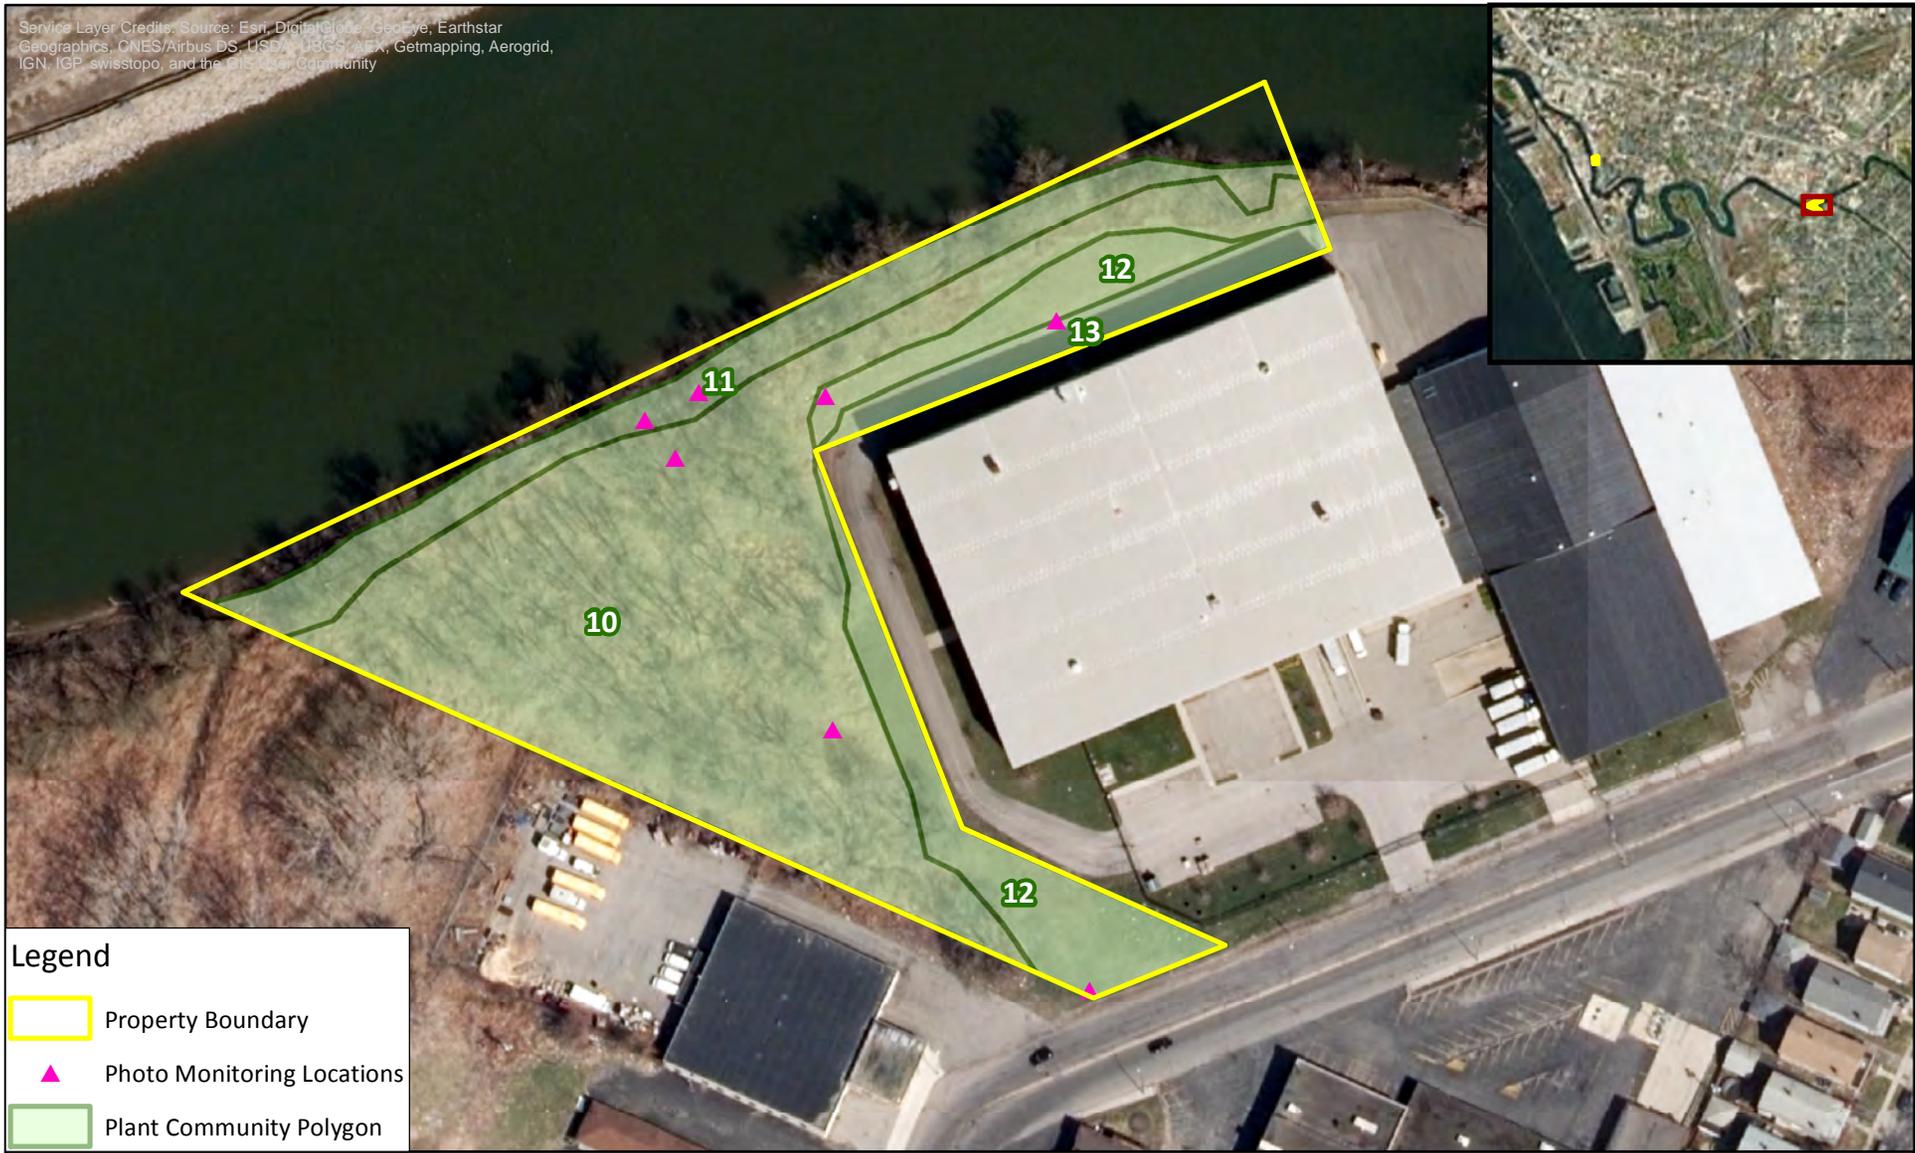
**Figure 3.2.1-1. Old Bailey Woods Project Area**

The land area within the surveyed property boundary encompasses 3.25 acres. Three cover type polygons were mapped at the Old Bailey Woods site ([Figure 3.2.1-1](#)). These polygons are summarized in [Table 3.2.1-1](#).

Area 10 is categorized as an Upland Wooded Area. This area is a floodplain forest with a canopy of black willow and cottonwood trees. The forest understory is dominated by invasive Japanese knotweed, garlic mustard (*Allaria petiolata*) and dame's rocket (*Hesperis matronalis*). Song birds and one deer were observed in this area during the site visit.

Area 11 is the Riparian Wooded Area at the Old Bailey Woods site. It is located on the slope that descends from the floodplain forest to the shoreline of the Buffalo River. Vegetation in this area is not as thick as in the floodplain forest; however, Japanese knotweed is still present. Dominant species in the canopy include walnut (*Juglans nigra*) and box elder (*Acer negundo*). The dominant shrub, growing close to the shoreline, is European black alder (*Alnus glutinosa*). Iris plants are also present along the shoreline. The plants are likely yellow iris (*Iris pseudoacorus*); however, they could not be identified to species at the time of the data collection.

Area 12 is a Grasses and Lawns area dominated by planted lawn grasses mixed with familiar lawn weeds, such as gill over the ground and red clover. Two stands of black willow (*Salix nigra*) trees and one large tree of heaven (*Ailanthus altissima*) are growing within the lawn, and are mowed around. This area is regularly mowed and was being mowed when Gomez and Sullivan and RIVERKEEPER were on site for the ecological data collection visit. No signs of animal use were observed in the grass and lawn area.

The driveway that is used by Iron Mountain Records Management, Inc. is shown as Area 13. The survey conducted by Foit-Albert Associates shows that Iron Mountain Records Management, Inc. holds an easement to this 25-foot wide area for fire access and maintenance.

The Old Bailey Woods site is dominated by invasive, herbaceous plant species. In order to restore the ecological benefits of a native floodplain forest, the invasive Japanese knotweed, garlic mustard, and dame's rocket populations must be reduced and the native plant species' populations increased.

On average, the shoreline has a generally steep slope with an average ratio of approximately 1:2. At its steepest point near the northern extent of the site, there is approximately 100 feet of shoreline where the slope ratio is approximately 1:1. Remedial efforts to reduce erosion along the steep slope in this area will be assessed. There is evidence of ice scraping on a few of the shoreline trees. Woody debris in the form of large driftwood and other woody debris is trapped along the shore in most places. Emergent species are sparse along the shore; none were seen during our field visit.

Area 10: In the upland areas the greatest need is to reduce the dominance of invasive and non-native species. While there are approaches that do not involve herbicides that might be tried, including hand removal of select species like garlic mustard, or covering select areas with dark tarps and mulch, the size of the area and the widespread occurrence of these undesirable species argues for a careful herbicide treatment. A low volume foliar application of an appropriate herbicide could be carefully applied to specific invasive and non-native target species. Given the seedbank that is most likely extant at the site, more than one application would likely be required to control these undesirable plants. A late summer application could be made in 2016, followed by a spring application in 2017. Planting could follow in 2017.

Area 11: The small eroded area of the shoreline at the northern end of the property should be addressed to restore natural shoreline characteristics and mitigate against further erosive damage. Repairs may include re-grading to a stable configuration and providing protection against future erosion with an emphasis on the use of "soft" shoreline protection techniques with native species plantings. Driftwood and other debris should be removed from the shoreline to allow for subsequent planting. Plantings will need to be protected with a wildlife deterrence system. Some consideration should be given to providing protection against ice scour along the shore. This could take the form of anchored logs, rock vanes, large boulders or other structures. Emergent species could be planted in shallow areas close to the shore.

Area 12: This is an area of mowed grasses and lawn species, with a few black willow trees. The soils are thin in spots, and many of the species are not native. Non-native grasses and herbs should be replaced with upland grasses, herbs and shrubs. A suitable mix might include Indian grass (*Sorghastrum nutans*), little bluestem (*Schizachyrium scoparium*), switchgrass (*Panicum virgatum*), butterfly weed (*Asclepias tuberosa*), bee-balm (*Monarda punctata*), smooth blue aster (*Symphyotrichum leave*), blackeyed Susan (*Rudbeckia hirta*), early goldenrod (*Solidago juncea*) or other meadow species. Appropriate shrubs for this area include common winterberry (*Ilex verticillata*), red-osier dogwood (*Cornus sericea*), New Jersey tea (*Ceanothus americana*) or inkberry (*Ilex glabra*).
