# Healthy Niagara

## Regional Niagara River/Lake Erie Watershed Management Plan (Phase 2)

*The Regional Niagara River/Lake Erie Watershed Management Plan (Phase 2) was prepared for the New York State Department of State with funds provided under Title 11 of the Environmental Protection Fund.*

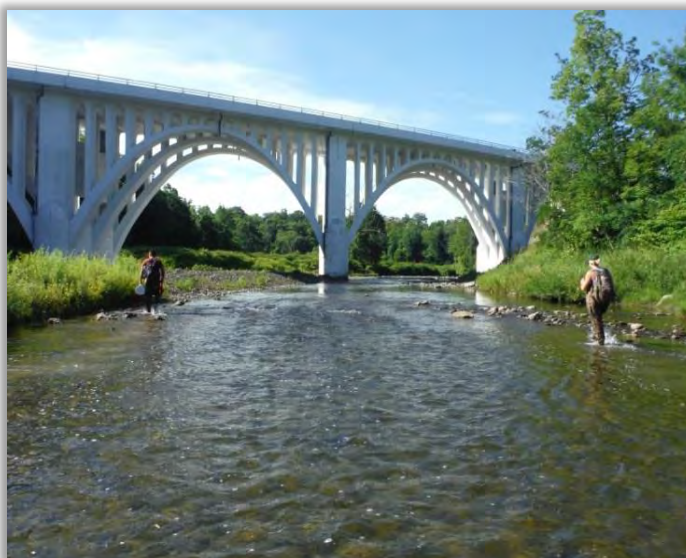
**Figure 2.1: Stream visual assessment in Eighteenmile Creek (BNR)**

Waterways within EC were assessed from July 30, 2015 to September 1, 2015. Within three stream bodies, 331 reaches were assessed. The streams assessed were Eighteenmile Creek (Main and South Branches), Hampton Brook, and Neuman Creek. Each stream was broken up into segments, and assigned a unique identifier based on location (18S, 18W 18M, SB, SSB, HAM, NEU).

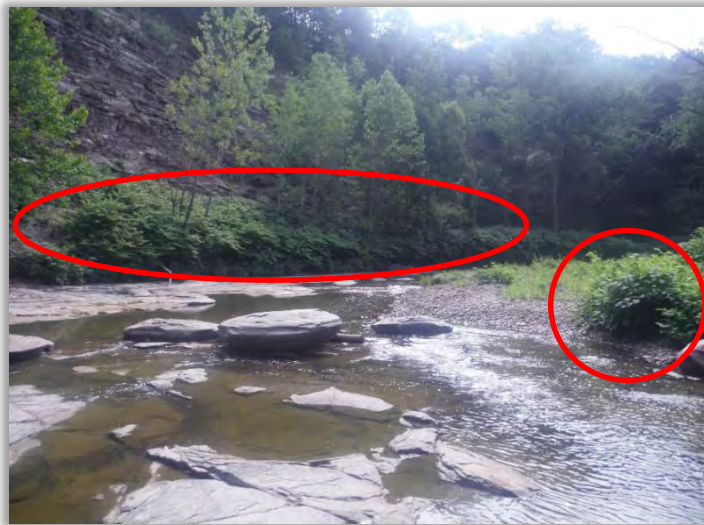
**Figure 2.2: Japanese Knotweed growth along Eighteenmile Creek (BNR)**

(*Polygonum cuspidatum*), an invasive plant introduced to the US from Eastern Asia, was observed at 66% of reaches assessed in the sub-watershed. Historically, the plant was used for erosion control, and thick growths tend to mask poor bank conditions that would otherwise be assessed as eroding. It spreads very quickly via a rhizome (underground) root system, thriving in recently disturbed areas and forming monoculture stands. Resistant to drought and high temperatures, Japanese knotweed can out-compete native plant communities

which are depended on by many wildlife species and important to the health and biodiversity of local habitats. As seen in Figure 2.2, large stands of Japanese knotweed were observed along the banks of Eighteenmile Creek.

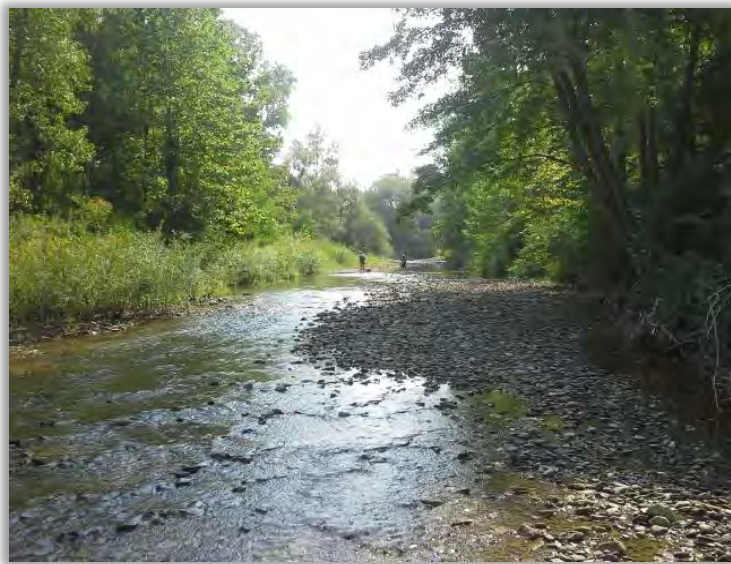
**Figure 2.3: Eighteenmile Creek Riparian Zone (BNR)**

The riparian zone, or area of natural vegetation bordering waterbodies, along assessed stretches received either ‘good’ or ‘excellent’ average scores throughout the sub-watershed. Figure 2.3 presents an example of a healthy riparian zone observed along Eighteenmile Creek. Poor scores indicate a lack of riparian cover or a narrow riparian zone width in comparison to the stream’s active channel. Excellent scores refer to a riparian zone extending at least two times the width of the stream’s active channel. This zone is a vital component to a healthy water body, as the roots of riparian vegetation naturally stabilize banks and control erosion. This zone of vegetation also functions as a surface water filter, slowing and absorbing stormwater runoff and the various pollutants it may be transporting and provides natural shade helping to regulate water temperature. Neuman Creek received the lowest average score of ‘good’ (8.1). Characterized by abundant riparian vegetation, there were a few sites observed where the riparian zone was lacking due to residential mowing.

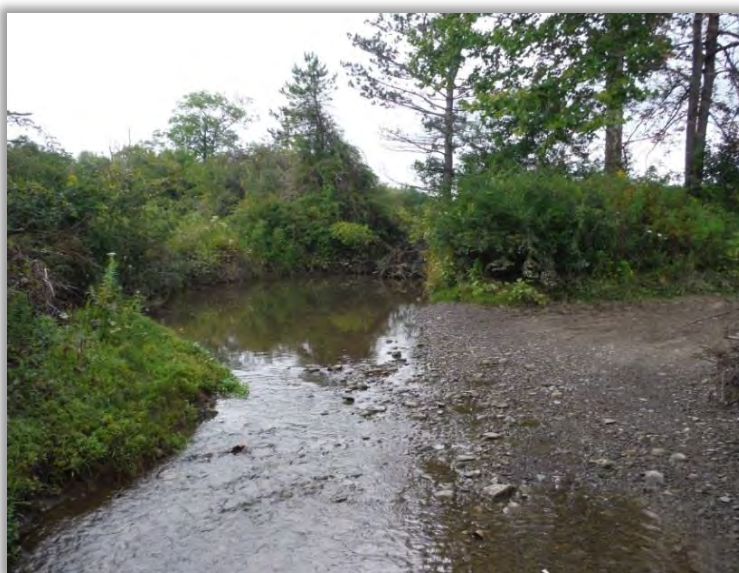
**Figure 2.6: Livestock Access to Neuman Creek (BNR)**

Cattle tracks were observed within the stream. Manure was also detected within this reach. As seen in Figure 2.6, a path used by cattle leads directly to the stream. Neuman Creek contained the reach that received the lowest overall score within the sub-watershed. The reach in question received a 'poor' score (4.2) and was located near a farm.

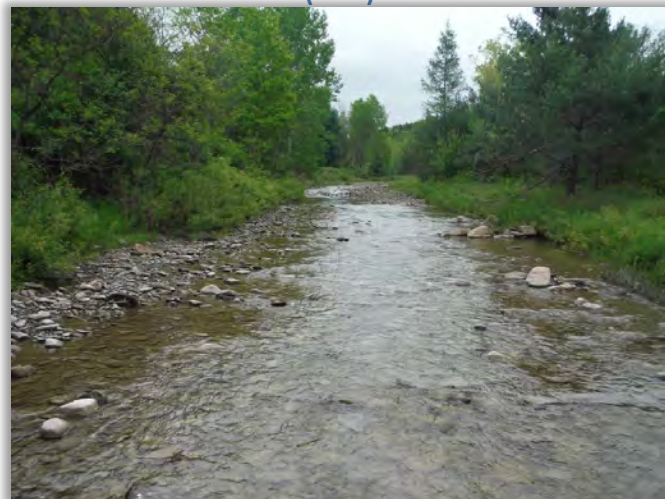
**Figure 3.4: Riparian vegetation along Sprague Brook (BNR)**

In areas closer to the headwaters, further removed from the pressures of development, riparian vegetation remains well intact. A segment of Sprague Brook over three miles long was assessed within the limits of Sprague Brook County Park. This segment received the highest average score for riparian zone within the entire sub-watershed of ‘excellent’ (9.9). This waterbody was characterized by extensive riparian vegetation, as

seen in Figure 3.4.

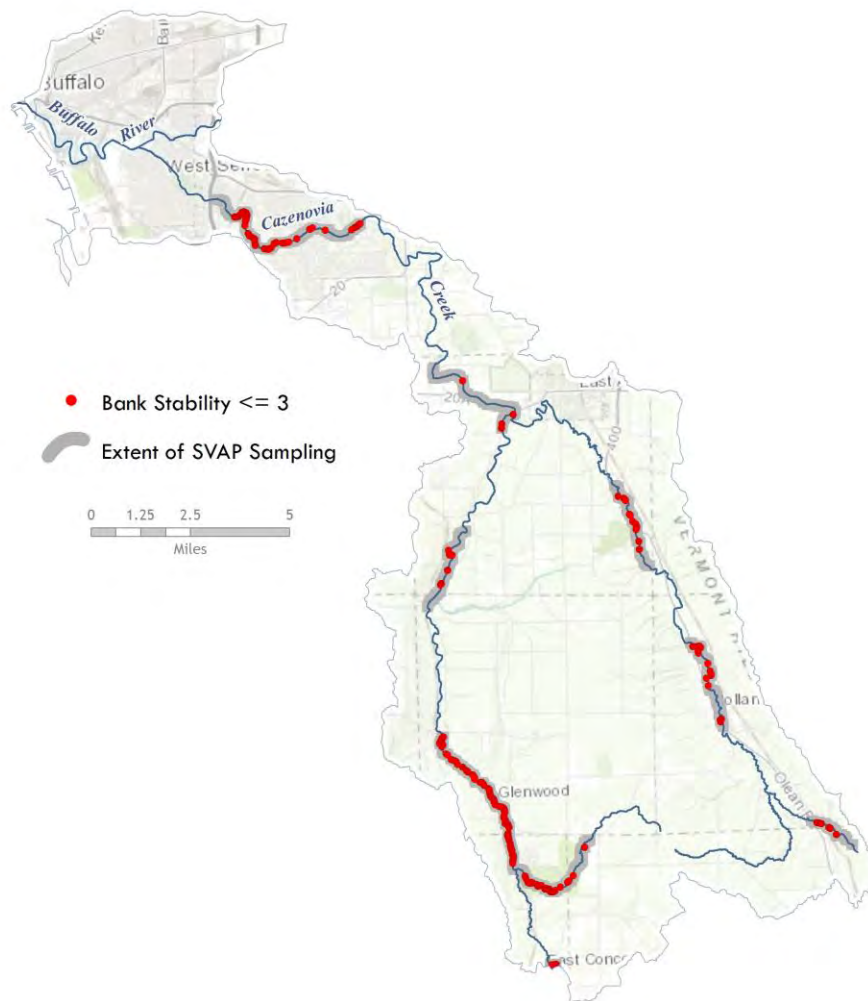
**Map 3.7: Bank Stability Score 1-3**

Bank stability within the sub-watershed recorded an average score of ‘fair’ (7.2). Bank stability scores can be impacted by the height of stream banks, current evidence or lack of erosion, and presence or absence of rip-rap. Bank stability was variable from reach to reach with 44% of reaches assessed recorded an ‘excellent’ score and 31% of reaches recorded a ‘poor’ score. Bank stability scores under 3 for the sub-watershed are shown in Map 3.7 below. A score of 3 indicates that “banks are moderately unstable, typically high, actively eroding at bends; ~50% rip-rap; excessive erosion” while a score of 1 represents “Unstable high banks, actively eroding at bends throughout; dominated by rip-rap.” As noted prior, inspections and ongoing active bank management projects by the Erie Wyoming County Joint Watershed Board show heavy erosion at locations in the sub-watershed that may be masked by thick growths of invasive plants.

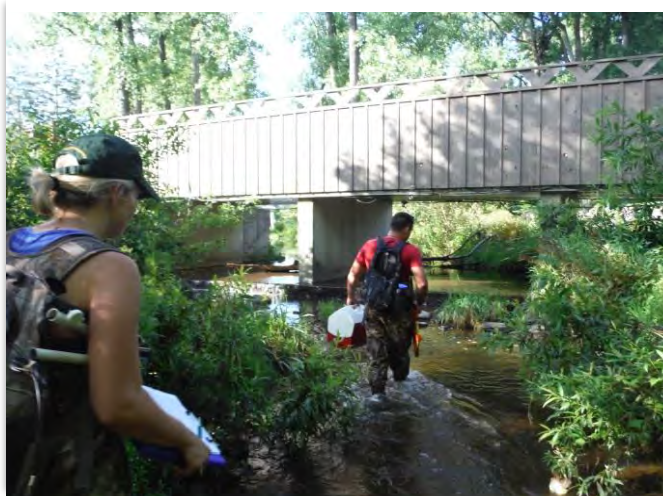
**Figure 4.1: Stream visual assessment in Smokes Creek (BNR)**

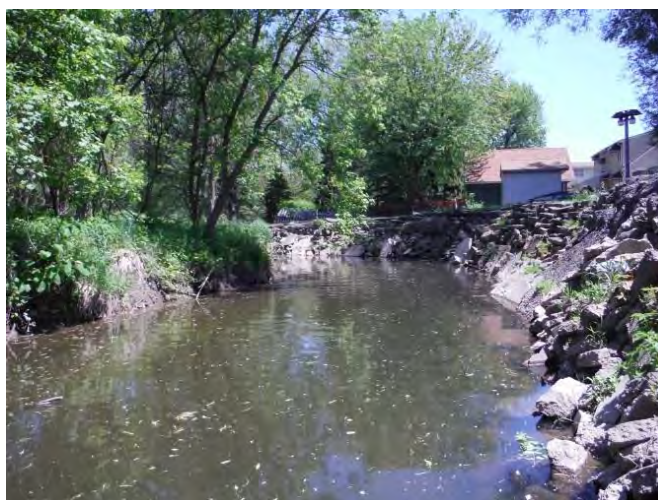
**Figure 4.2: Altered Stream Channel with use of Rip-Rap (BNR)**

Within the sub-watershed, the Main Stem of Smokes Creek recorded the lowest average channel condition score of ‘good’ (7.5). Channel conditions were lowest in areas where the stream cut through residential areas. Abundant use of rip-rap and other methods of hard engineered stream bank stabilization were observed, as seen in Figure 4.2.

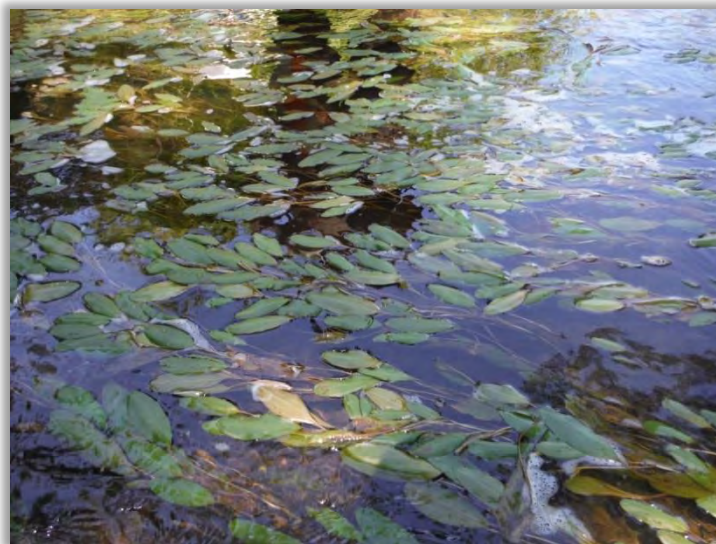
**Figure 4.6: Long-Leaf Pondweed (*Potamogeton nodosus*) (BNR)**

While nitrogen and phosphorus are vital for a healthy stream, the correct balance is critical to sustain aquatic life.<sup>18</sup> High nutrient levels can fuel growth of aquatic vegetation and algae which can congest streams, restricting water flow and fish movement. Large quantities of long leaf pondweed, as seen in Figure 4.6 were observed in the Main Stem of Smokes Creek near a corn field. Potential non-point nutrient runoff could be contributing to this extensive plant growth. Large quantities of

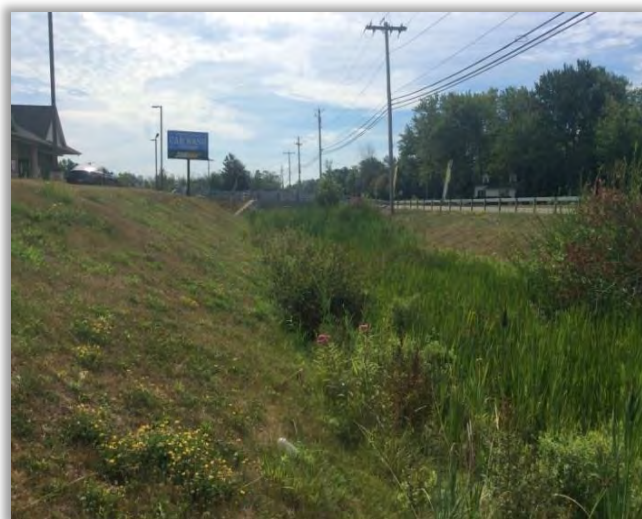
**Figure 5.2: Lack of Riparian Vegetation along Sawyer Creek (BNR)**

The riparian zone, or area of natural vegetation bordering waterbodies, along assessed stretches of Sawyer Creek recorded an average score of 'poor' (3.0), the lowest of all waterbody segments assessed within LT. Poor scores indicate a lack of riparian zone or a narrow riparian zone in comparison to the streams active channel. This zone is vital component to a healthy waterbody, as the roots of riparian vegetation naturally stabilize banks and control erosion. This zone of vegetation also functions as a surface water filter, slowing and absorbing storm water

runoff and the various pollutants it transports. Due to the extent of development along Sawyer creek, the natural vegetation has been severely depleted as seen in Figure 5.2. Excellent scores (9.0+) refer to a riparian zone extending at least two times the width of the streams active channel.

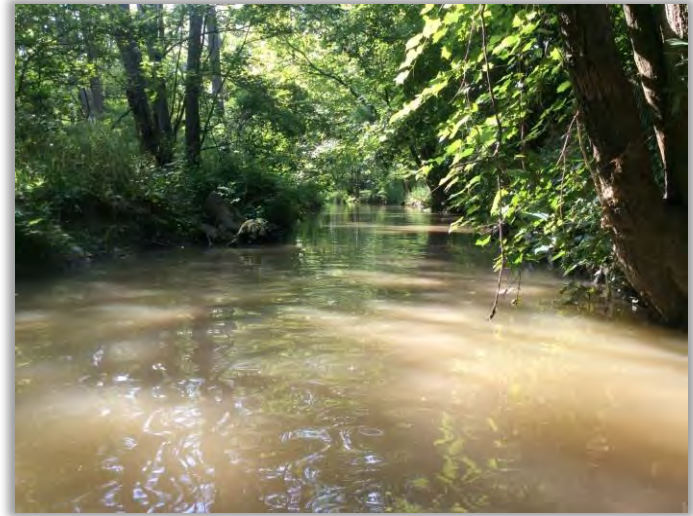
**Figure 5.3: Riparian Vegetation along Bull Creek (BNR)**

In contrast, Bull Creek recorded a ‘good’ (8.8) score in regards to riparian zone. Bull Creek flows in a less developed area, primarily agricultural land, and its riparian vegetation has been less modified which can be seen in Figure 5.3.

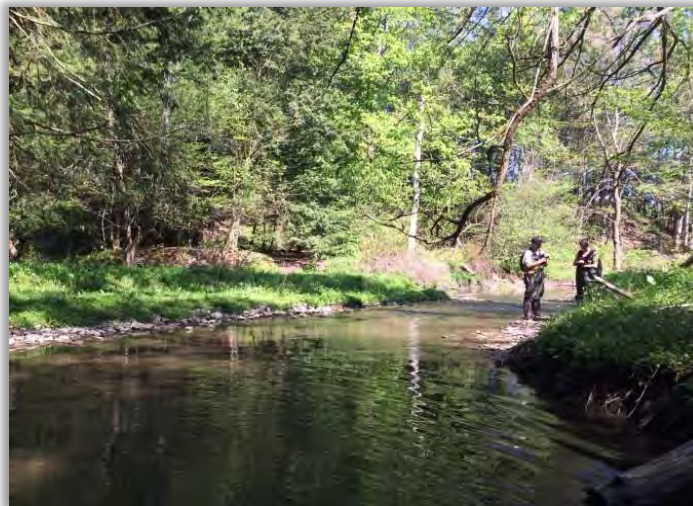
**Figure 6.1: Stream visual assessment in Tonawanda Creek (BNR)**

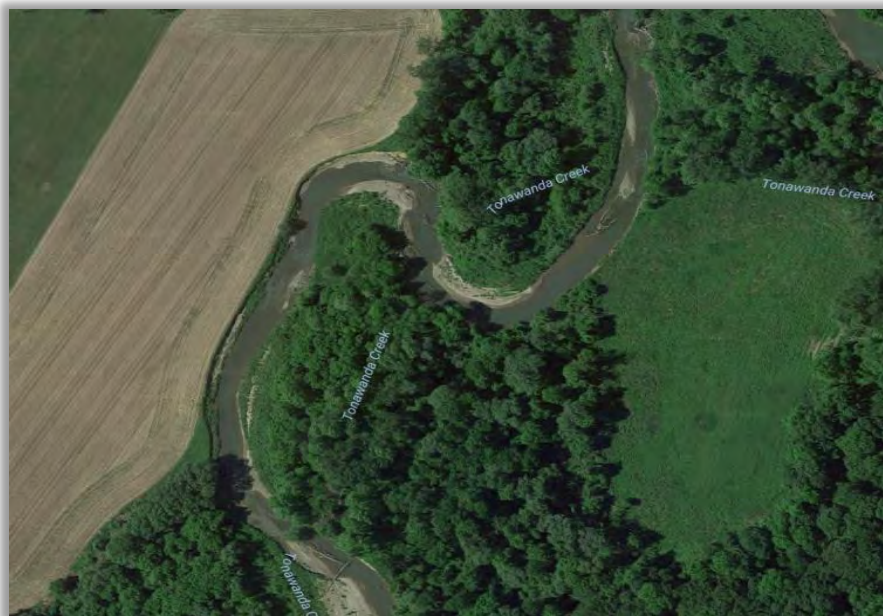
**Figure 6.4: Riparian Zone -Tonawanda Creek (Google Maps)**

Several sites, many occurring in agricultural areas, were observed along Tonawanda Creek that lacked a riparian zone. The location depicted in Figure 6.4, in particular received poor scores for bank stability and riparian zone (one side), as the stream bank's natural vegetation had been completely removed. The bank was actively eroding, and heightened levels of turbidity and phosphorus were recorded just downstream.

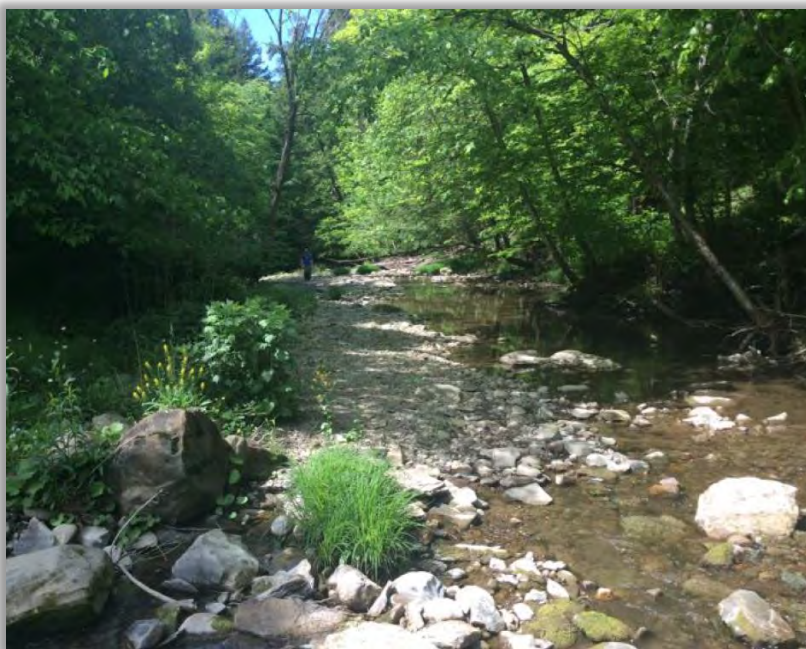
**Figure 6.5: Stony Brook Riparian Zone (BNR)**

extending at least two times the width of the stream’s active channel. Stony Brook received the highest average score for riparian zone of ‘excellent’ (9.87). This waterbody was characterized by

extensive riparian vegetation as seen in Figure 6.5. This vegetation provides ample shade, which helps maintain cool water temperatures.

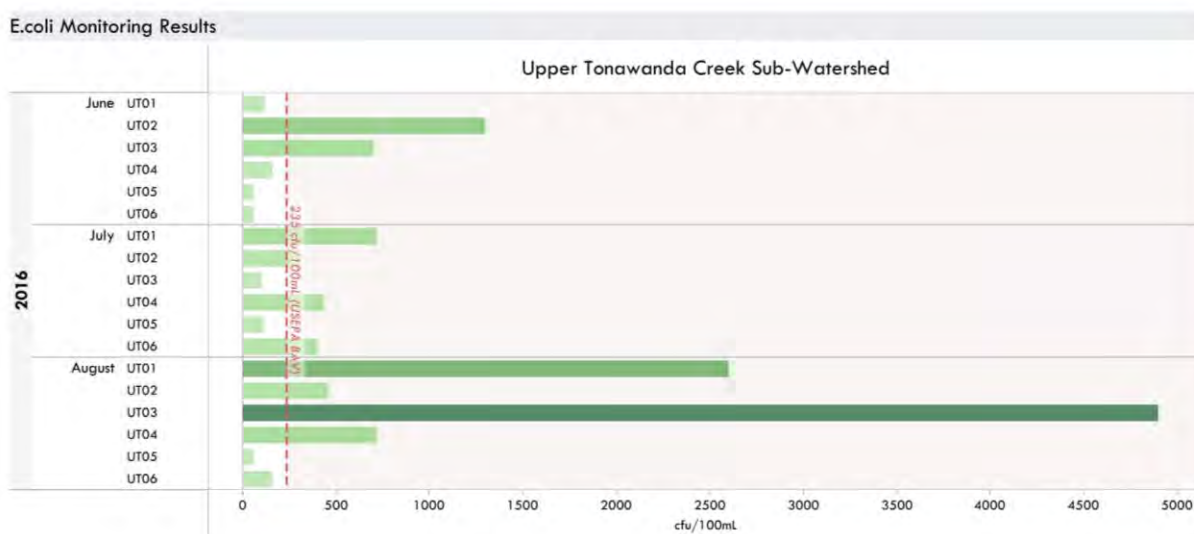
**Figure 6.7: *Escherichia coli* Monitoring Results 2016**

Concentrations of livestock activity were observed along Tonawanda Creek as seen in Figure 6.6 (a) and (b). Along some streams, livestock appeared to have unlimited access. Livestock activity can degrade riparian vegetation and escalate bank erosion, and the presence of manure in streams can increase nutrient and bacteria levels. *E. coli* samples collected at 6 various sites within UT frequently exceeded the United States Environmental Protection Agency (USEPA) Beach Action Value (BAV) of 235 cfu/100mL as seen in Figure 6.7. The BAV is a tool often used to assist in making beach notifications and closures.<sup>29</sup>
