Chapter 5: Lower Tonawanda Creek

REGIONAL NIAGARA RIVER/ LAKE ERIE WATERSHED MANAGEMENT PLAN (Phase 2)

Sub-watershed Implementation Plans

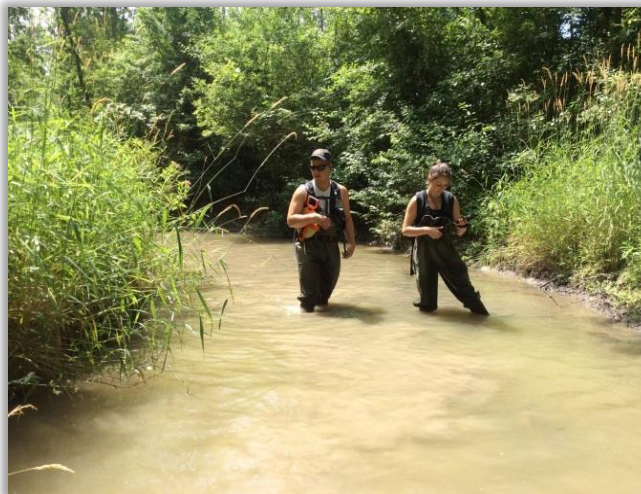
Figure 5.1: Stream visual assessment in Bull Creek (BNR)

Waterways within LT were assessed from June 20, 2016 to August 8, 2016. Within eight stream bodies, 825 reaches were assessed. Reaches refer to a length of stream 200 feet in length. The streams assessed were Sawyer Creek, Black Creek, Bull Creek, Ransom Creek, Gott Creek, a tributary of Ransom Creek, a tributary of Tonawanda Creek, and another minor tributary to Tonawanda Creek. Each stream was broken up into segments and assigned a unique identifier based on location (SAW, BLK, BUL, RSM, GOT, RT, TOND, EC).

Within LT, 31 of the total 216 miles (14%) of waterways were assessed using a modified version of the Stream Visual Assessment Protocol (SVAP).²¹ Field teams encountered numerous streams where water depth was too high or where drought conditions resulted in dry stream beds. In these locations, assessment was not possible.

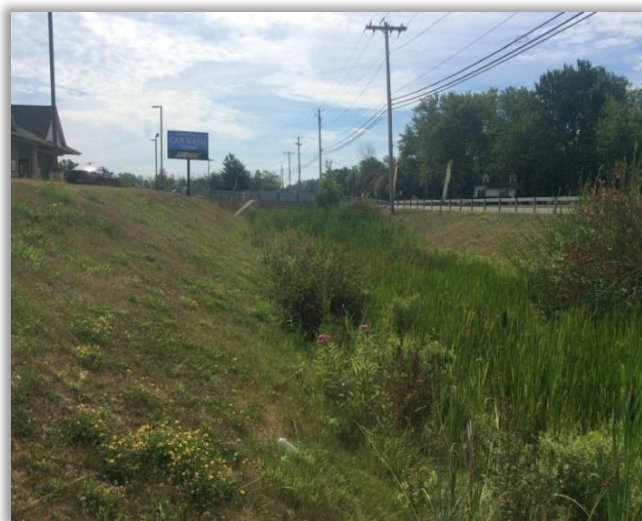
Figure 5.2: Lack of Riparian Vegetation along Sawyer Creek (BNR)

The riparian zone, or area of natural vegetation bordering waterbodies, along assessed stretches of Sawyer Creek recorded an average score of 'poor' (3.0), the lowest of all waterbody segments assessed within LT. Poor scores indicate a lack of riparian zone or a narrow riparian zone in comparison to the streams active channel. This zone is vital component to a healthy waterbody, as the roots of riparian vegetation naturally stabilize banks and control erosion. This zone of vegetation also functions as a surface water filter, slowing and absorbing storm water

runoff and the various pollutants it transports. Due to the extent of development along Sawyer creek, the natural vegetation has been severely depleted as seen in Figure 5.2. Excellent scores (9.0+) refer to a riparian zone extending at least two times the width of the streams active channel.

As noted above, including vegetated buffer or setback requirements into a municipality's zoning code is one regulatory mechanism to ensure measures are taken to protect water health. Not all land can be regulated through laws so in some instances encouraging best management practices or utilizing incentive programs may be a more effective approach. Towns of Amherst and Pendleton both include language in their zoning codes for vegetated buffers. For example, Goal 4-4 of The Bicentennial Comprehensive Plan for the Town of Amherst (amended Feb 2011) sets a goal, "To establish buffer/setback standards for new development to help protect streams of significance." This goal is then applied in the town's zoning code in Chap. 204, Part 3 §3-5-6, "Lots abutting a watercourse." This sections requires that lots abutting a watercourse install a 50-foot-wide riparian buffer on either side of a watercourse and further, any building be an additional 10 feet from the buffer.

Recommended Actions to increase the length and width of riparian zones:

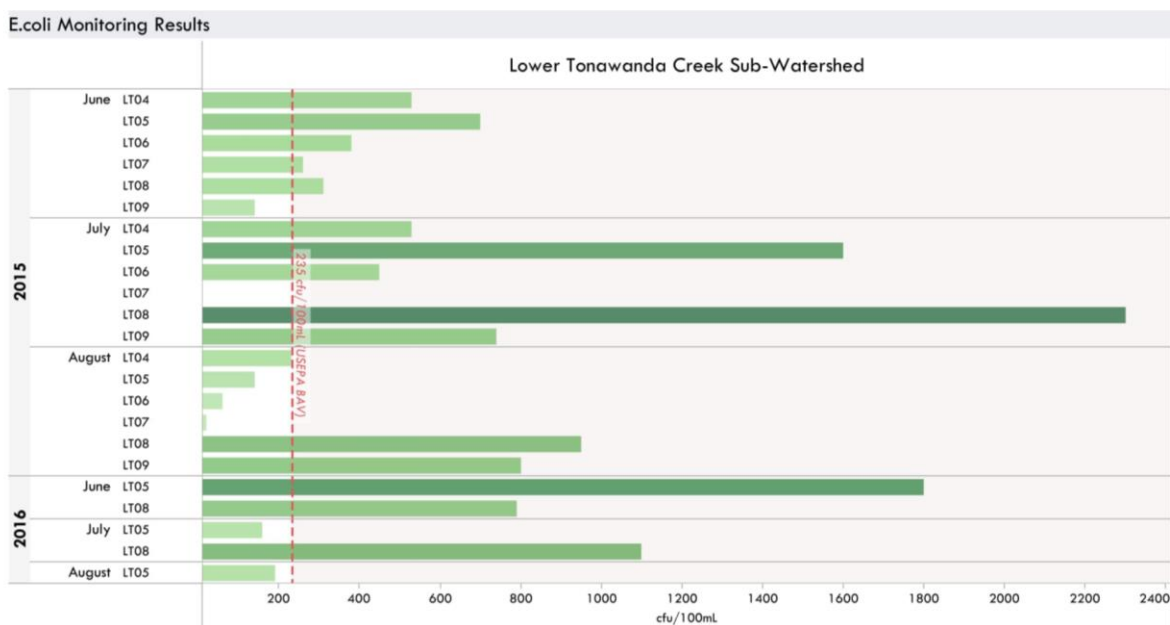
Figure 5.4 *Escherichia coli* Monitoring Results

Escherichia coli (*E. coli*) samples were collected within LT at six sites during 2015 and two sites during 2016. Results were frequently above the USEPA Beach Action Value (BAV) of 235 cfu/100mL as seen in Figure 5.4. The BAV is a tool often used to assist in making beach notifications and closures.²⁹ Overall higher levels of *E. coli* measured in 2015 can be partially explained by more precipitation during the sampling season than 2016, although the LT08 site in 2016 was also well above the recommended value, indicating input during non-storm event conditions.

Target: Samples at or below USEPA BAV throughout the sub-watershed or reduce 30-day geometric mean value to meet USEPA recommended value of 126 cfu/100mL.

Leaking septic systems are a direct input of bacteria into groundwater which can pollute drinking water and contaminate streams. It is important to recall that the presence of *E. coli* is not the only indicator species of biological pollution—it is just the simplest and most widely tested for. *E. coli* often occurs in tandem with other pathogenic bacteria, viruses and protozoans, such as those that cause cholera, dysentery, and Giardia. Upgrading septic systems with denitrification systems and fixing leaking systems is a necessary solution to mitigate this input.

Recommended Actions to reduce bacterial inputs into streams:

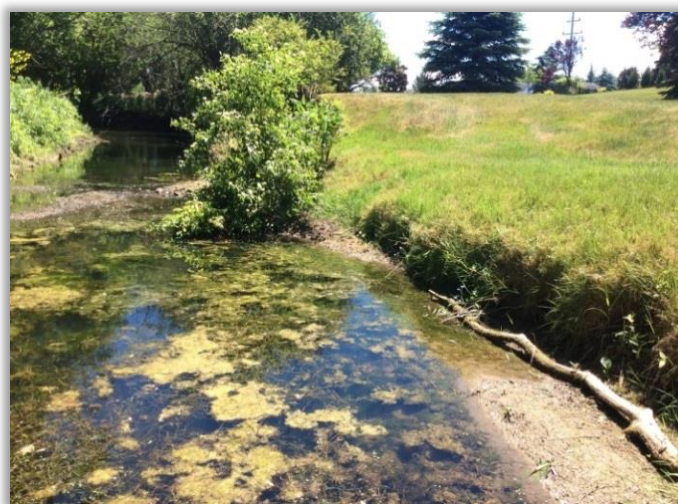
Figure 5.5: Mowed Lawn Adjacent to Stream with Extensive Algal Growth (BNR)

During stream assessment, scores for nutrient enrichment were recorded. LT recorded an average 'poor' (4.5) score indicating high levels of nutrients throughout the assessed waterbodies. Abundant macrophyte and algal growth was observed (Figure 5.5) in addition to abundant lawn debris in the streams or on the stream banks (Figure 5.6). This lawn debris contributes nutrients, including phosphorus, promoting the growth of algae and other aquatic vegetation. Samples to assess nutrient levels (phosphorus and nitrate) were also collected and processed. Phosphorus levels recorded an average of 129.7 µg/L, well above the NYSDEC guidance value of 10 µg/L for Lake Erie Eastern basins.⁸ Sawyer Creek recorded the highest average phosphorus reading of 305.5 µg/L. All waterbody segments sampled recorded average nitrate readings below the NYSDEC standard value of 10,000 µg/L.⁶

Nitrogen and phosphorus are natural constituents of the environment, but can also be introduced into the system via fertilizers and sewage inputs. Most

traditional fertilizers, used both for agricultural or residential purposes, contain nitrogen, phosphorus, and potassium (or potash). Animal manure and commercial fertilizer, used as a crop fertilizer, are primary sources of nitrogen and phosphorus to surface and groundwater via runoff or infiltration.²⁶

While nitrogen and phosphorus are vital for a healthy stream, the correct balance is critical to sustain aquatic life.¹⁸ High nutrient levels can fuel growth of aquatic vegetation and algae which can congest streams, restricting water flow and fish movement as seen in Figure 5.7. With elevated plant respiration and decomposition, dissolved oxygen levels become depleted. These oxygen-depleted environments can stress and have detrimental impacts on aquatic life. At times, algae will grow in large, expansive colonies often referred to as an algal bloom. Under the right conditions, some algal blooms will produce toxins that can be dangerous to wildlife and human health.¹⁴

Many of the changes that could result in the greatest improvement on the overall health of water bodies are behavioral. Encouraging changes in actions or promoting different protocols can be beneficial to combatting nutrient loadings along waterways. For instance, while in the field, the data collection team observed a number of piles of grass clippings abutting the stream and getting blown into the water. Inputs of grass clippings and yard waste into a waterway cause a direct increase in nutrients. Similar minor changes in farming practices or utilizing well known best practices can have significant impacts to the health of a waterbody. Suburban communities can benefit from individual small changes like using phosphorous-free fertilizer and consulting local town or village officials on lawn debris pick-up policies.

Recommended Actions to reduce nutrient loadings:

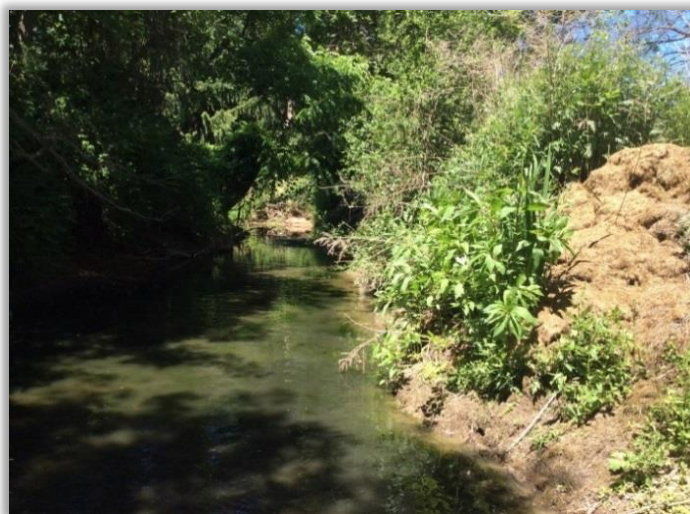
Figure 5.6: Grass Clippings along Ransom Creek (BNR)

Limiting nutrient inputs, such as from lawn fertilizer, can help address low dissolved oxygen. Efforts to decrease fertilizer inputs are particularly important in the Lower Tonawanda sub-watershed as the team observed grass cuttings and animal access directly abutting the stream.
