## Chapter 6: Upper Tonawanda Creek

**REGIONAL NIAGARA RIVER/ LAKE ERIE WATERSHED MANAGEMENT PLAN (Phase 2)**  
**Sub-watershed Implementation Plans**

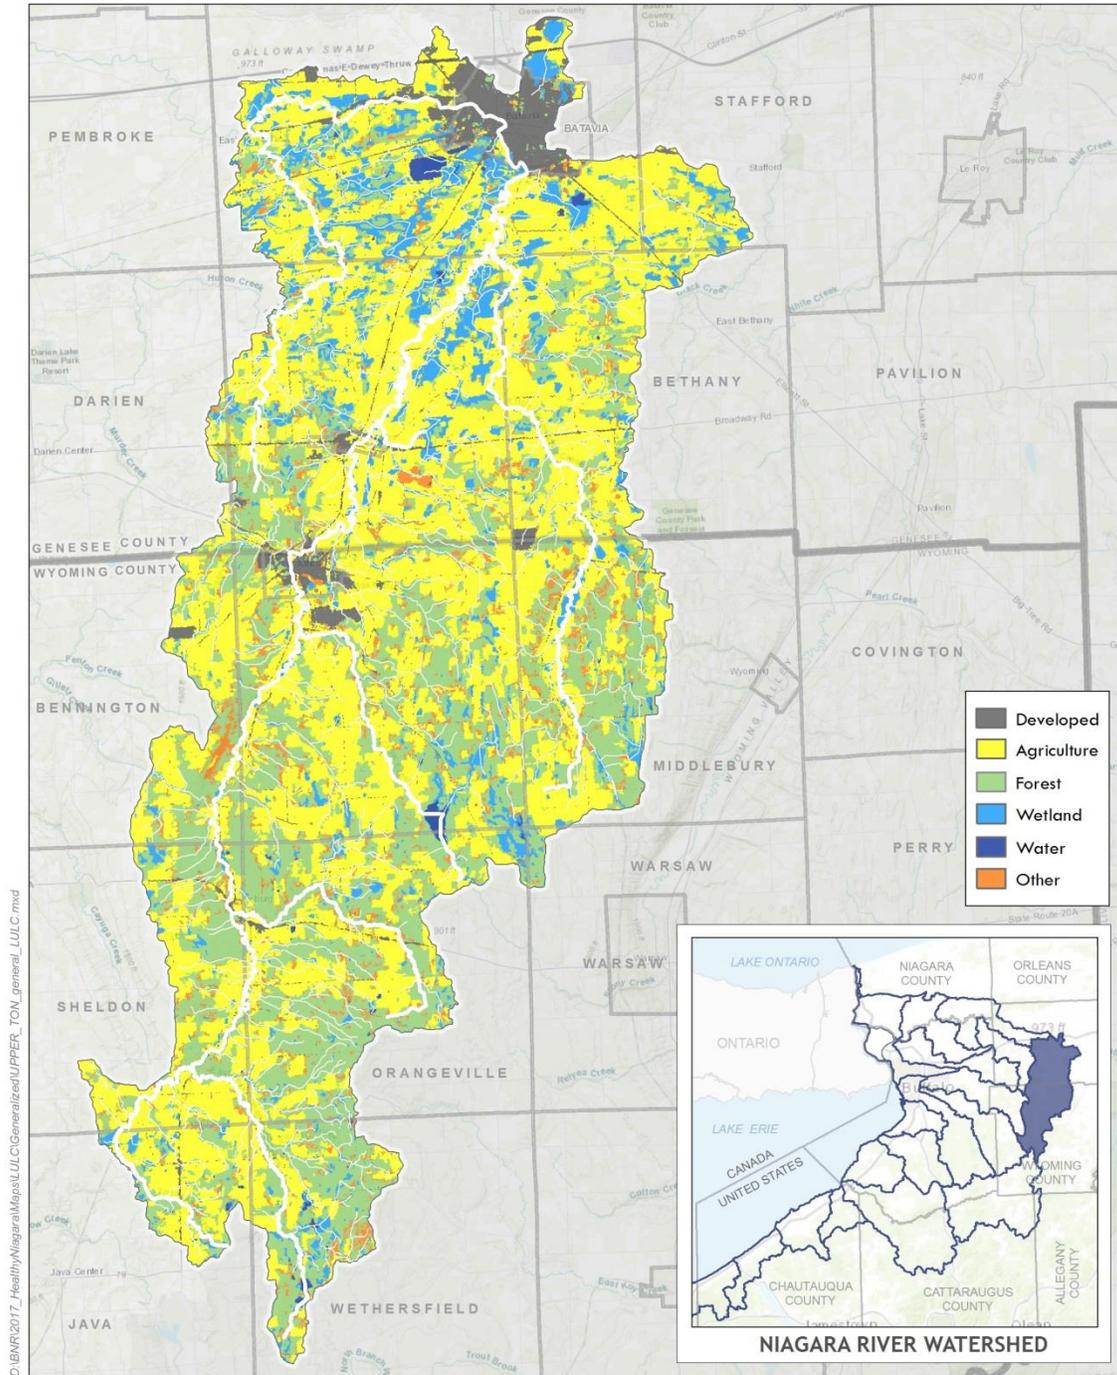
Shown in Map 6.2, large amounts of agriculture LULC exist throughout the watershed, with the northern region of the sub-watershed near Batavia becoming increasingly urbanized and developed, while the southern region remains predominately agriculture and forested land.

**Map 6.1: Upper Tonawanda Creek Sub-watershed Land Use/Land Cover**

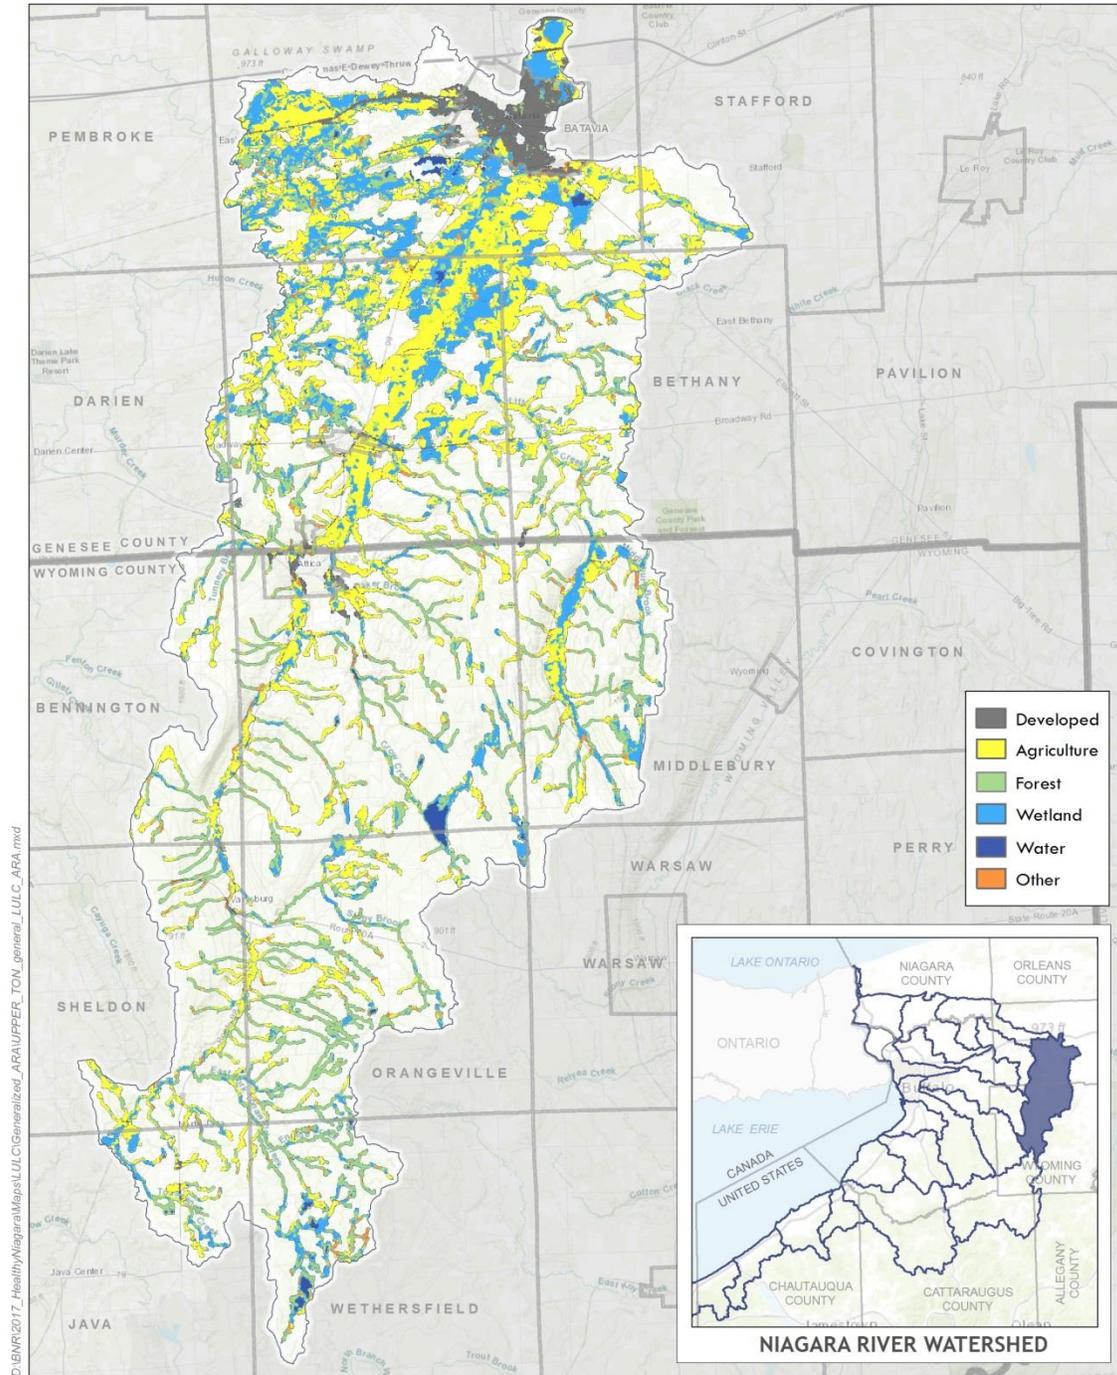
Sections within the ARA in the headwaters of UT interact hydrologically with a variety of land uses such as forest, wetland/palustrine aquatic bed, and agriculture. As the ARA widens flowing downstream, the land-to-stream interaction becomes increasingly dominated by agricultural land use, suggesting that runoff occurs from more homogenous plots of land. Additionally, in the lower reaches of UT, as Tonawanda Creek enters Batavia, land use gives way to urbanized development, where inputs into the creek, such as road runoff and industrial effluent, reflect developed land use and urban environments.

**Map 6.4: LULC and ARA Interaction**

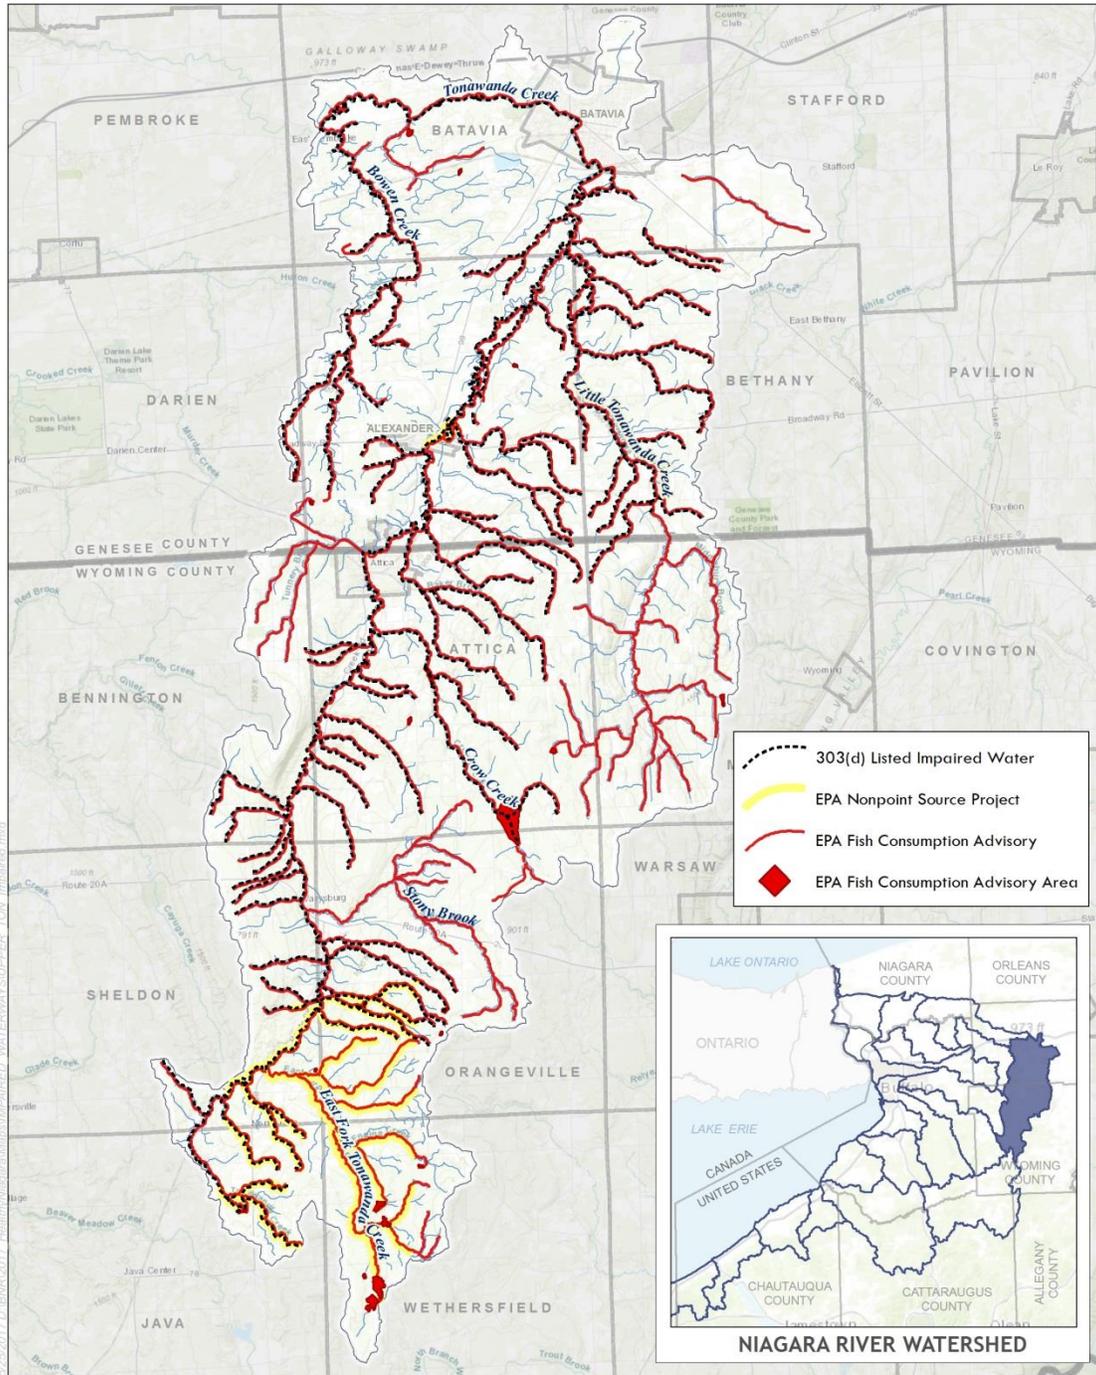
As depicted in Map 6.5, much of the sub-watershed's main streams, Tonawanda Creek, Little Tonawanda Creek, Bowen Creek, and Crow Creek, are listed on the 303(d) list, indicating impaired waterways, while a majority of streams are listed as being under EPA Fish Advisories, including some waterbodies throughout the sub-watershed, such as the Attica Reservoir. The southern tip of the sub-watershed, including the East Fork of Tonawanda Creek, is listed as an area under the EPA Nonpoint Source Project, a program established under Section 319 of the Clean Water Act, and administered by the NYS DEC to "control pollution from nonpoint sources to the waters of the state and to protect, maintain and restore waters of the state that are vulnerable to, or are impaired by nonpoint source pollution"<sup>6</sup>.

**Map 6.5: Upper Tonawanda Creek Sub-watershed Impaired Waterways**

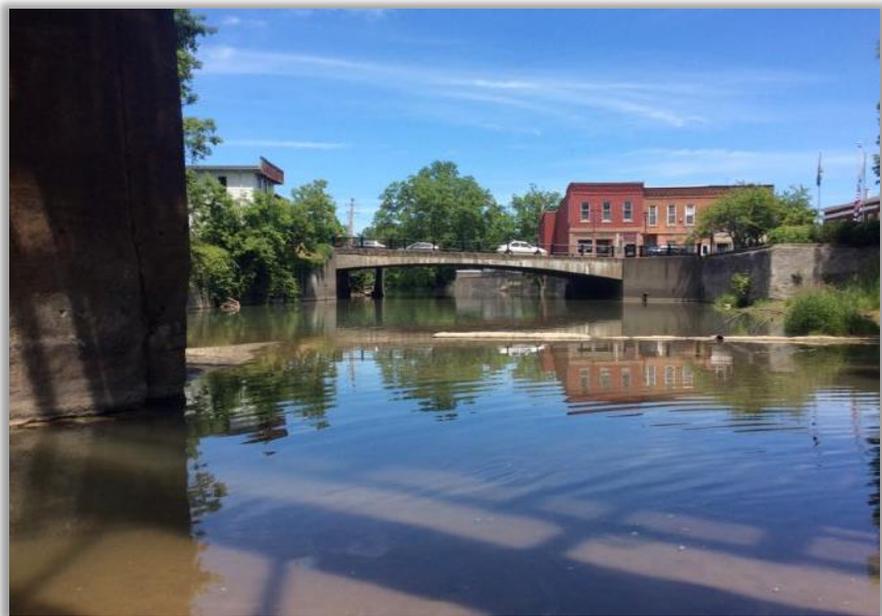
have a positive impact on wildlife and overall stream health. Areas of channel alteration were concentrated around more urban areas, such as the town of Attica. This stretch of stream received the lowest average SVAP score within Tonawanda Creek of 'poor' (2.2), partly due to the level of channelization.

Figure 6.2: Altered Stream Channel in Attica - Tonawanda Creek (BNR)

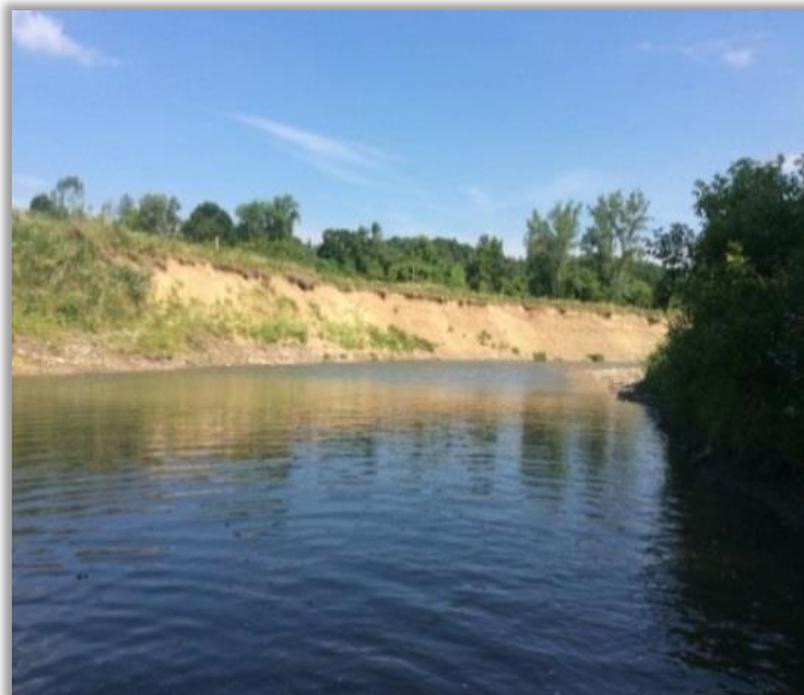
Tonawanda Creek recorded an average bank stability score of 'fair' (6.1), the lowest of all waterbody segments assessed. All other assessed waterbody segments recorded 'good' average bank stability scores (7.9-8.8). The low bank stability scores along Tonawanda Creek indicate that reaches have a higher existence of, or potential for bank erosion. Several sites with significant stream bank erosion were observed as seen in Figure 6.3. Stream banks with limited riparian vegetation have a greater potential to erode and would receive a poor SVAP score.

Figure 6.3: Tonawanda Creek Bank Erosion (BNR)

<b>Short Term</b>	<ul style="list-style-type: none"> <li>• Landowners should replant and reshape failing streambanks with stabilizing vegetation to reduce erosion and sediment deposition               <ul style="list-style-type: none"> <li>○ Cost: Low to High</li> </ul> </li> </ul>
<b>Long Term</b>	<ul style="list-style-type: none"> <li>• Develop restoration plans for severely failing waterways such as Tonawanda Creek and Bowen Creek.               <ul style="list-style-type: none"> <li>○ Cost: Medium</li> </ul> </li> <li>• Develop vegetated buffer standards for all waterfront development that ensure a protected, stabilized shoreline.               <ul style="list-style-type: none"> <li>○ Cost: Low</li> </ul> </li> <li>• Identify and mitigate or replace improperly installed road/stream crossings and stream barriers               <ul style="list-style-type: none"> <li>○ Cost: Medium to High</li> </ul> </li> </ul>

Stabilization of actively eroding shorelines using living and natural infrastructure is recommended where appropriate. Other engineered stabilization techniques should be used only in extreme cases.

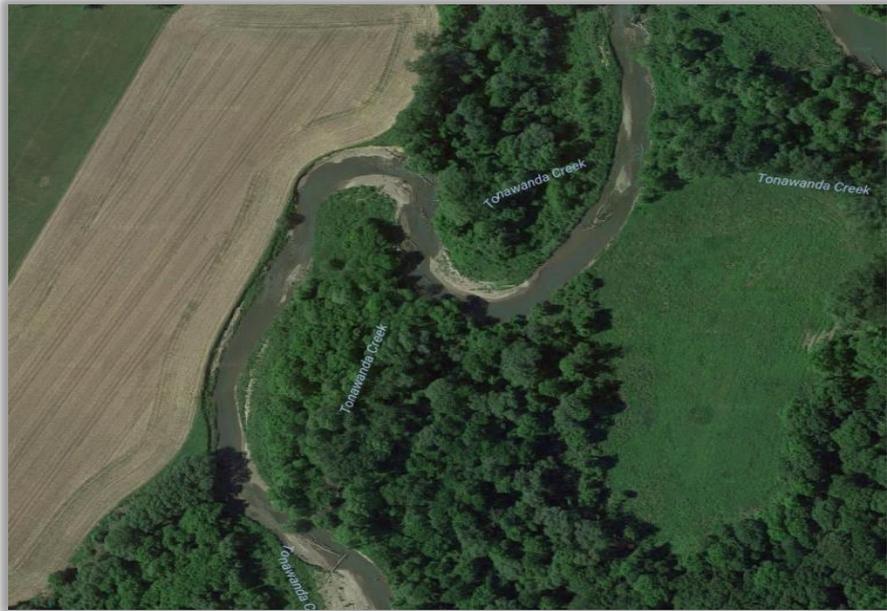
Several sites, many occurring in agricultural areas, were observed along Tonawanda Creek that lacked a riparian zone. The location depicted in Figure 6.4, in particular received poor scores for bank stability and riparian zone (one side), as the stream bank's natural vegetation had been completely removed. The bank was actively eroding, and heightened levels of turbidity and phosphorus were recorded just downstream.

Figure 6.4: Riparian Zone -Tonawanda Creek (Google Maps)

**Recommended Actions to increase the length and width of riparian zones:**

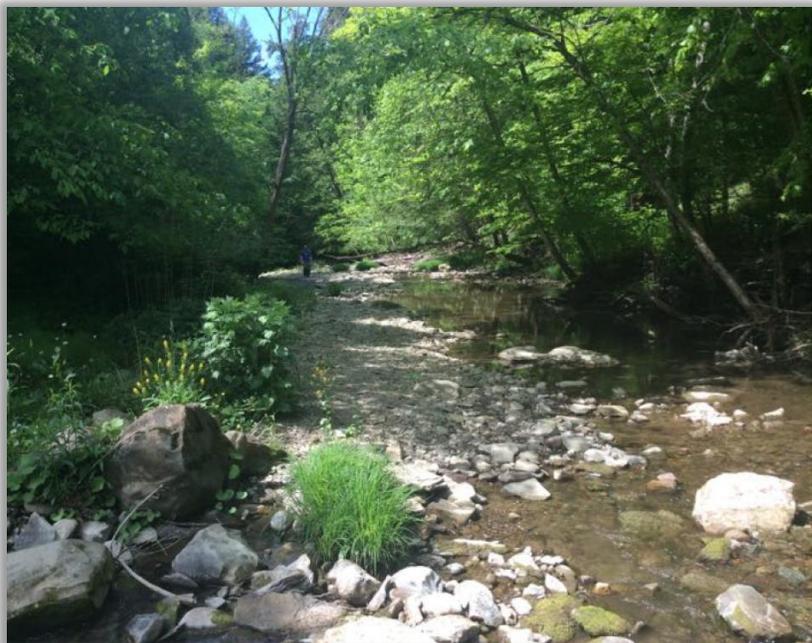
extending at least two times the width of the stream’s active channel. Stony Brook received the highest average score for riparian zone of ‘excellent’ (9.87). This waterbody was characterized by

Figure 6.5: Stony Brook Riparian Zone (BNR)

extensive riparian vegetation as seen in Figure 6.5. This vegetation provides ample shade, which helps maintain cool water temperatures.

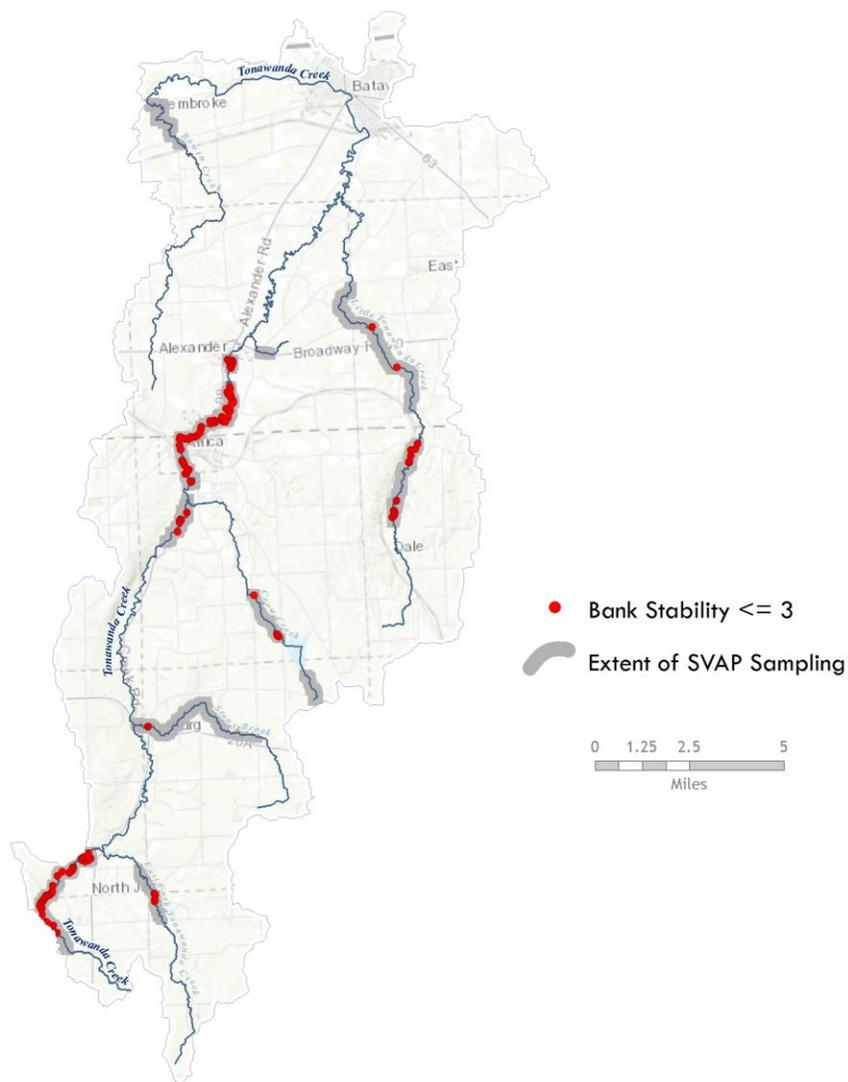
**Map 6.7: Bank Stability Scores 1-3**

Bank stability scores under 3 for the sub-watershed are shown in Map 6.7 below. A score of 3 indicates that “banks are moderately unstable, typically high, actively eroding at bends; ~50% rip-rap; excessive erosion” while a score of 1 represents “Unstable high banks, actively eroding at bends throughout; dominated by rip-rap.”

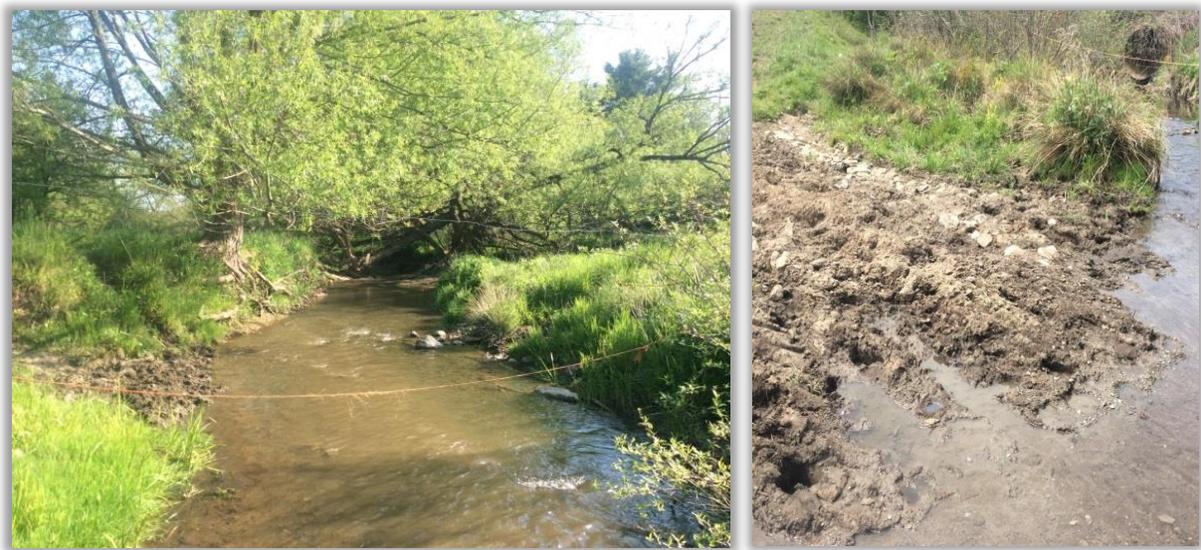
Concentrations of livestock activity were observed along Tonawanda Creek as seen in Figure 6.6 (a) and (b). Along some streams, livestock appeared to have unlimited access. Livestock activity can degrade riparian vegetation and escalate bank erosion, and the presence of manure in streams can increase nutrient and bacteria levels. *E. coli* samples collected at 6 various sites within UT frequently exceeded the United States Environmental Protection Agency (USEPA) Beach Action Value (BAV) of 235 cfu/100mL as seen in Figure 6.7. The BAV is a tool often used to assist in making beach notifications and closures.<sup>29</sup>

**Figure 6.6 (a) and (b): In-stream Cattle Crossing (BNR)**

**Recommended Actions to reduce bacterial inputs into streams:**

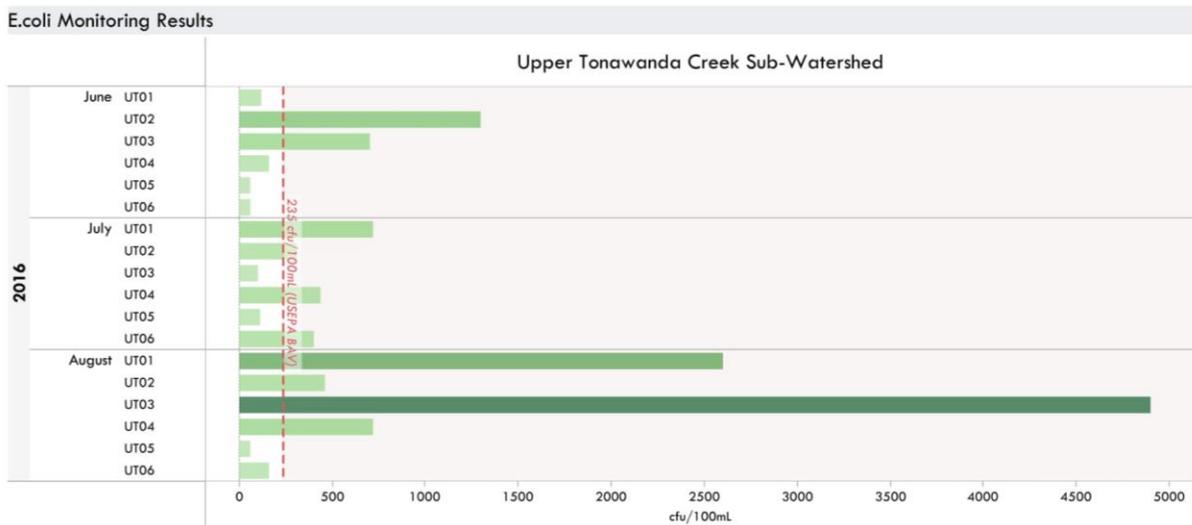
- *E. coli*
  - *E. coli* measurements performed in the sub-watershed had levels greatly exceeding recommended levels for recreational use, but as many of the waterways in the sub-watershed are class A, with drinking water uses, *E. coli* inputs must be addressed.

**Figure 6.7: Escherichia coli Monitoring Results 2016**

**Target:** Samples test at or below USEPA BAV throughout the sub-watershed, or reduce 30-day geometric mean value to meet USEPA recommended value of 126 cfu/100mL.

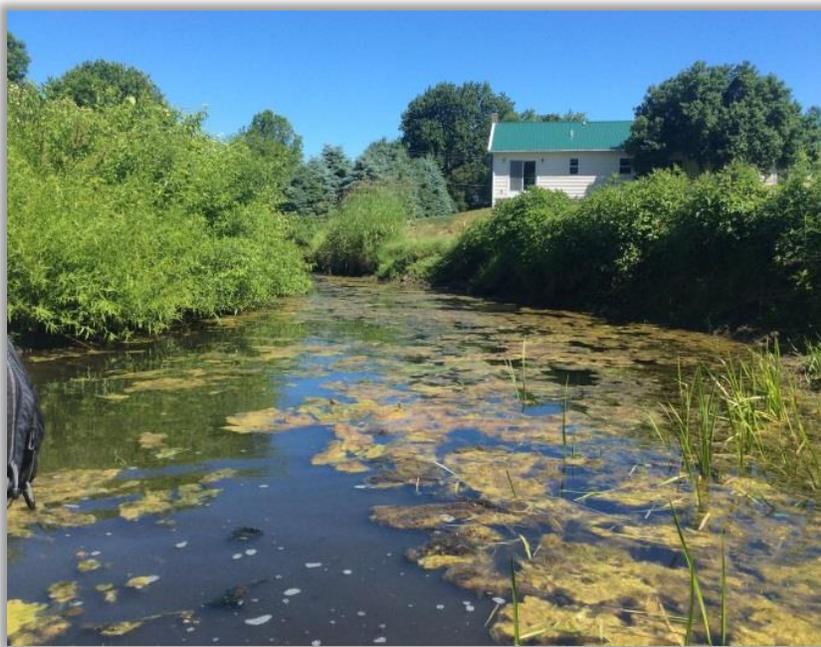
During monthly sampling phosphorus levels measured at the same stationary sites ranged from 0 µg/L measured in June, to a high level 148.5 µg/L measured in August. While the high value recorded at UT02 is well above the range of other measurements within the sub-watershed, it is in line with

Figure 6.8: Abundant growth of aquatic vegetation within Bowen Creek (BNR)

observations made in other sub-watersheds where agricultural land use is prevalent. UT02 is located between active farm fields, and is also directly downstream of a registered medium Consolidated Agricultural Feeding Operation (CAFO), so high levels of pollutants related to agriculture and livestock operations are to be expected.

**Recommended Actions to reduce nutrient loadings**
