2019 RIVERWATCH CITIZEN SCIENCE

WATER QUALITY REPORT

INTRODUCTION

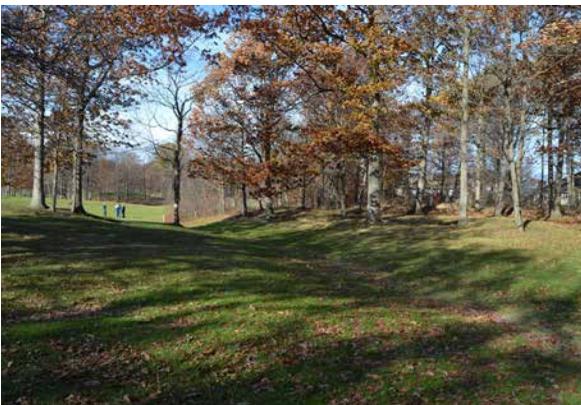
BEFORE: Runoff and snowmelt from the golf course flowed directly down into Spicer Creek

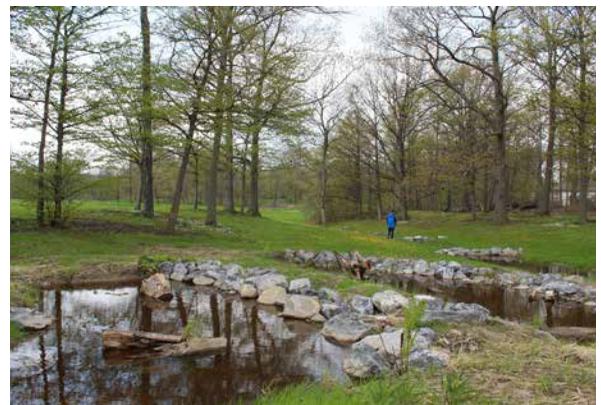
AFTER: Step-pools and check dams were created to slow runoff and capture excess sediment

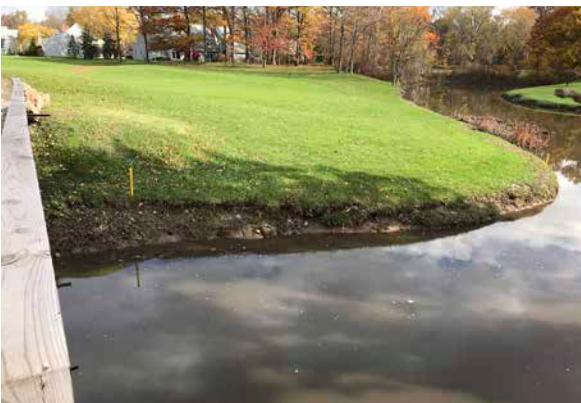
BEFORE: Runoff flowed down steep, slumping slopes

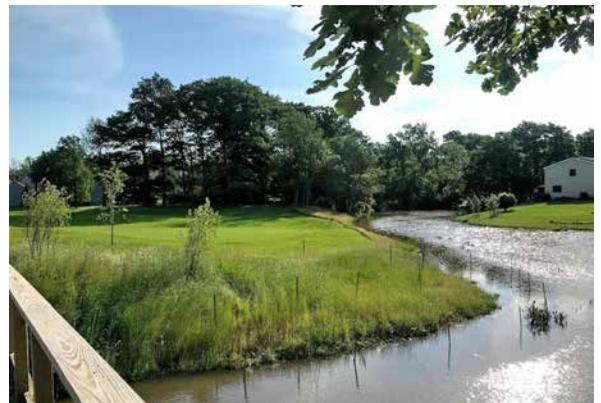
AFTER: Shoreline regrading and a submerged stone sill help to stabilize the bank and create ideal conditions for in-water marsh plants.

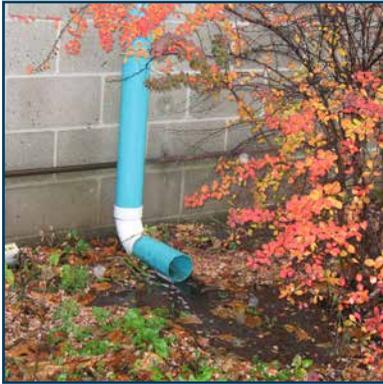
Downspout Disconnection

Downspouts on many homes are connected directly to the sewer system, contributing to sewer overflows. By disconnecting downspouts from the sewer system, water is able to drain to lawns or gardens, thereby allowing water to soak slowly into the ground as plants and soils filter out pollutants.

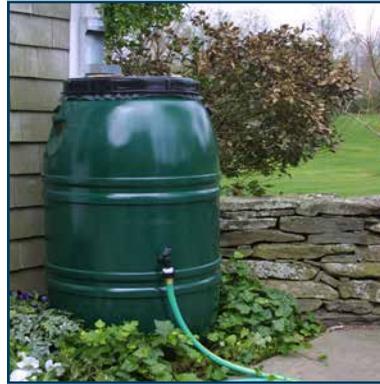
Rain Barrels

Rain barrels are containers that collect and store rain water for future uses (like watering a garden) while decreasing the amount of stormwater runoff that leaves your property. A rain barrel is placed under the downspout to channel rainwater into the barrel for later use. You can purchase one at our office or at various events we attend during the year! Learn more: bnwaterkeeper.org/programs/rainbarrels/

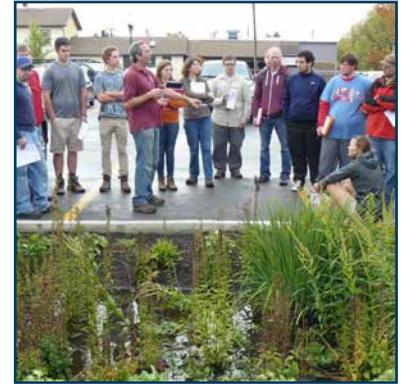
Rain Gardens

A rain garden is a planted depression that allows rainwater runoff from impervious urban areas like roofs, driveways, walkways, and compacted lawns to be absorbed. This reduces rain runoff by allowing stormwater to soak into the ground. Need design inspiration or plant ideas? Find our Native Plant Guide at our office or online at: bnwaterkeeper.org/nativeplantguide
