BUFFALO NIAGARA
WATERKEEPER

2021 RIVERWATCH CITIZEN SCIENCE

WATER QUALITY REPORT

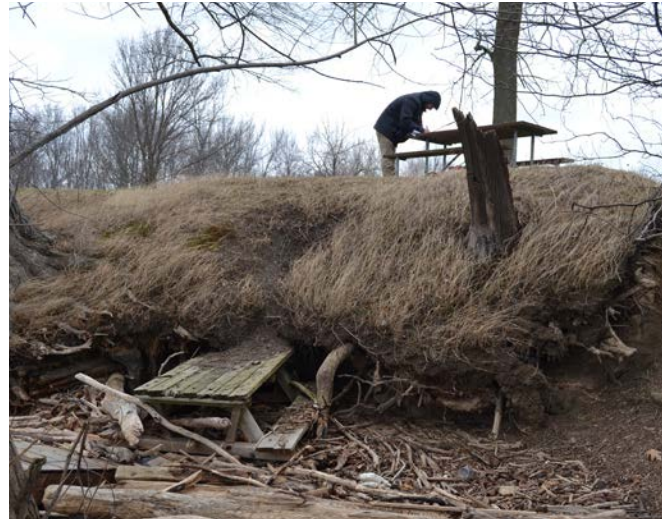
BEFORE: Extreme shoreline erosion

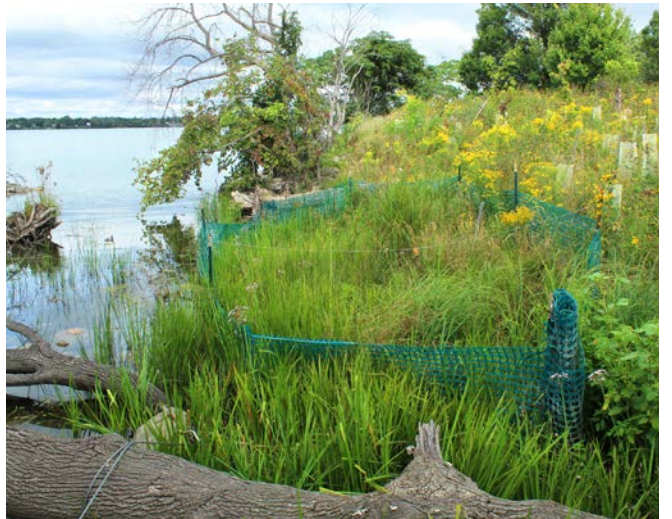
MID CONSTRUCTION: Shoreline is regraded to a gentle slope including native plantings

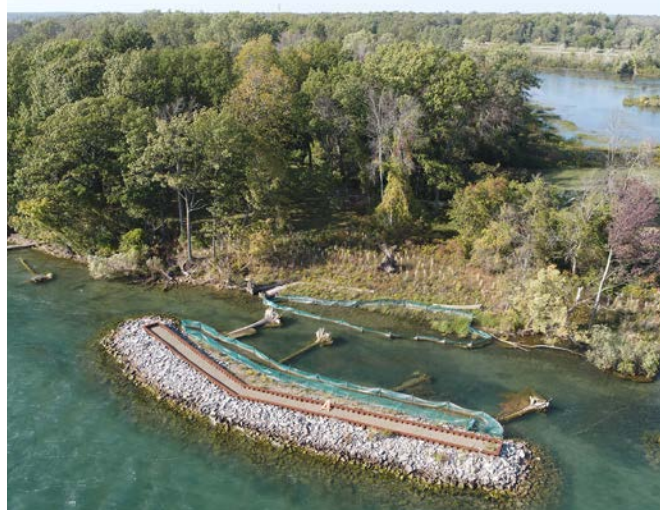
AFTER CONSTRUCTION: Rock Barrier Reefs slow wave action and limits shoreline ice scour

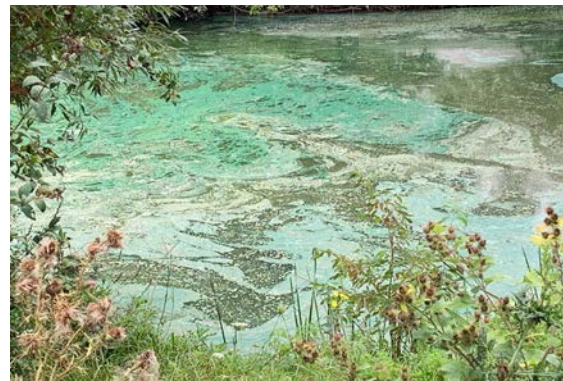
Cyanobacteria blooms can be a white color and often look like spilled paint, like this cyanobacteria bloom at Hyde Park Lake

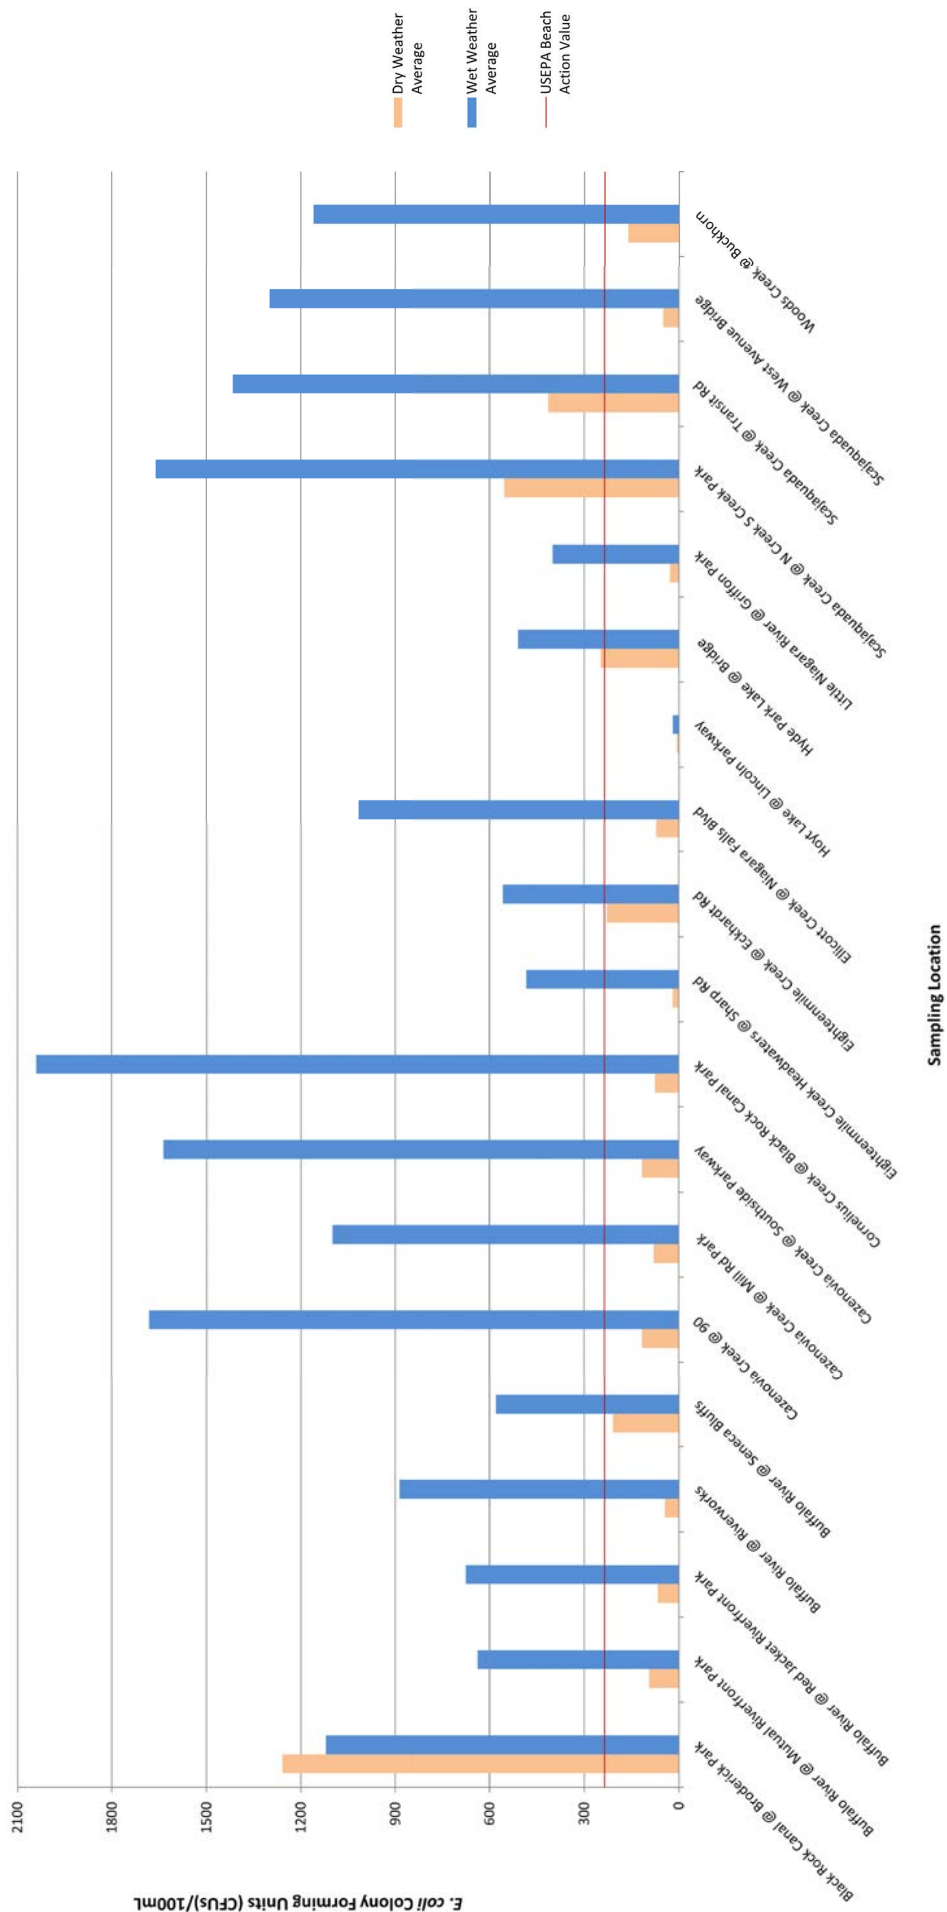
Figure 1: *Escherichia coli* results in comparison to the EPA BAV

Average *E. coli* Counts On Dry and Wet Weather Days

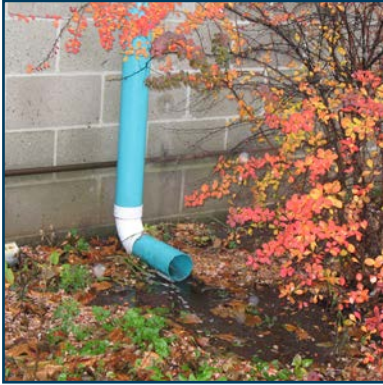
Downspout Disconnection

Downspouts on many homes are connected directly to the sewer system, contributing to sewer overflows. By disconnecting downspouts from the sewer system, water is able to drain to lawns or gardens, thereby allowing water to soak slowly into the ground as plants and soils filter out pollutants.

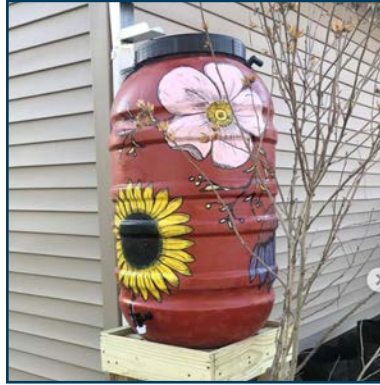
Rain Barrels

Rain barrels are containers that collect and store rain water for future uses (like watering a garden) while decreasing the amount of stormwater runoff that leaves your property. A rain barrel is placed under the downspout to channel rainwater into the barrel for later use. You can purchase one at our office or at various events we attend during the year! Learn more: bnwaterkeeper.org/programs/rainbarrels/
