2022

Riverwatch Report

An overview of Buffalo Niagara Waterkeeper's water quality sampling, restoration, and cleanup efforts

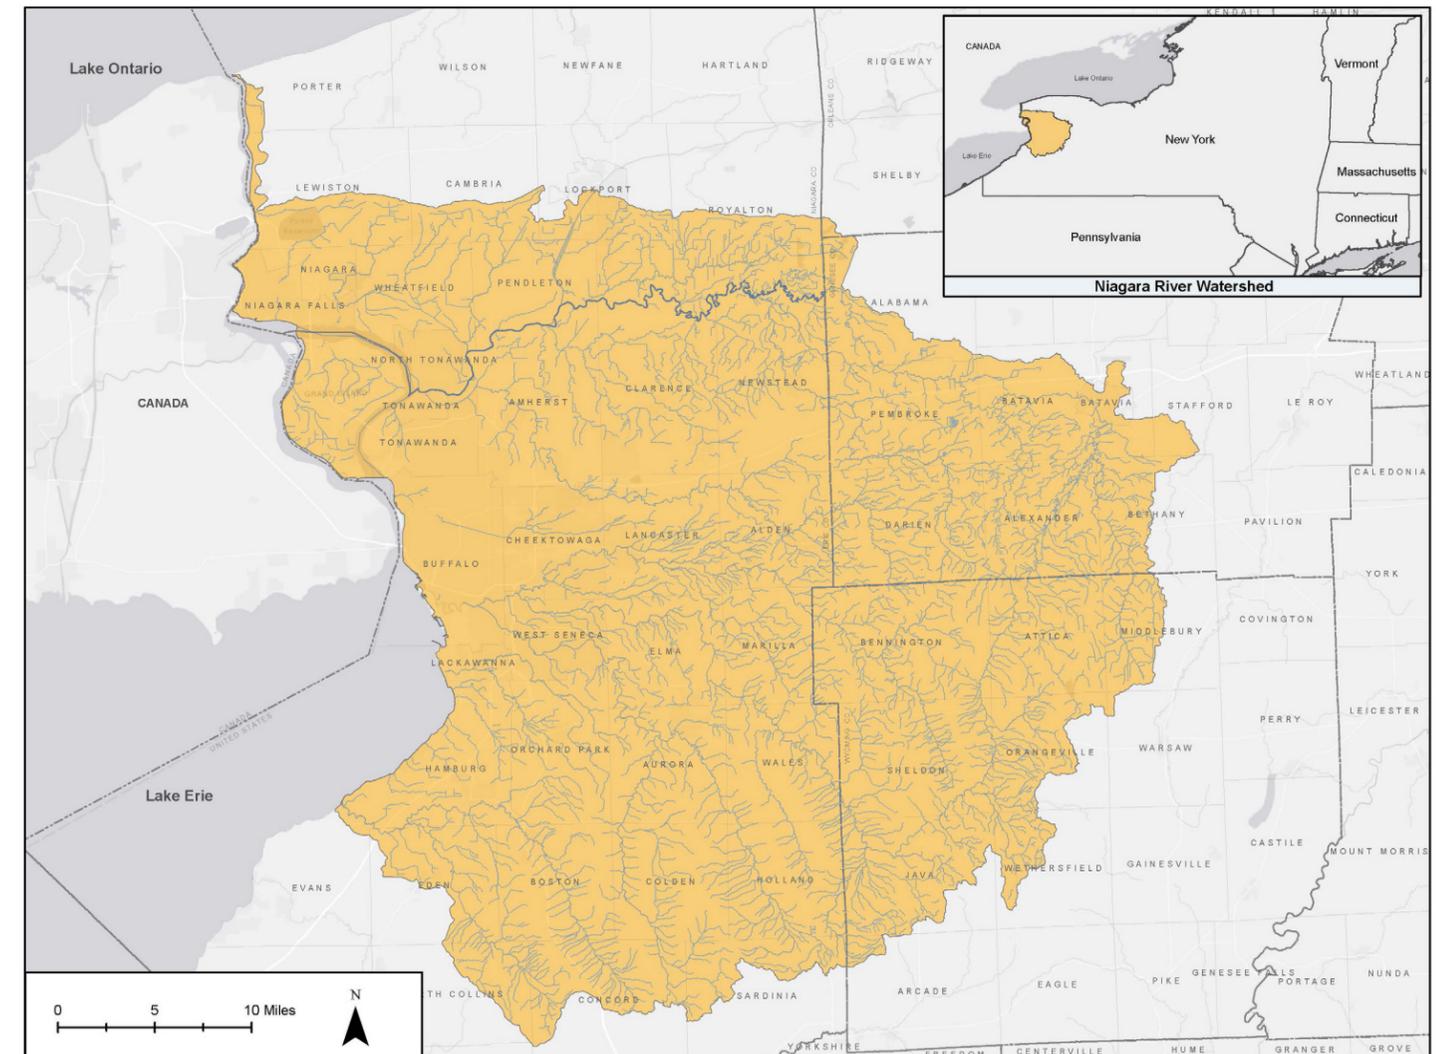
Map 1: Niagara River Watershed and tributaries

The Niagara River Watershed is located along the western most portion of New York State and encompasses lands that drain into the Niagara River, a channel that connects the Great Lakes of Erie and Ontario. The Niagara River Watershed is also part of the larger Great Lakes Drainage Basin.

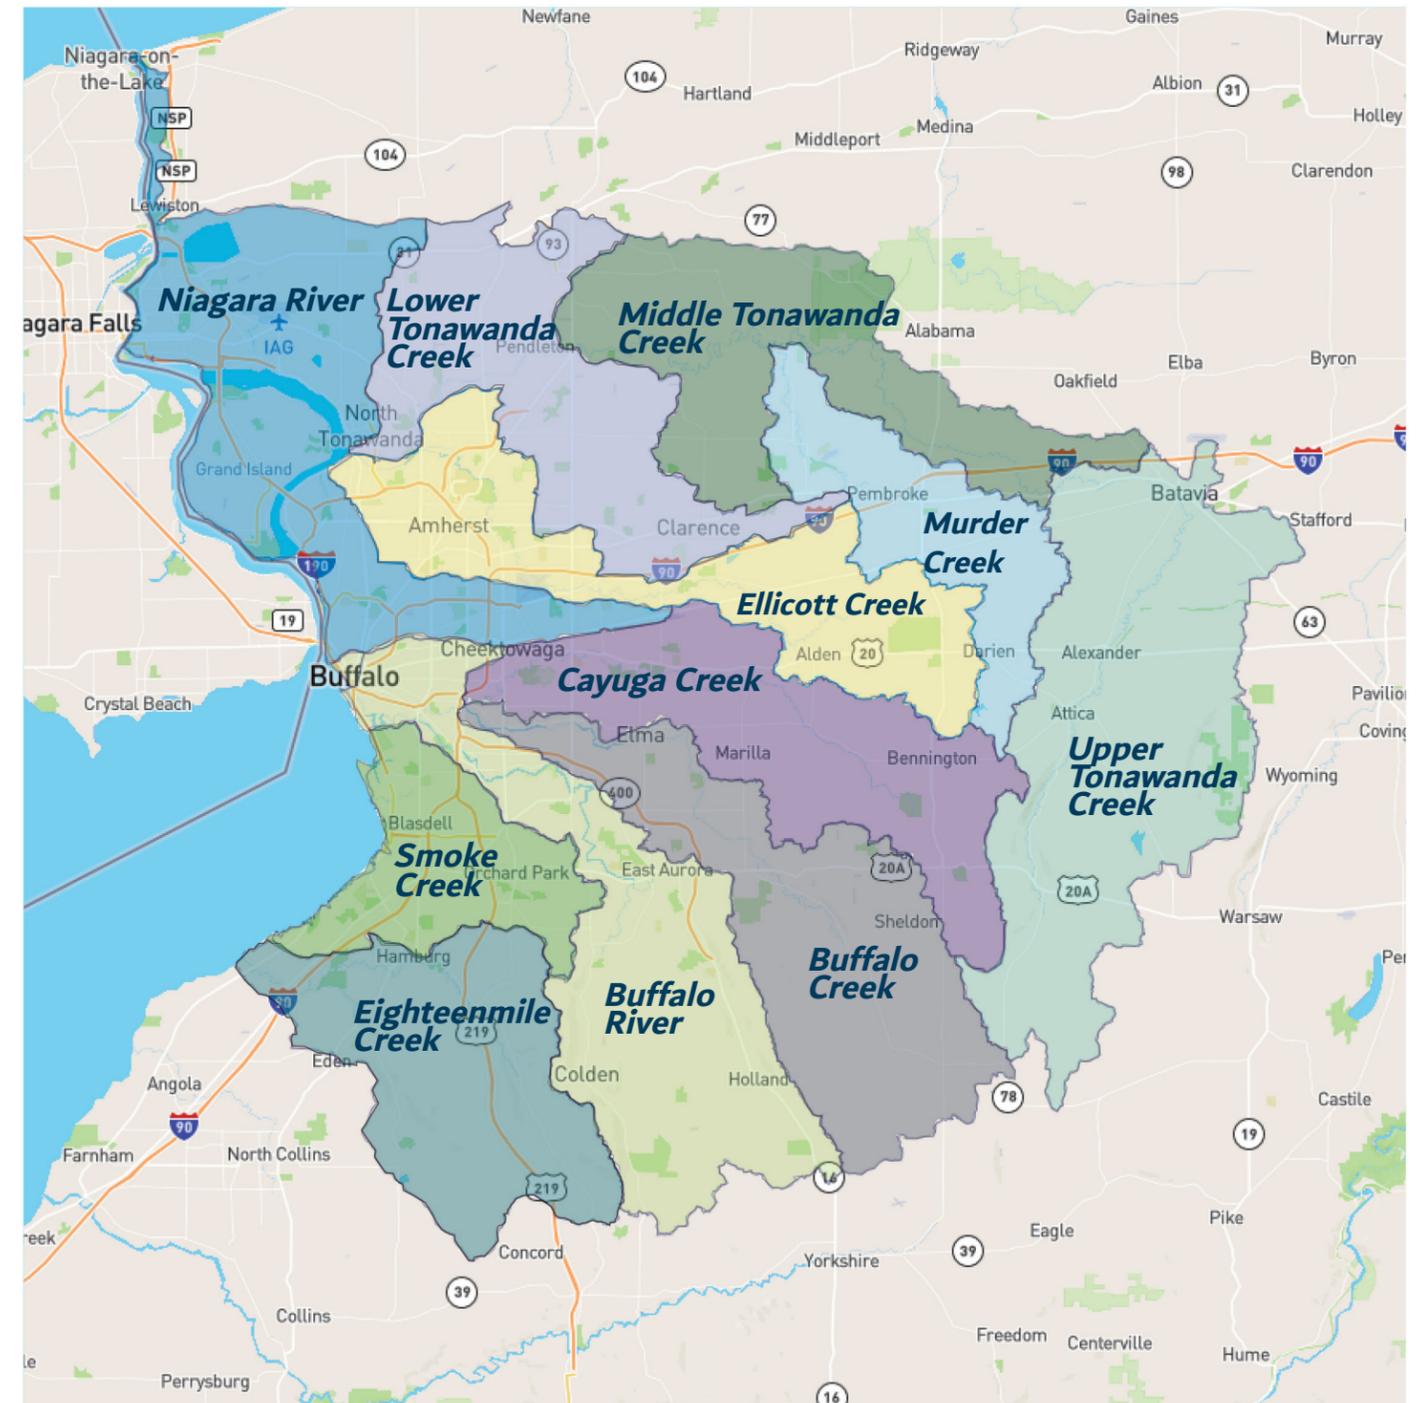
Map 2: Niagara River Watershed with sub-watershed detail

The Niagara River Watershed is comprised of 11 sub-watersheds. These two pages indicate the waterbodies sampled by Riverwatch volunteers and their correlating sub-watershed. Use the map on the following page to explore locations and boundaries of these sub-watersheds. The water quality issues listed here reference the DEC's Waterbody Inventory/Priority Waterbodies List. Length often includes waterbody tributaries.

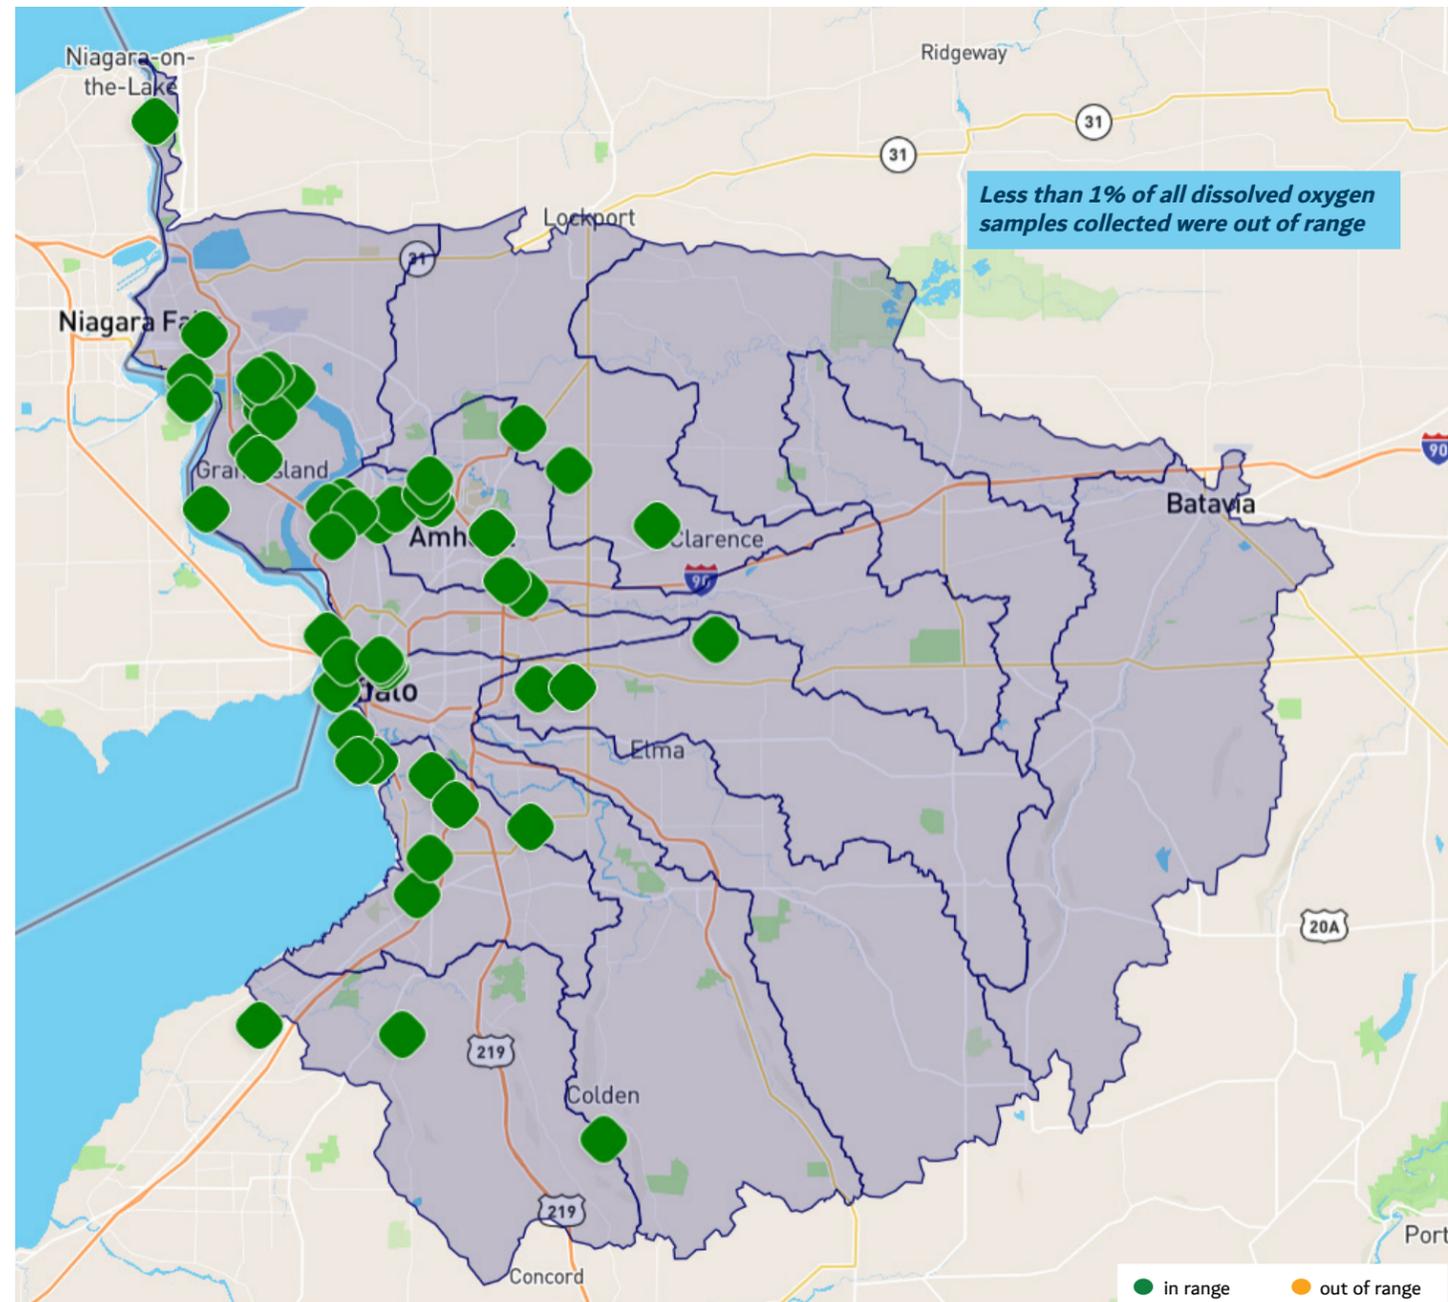
Map 3: Average Dissolved Oxygen Sample Results Compared to Standard

DISSOLVED OXYGEN RESULTS COMPARED TO STANDARDS

DO enters water from the atmosphere, from aeration as it tumbles over rocks and falls, and from photosynthesis. DO is essential for the survival of nearly all aquatic life and levels can decrease with the introduction of various pollutants including sewage discharges, stormwater runoff, and failing septic systems.

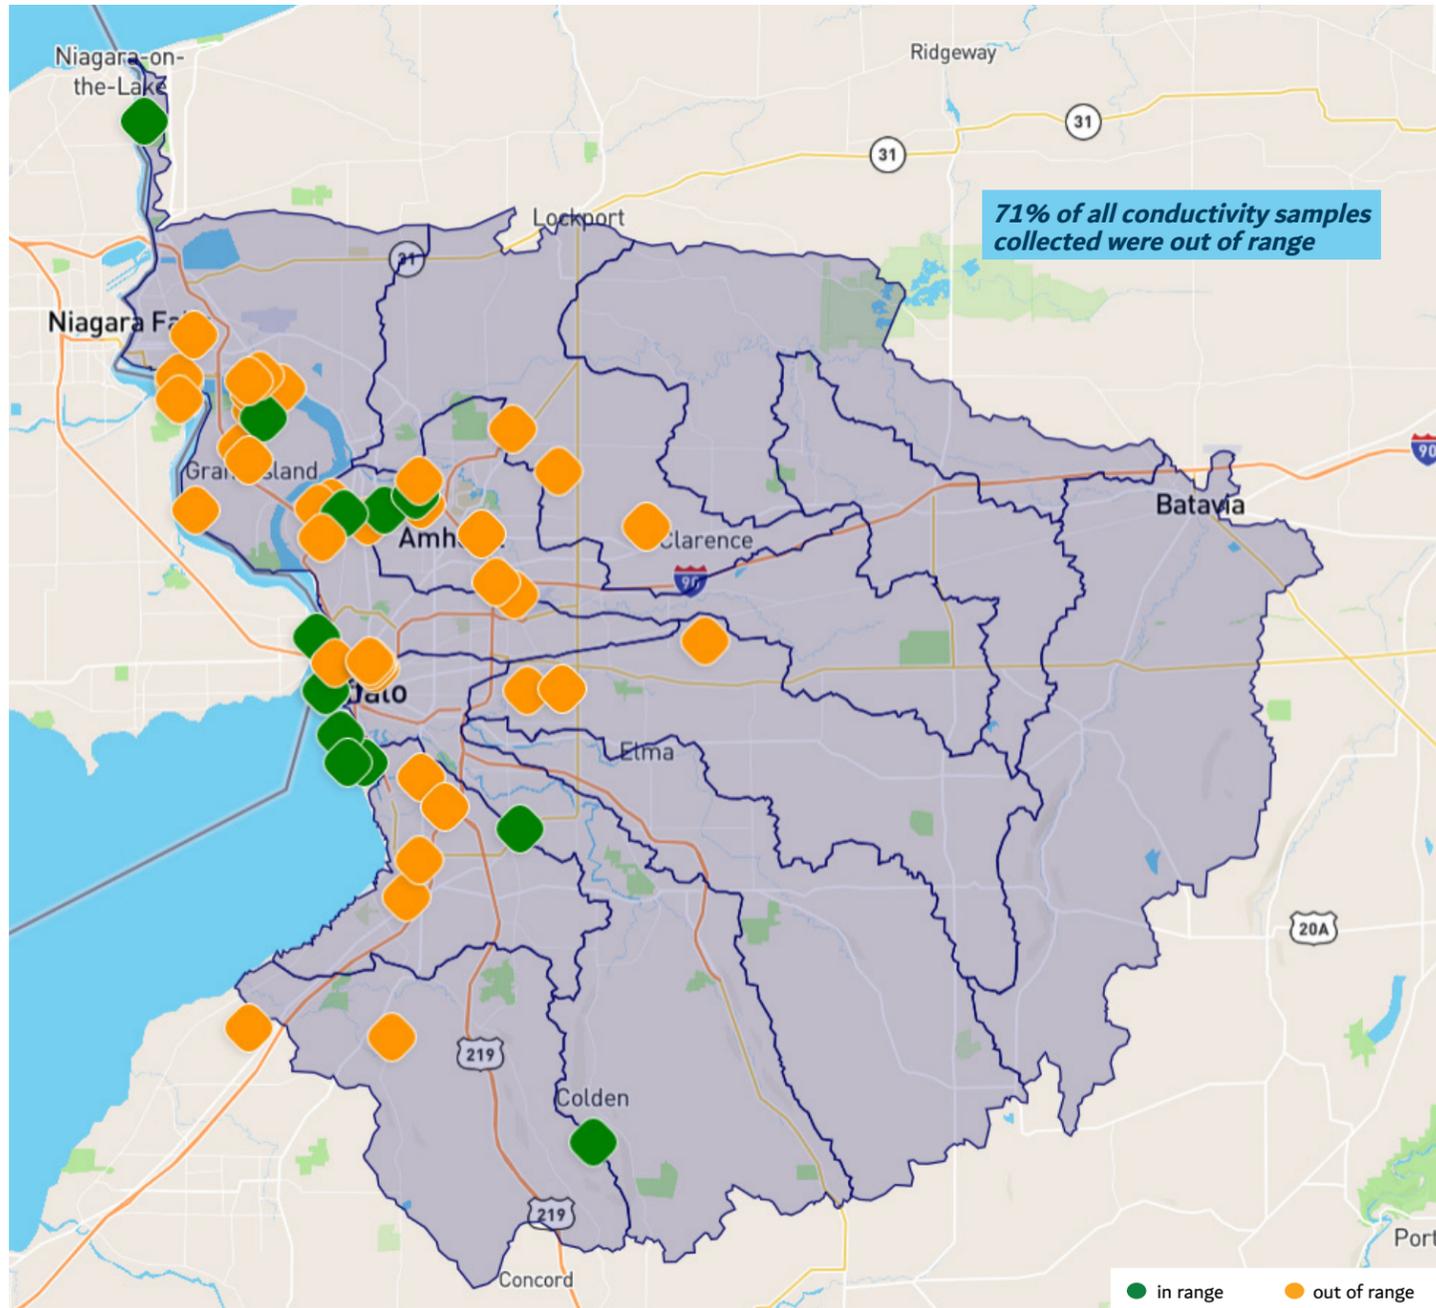
Map 4: Average Conductivity Sample Results Compared to Standard

CONDUCTIVITY RESULTS COMPARED TO STANDARDS

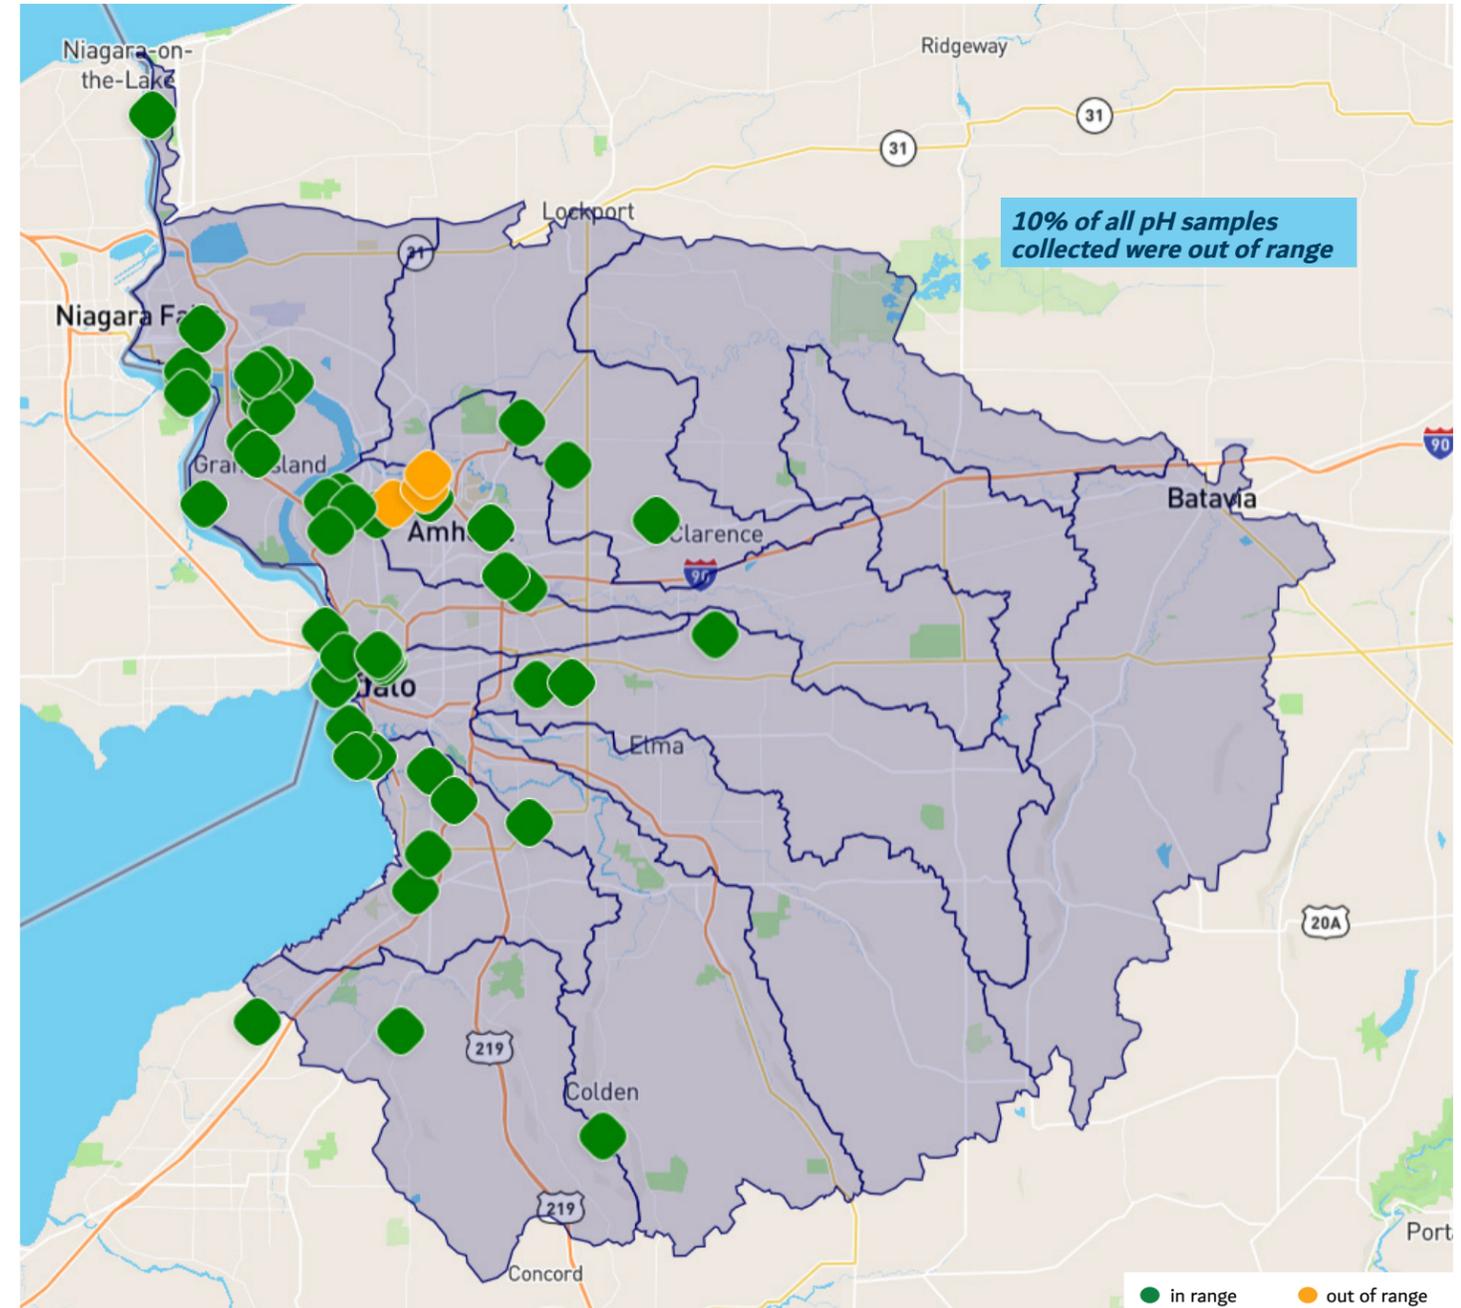
Map 5: Average pH Sample Results Compared to Standard

pH RESULTS COMPARED TO STANDARDS

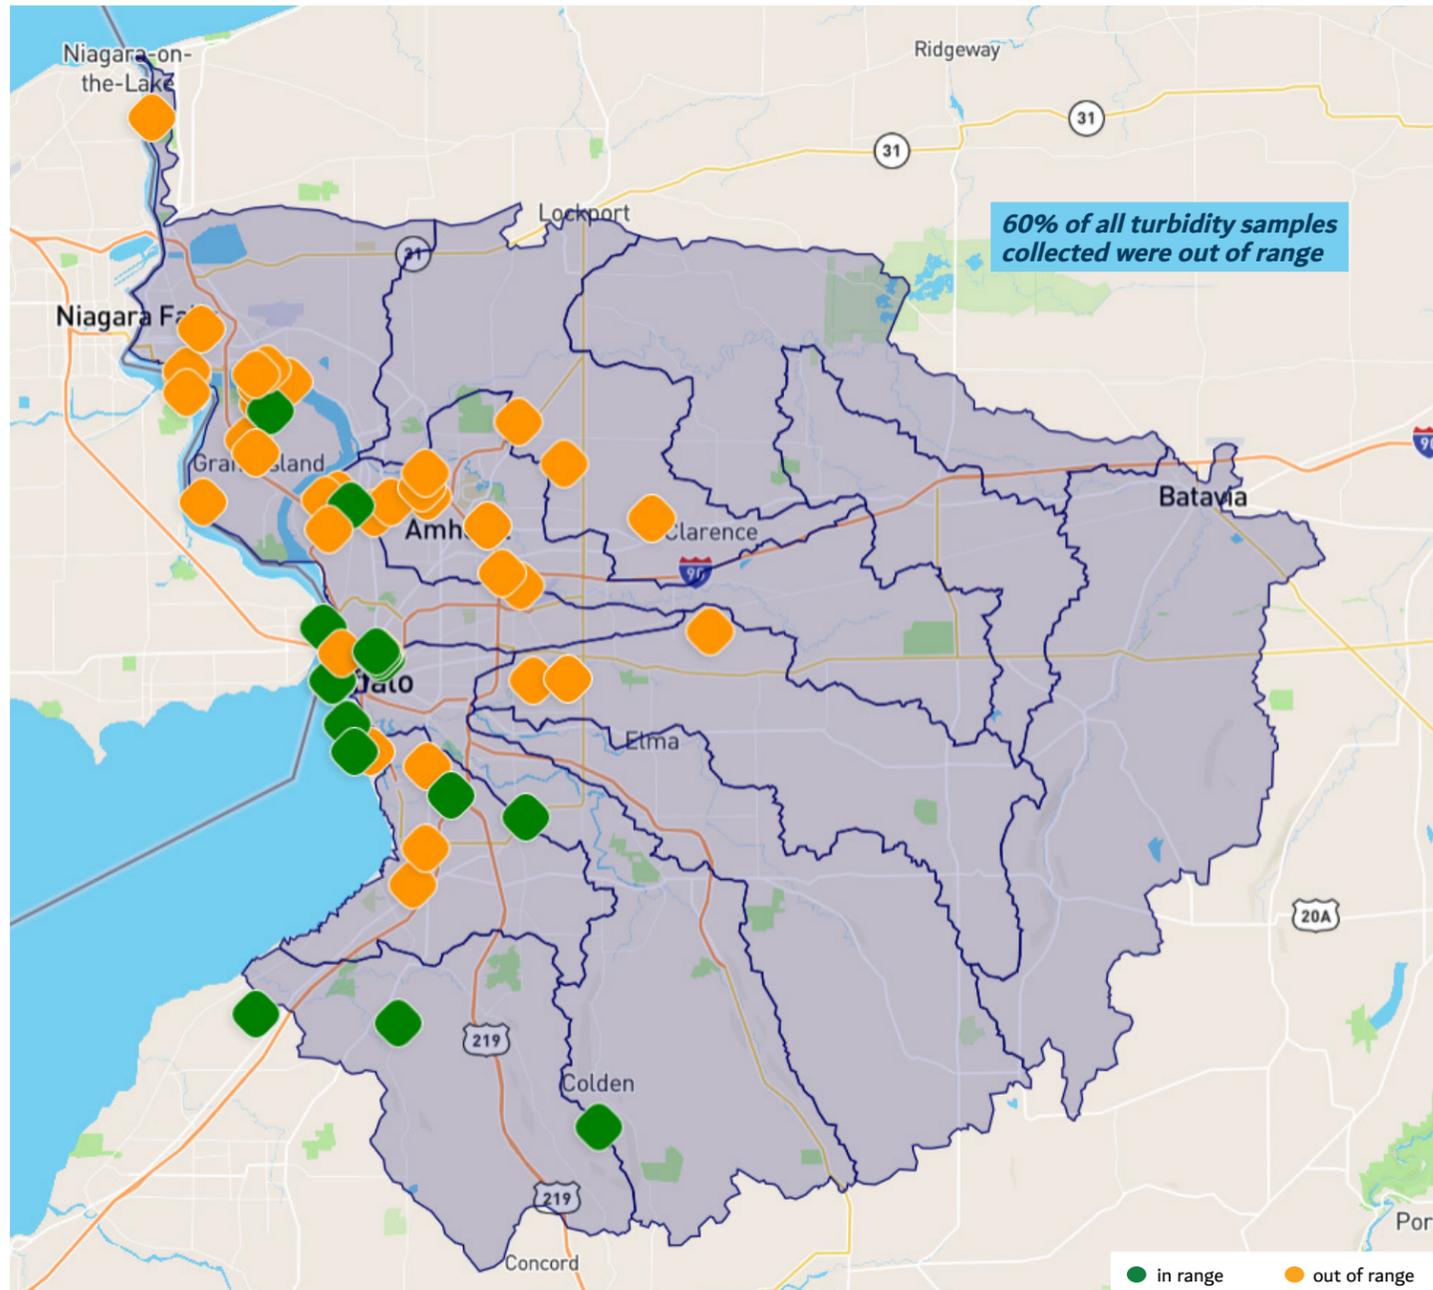
Map 6: Average Turbidity Sample Results Compared to Standard

TURBIDITY RESULTS COMPARED TO STANDARDS

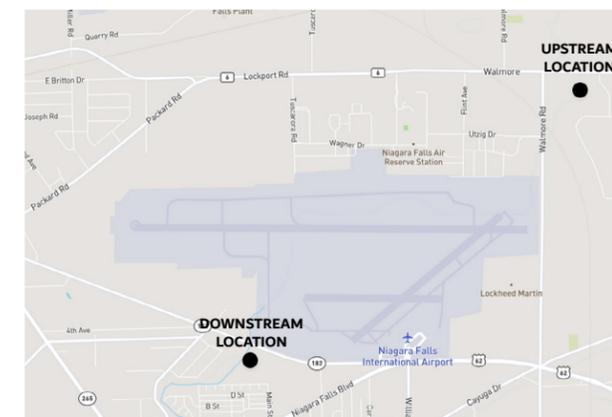
Map 7: PFAS Surface Water Sampling Locations along Cayuga Creek (Niagara County)

Samples were collected and analyzed from 12 additional sites throughout the Niagara River Watershed. Findings can be viewed at bnwaterkeeper.org/pfas-pfoa-pfos/

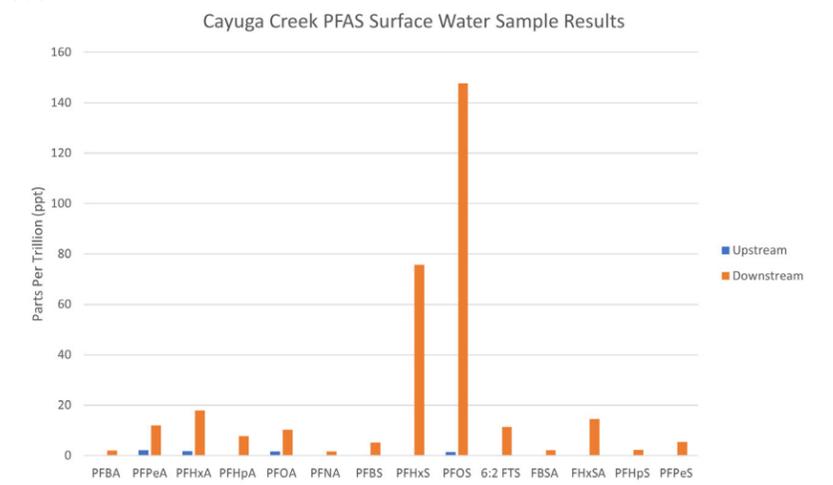
Figure 1: PFAS Compounds detected in Cayuga Creek (Niagara County) from samples collected on 6/16/2022

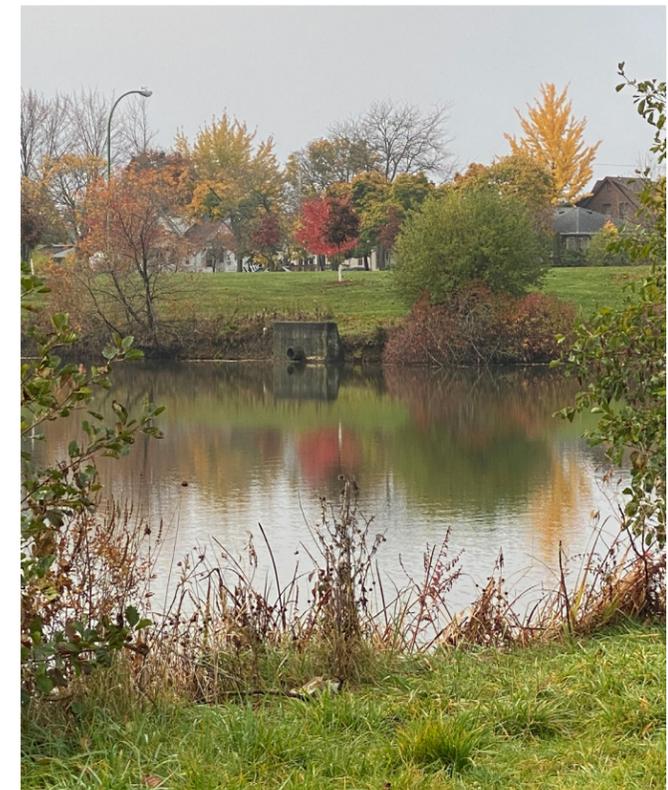
Hyde Park Lake stormwater outfall which will be impacted by this project

Waterkeeper recently received funding from the EPA Great Lakes Restoration Initiative (GLRI) to coordinate an exciting green infrastructure project in Hyde Park in the City of Niagara Falls. Currently there is an abundant amount of unfiltered stormwater runoff that flows into Gill Creek (which forms Hyde Park Lake). This stormwater runoff enters the creek through two outfalls and from the Hyde Park Golf Course. Waterkeeper has recorded several HABs in Hyde Park Lake just downstream from these areas.

The goal of the project is to apply green infrastructure practices throughout the area to both reduce the amount of unfiltered stormwater flowing into the waterway and improve wildlife habitat. Green infrastructure practices mimic natural hydrological processes and uses natural elements such as soil and plants to filter rainfall and increase water quality while providing other environmental, economic, and health benefits. Waterkeeper is optimistic that projects like this will have a positive impact on the water quality of Hyde Park Lake and downstream waterways, reducing nutrients that contribute to the formation of HABs. This green infrastructure project is planned to be completed by 2025.

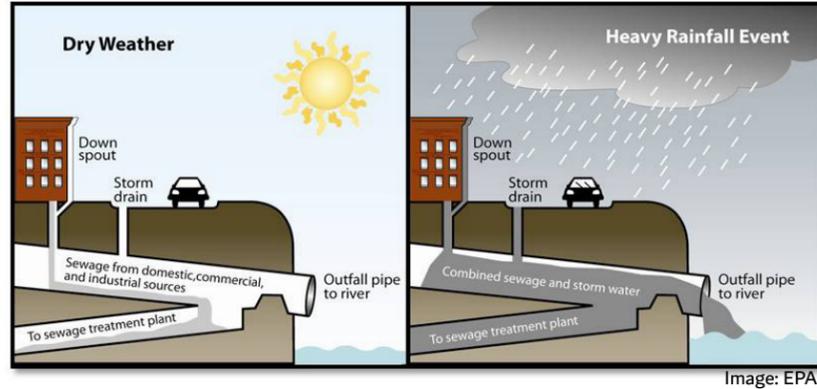
During rain events in a combined sewer system, water from streets, roofs, and lawns flows into storm drains and combines with sewage in one system. When there is heavy rainfall, the volume of water overwhelms the system and overflows into local waterways by design. These overflows are referred to as Combined Sewer Overflows (CSOs). These overflows contain not only stormwater, but untreated human waste, toxins, and debris. When improperly maintained, septic systems also have the potential to discharge bacteria and pathogens into area waters.

Most older cities and municipalities in New York State, including the cities of Buffalo and Niagara Falls, have combined sewer systems. In contrast, most outlying suburban areas utilize separate storm and sanitary sewers.

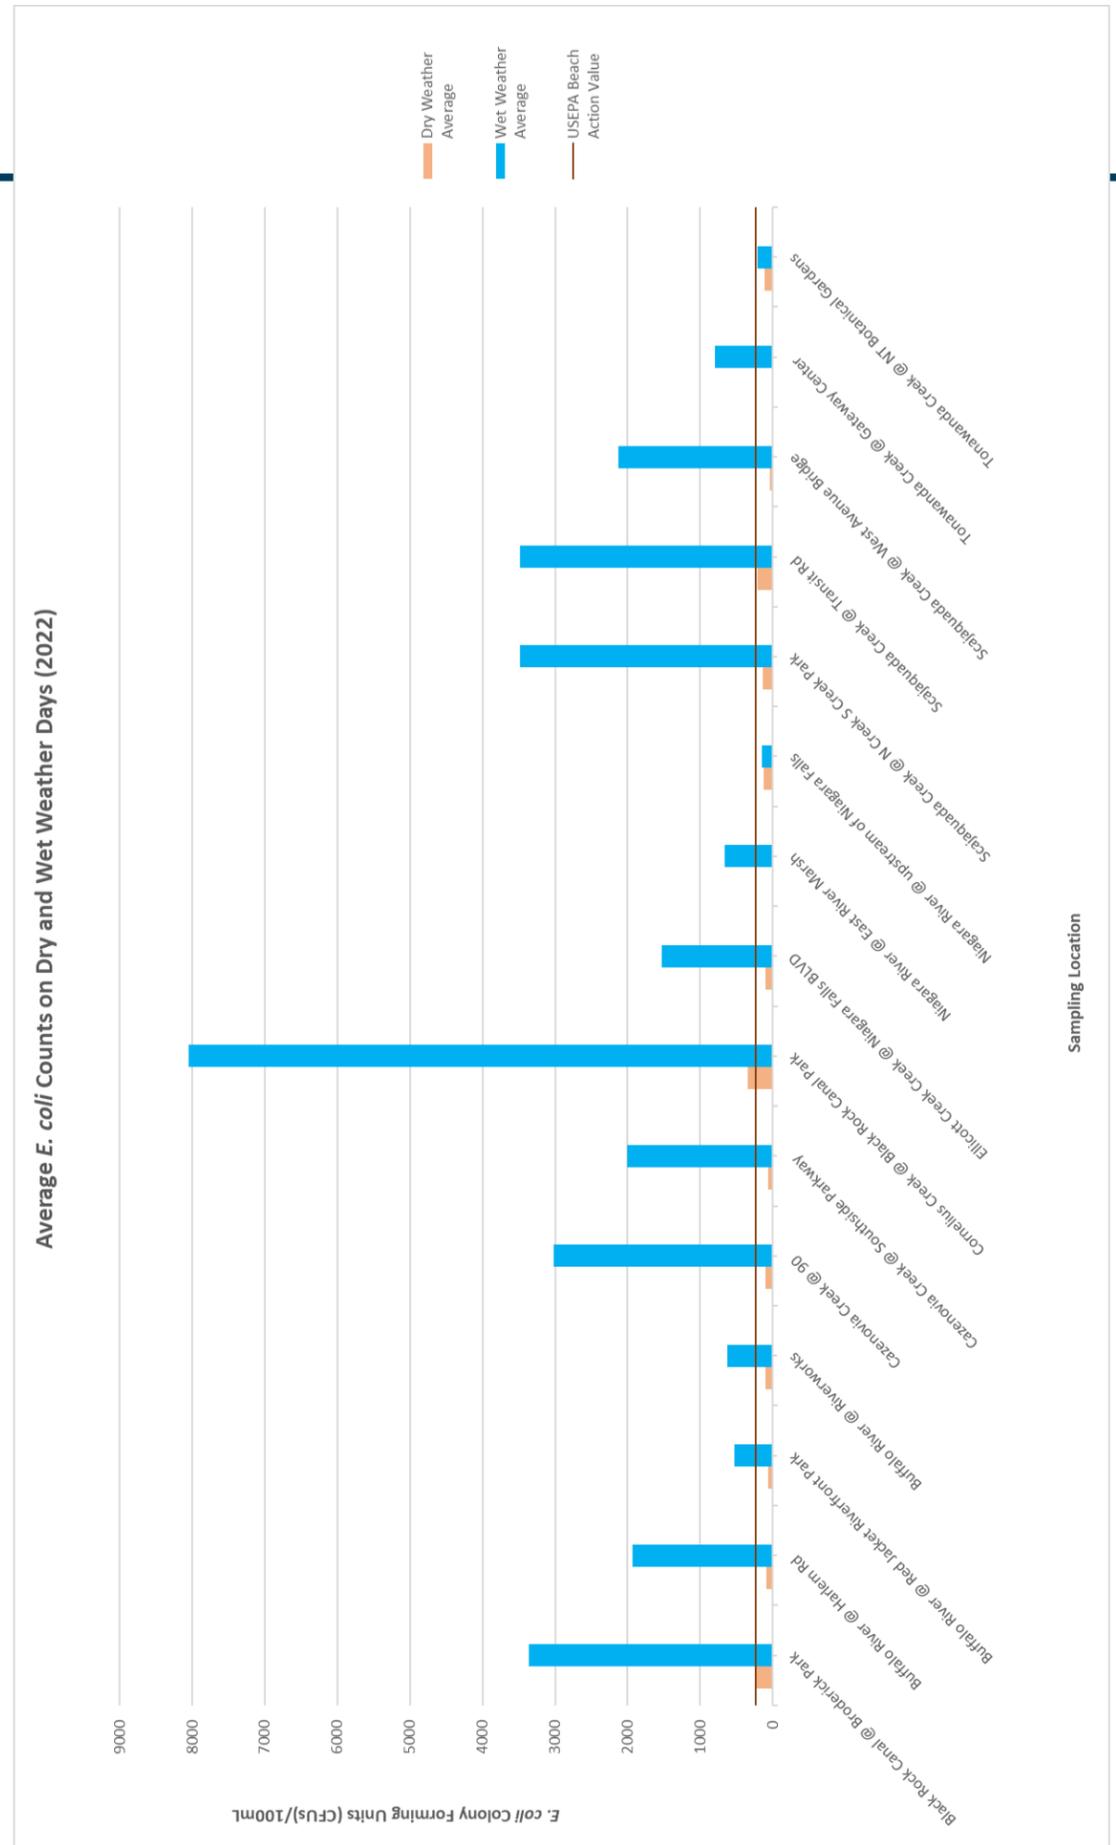
Figure 2: *Escherichia coli* results in comparison to the EPA BAV NOTE: Due to staff restrictions, no samples were collected in April during dry weather conditions, and in September for dry weather conditions.

Waterkeeper staff sampled 15 sites during 2022 between the months of April and October for *E. coli* bacteria. Locations were selected based on the presence of combined sewer outfall pipes nearby or the presence of a kayak launch. Some sites were not sampled each month due to access issues or weather related events. Samples were analyzed using the Coliscan Easygel Method. Samples were collected during a dry weather period and a wet weather period. Some months only allowed for the collection of samples during either dry weather or wet weather.

- **Dry Weather Period:** A water sample can be collected at the sample site if there has been no rain in the past 3 days.
- **Wet Weather Period:** A water sample can be collected at the sample site during a rain event or immediately after a rain event. A qualifying rain event is 5 hours of rain OR 1/2 inch of rain at the sample site.

Caution should be made when recreating in local waterways during or soon after wet weather periods. Waterkeeper will continue to conduct bacteria sampling of local waterways to better inform community members of waterway conditions and to track down pollution sources.

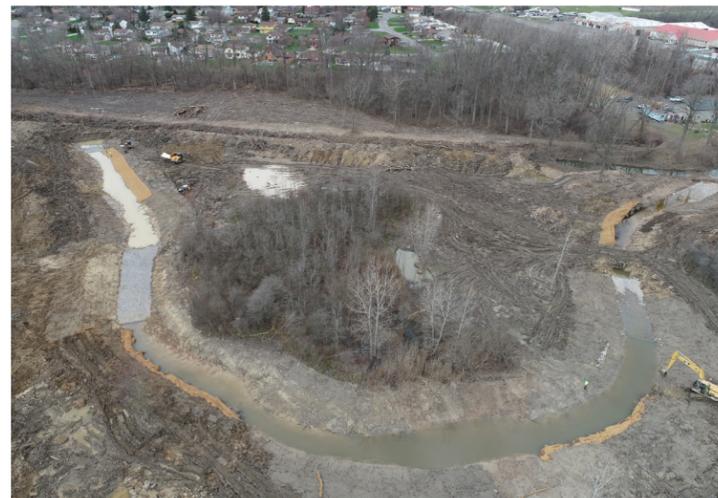
MID CONSTRUCTION: Site conditions as of Spring 2022

- Constructing a new creek channel to replace the previous channelized and bermed creek channel, as shown in the photo to the right. This reconnected the creek to its floodplain, significantly increasing flood storage in this section of the creek.
- Creating vernal pools which hold excess water during flooding events and provide valuable habitat.
- Creating habitat features including riffles in the creek and upland plantings.
- Installing a trail system to allow community members to interact with and enjoy the property.
- **Waterkeeper also worked with the Buffalo Niagara River Land Trust to apply a conservation easement on the Town-Owned land to permanently protect this space, and to also acquire an additional 12 acres of adjacent intact forested wetland.**

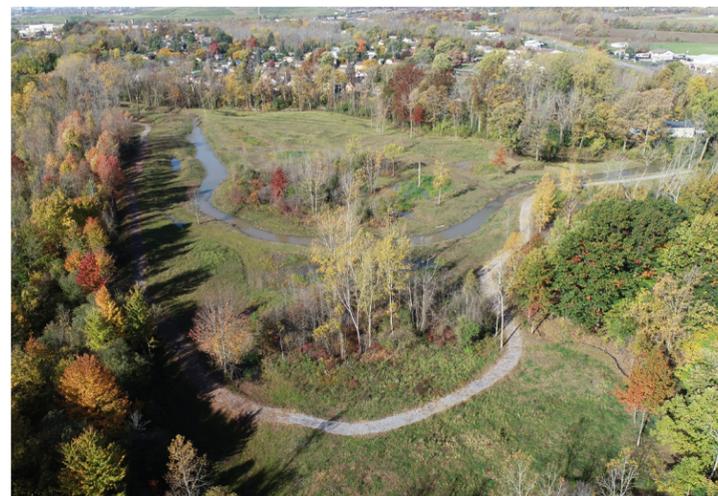
AFTER CONSTRUCTION: Site conditions as of Fall 2022

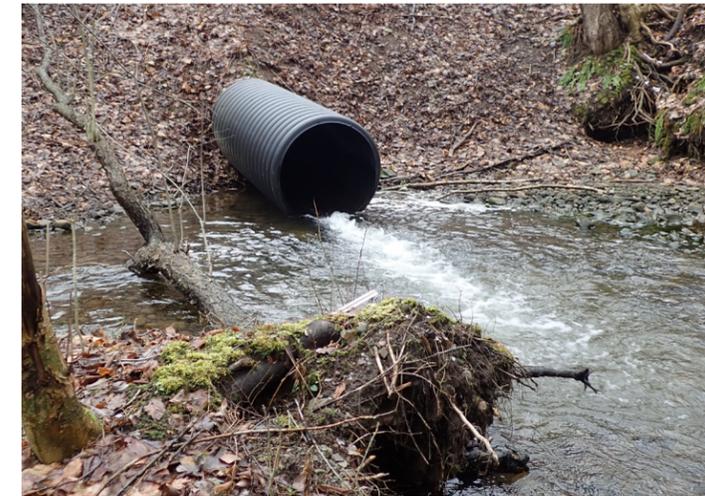
BEFORE CULVERT REPLACEMENT

Recent studies, which assessed fish barriers, indicated that the numbers of native Brook Trout in Crow Creek were impacted by an under-road culvert that was too narrow, crooked, and placed too high relative to the creek's water line for the fish to pass through and successfully spawn. The improper culvert was also causing creek channel issues upstream and downstream.

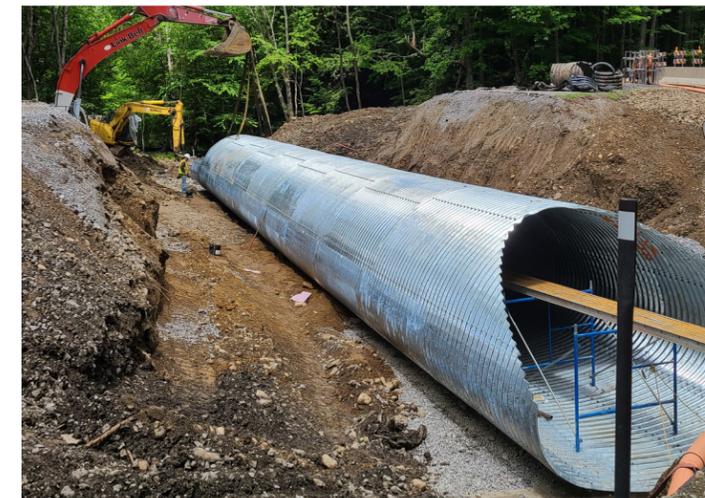
MID INSTALLATION

Waterkeeper, with the partnership of the DEC, the US Fish and Wildlife Service - Lower Great Lakes Fish and Wildlife Conservation Office, Wyoming County Highway, Wyoming County Soil and Water Conservation District and WNY Trout Unlimited redesigned and replaced this culvert, which opened up 1.5 additional miles of cold-water habitat for the native Brook Trout. The culvert was replaced in 2022, prior to their spawning period. Additional work took place to properly align the stream channel and install several instream habitat features to support the passage of the native Brook Trout.

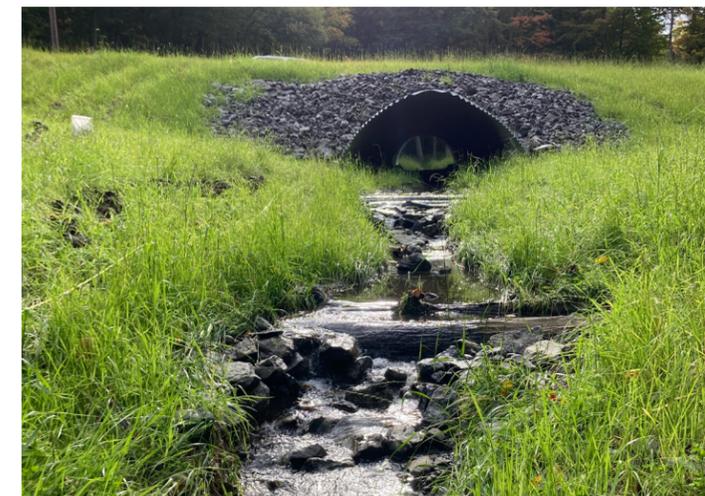
AFTER INSTALLATION: Site conditions as of Fall 2022

A 1000% increase in the number of native Brook Trout upstream was observed just 3 months after the installation of the new culvert.

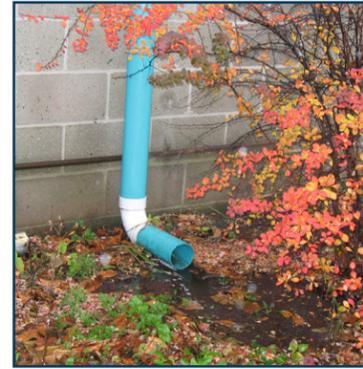
Downspout Disconnection

Downspouts on many homes are connected directly to the sewer system, contributing to sewer overflows. By disconnecting downspouts from the sewer system, water is able to drain to lawns or gardens, thereby allowing water to soak slowly into the ground as plants and soils filter out pollutants.

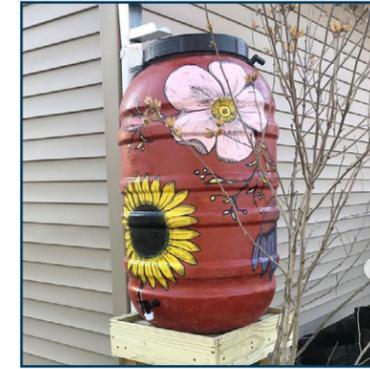
Rain Barrels

Rain barrels are containers that collect and store rain water for future uses (like watering a garden) while decreasing the amount of stormwater runoff that leaves your property. A rain barrel is placed under the downspout to channel rainwater into the barrel for later use. You can purchase one at our office or at various events we attend during the year! Learn more: bnwaterkeeper.org/rainbarrels/
