Removal Recommendation

Beneficial Use Impairment 14: Loss of Fish and Wildlife Habitat

Buffalo River Area of Concern

Prepared by Buffalo Niagara Waterkeeper

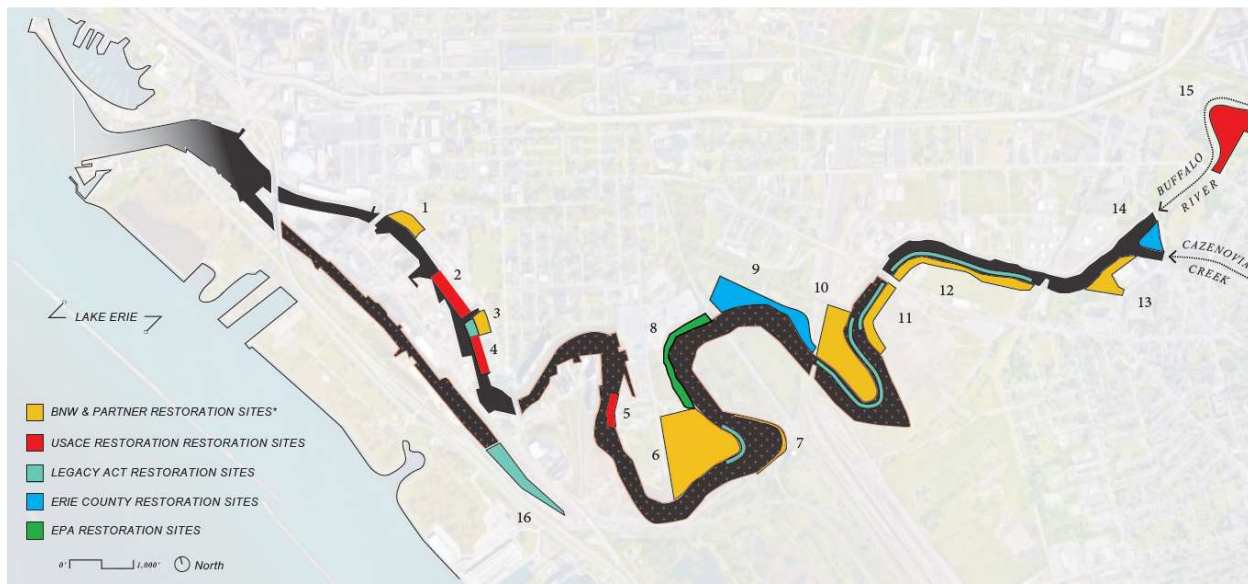
Figure 2: A Summary Map of Habitat Restoration Projects

** The table above and figure below summarize the contents of Appendix B.: Buffalo River Habitat Restoration Site Summary: Action Plan and GLLA. The map site numbers above correlate with the location of the restoration site on the map below only.*

In 2013, the habitat action plan was developed, and the completion of which meets the management action for removal criteria 1 “restore habitat connectivity”. Implementation began in 2015 and was completed in 2021. The habitat action plan set a target of a minimum of 25% (19,941 linear feet) of the AOC Shoreline to be restored to natural slope, shallows, and aquatic (EV and submerged aquatic vegetation (SAV)) native vegetation, including naturalizing areas of the City Ship Canal shoreline.⁵⁰ This target was based on NYSDEC recommendation made in a baseline report conducted in 1993 and a riparian corridor and buffer recommendations published in a U.S. Army guidance document.⁵¹ The action plan assessed the potential sites along the river considering ownership, accessibility and habitat value. After initially considering twenty locations in or just upstream of the AOC. Fourteen sites were settled upon which would meet the goal. The sites are listed in Table 2, and the work completed at each site is further described in Appendix B. Ultimately, the restoration at the 14 sites exceeded the 25% goal and 20,622 linear feet of shoreline habitat was restored.

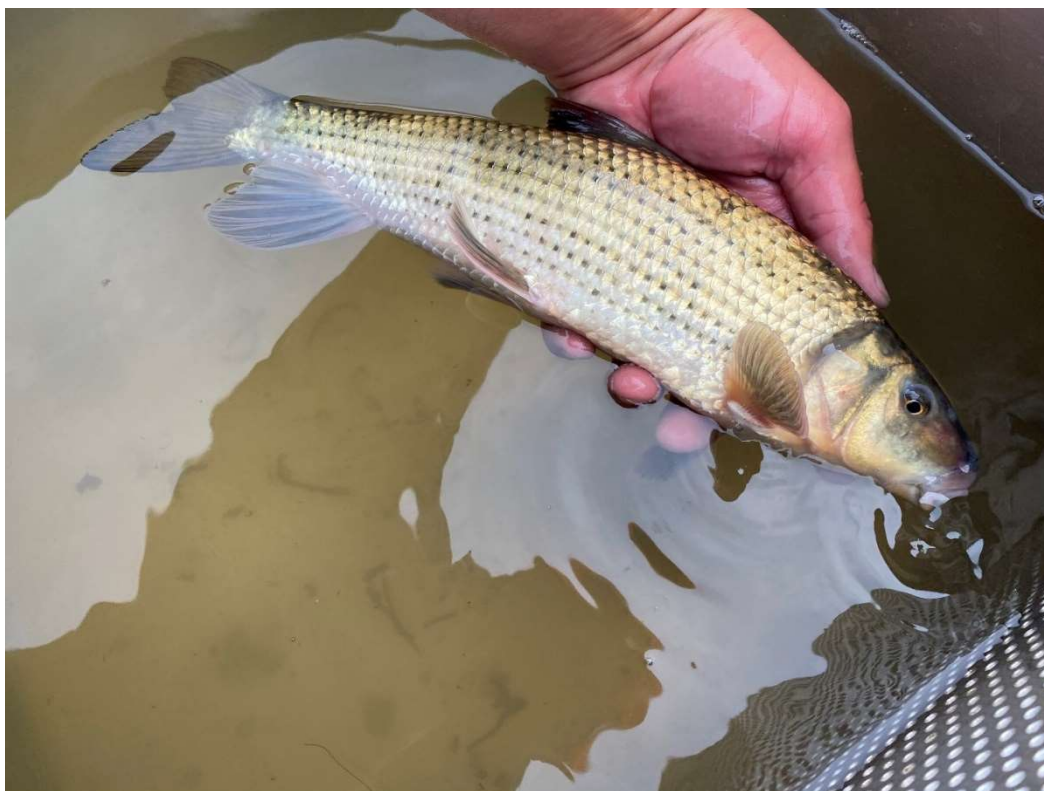
Figure 3: Spotted sucker caught on 6/21/21 in the lower Buffalo River; Photo by USGS

The Buffalo River Wildlife Survey conducted in 2012, 2019, 2020 and 2021 found evidence of nesting turtles and the presence of spiny soft-shelled turtles (*Apalone spinifera*).⁵⁹ A U.S. Geological Survey crew found several spotted suckers (*Minytrema melanops*), adults and juveniles, during a 2021 sampling effort of the Buffalo River.⁶⁰ Spotted suckers are an indicator of good water quality (see Appendix A: figure 3).

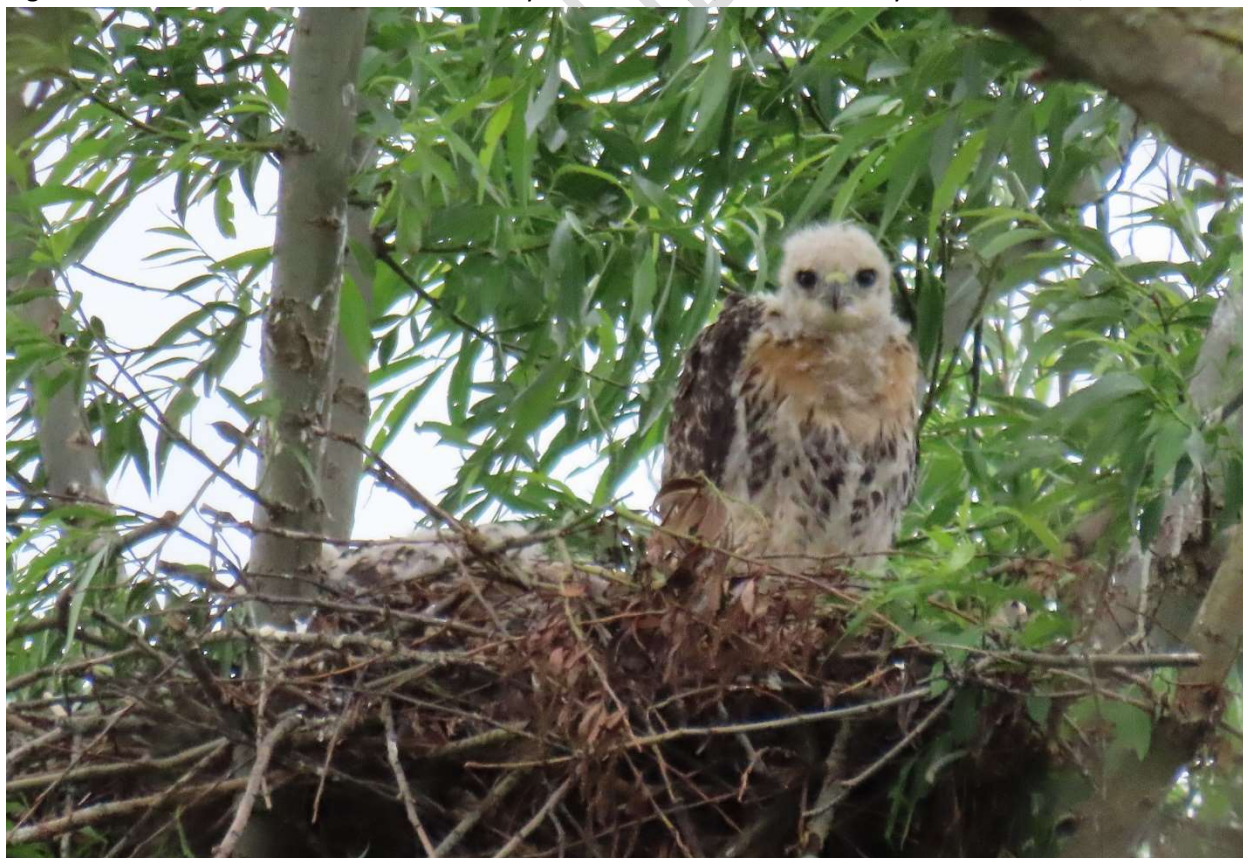
Figure 4: Red-tailed Hawk Chick at Old Bailey Woods on 6/2/2020. Photo by Claudia Rosen, BNW

Wildlife have moved into the habitat restoration sites immediately. Monitoring observations of the sites include successful turtle and hawk nesting activity Appendix A: (figure 4), visiting bald eagles and nesting osprey, monarch butterfly caterpillars and adults (Appendix A: figure 5), the presence of beaver Appendix A: (figure 6), mink, fox and river otters.⁶¹ In addition, anglers have noted the improvement in both fish and wildlife diversity.⁶² The wildlife survey conducted to monitor the AOC restoration sites recorded nesting pairs of red-headed woodpeckers (*Melanerpes erythrocephalus*), which are a New York State Species of Concern Appendix A: (figure 7), at the AOC reference site of Seneca Bluffs and an increase in breeding bird pairs from 63 in 2012 and 71 in 2021. Song sparrows (*Melospiza melodia*) and yellow warblers (*Setophaga petechia*) doubled in nesting pairs observed from 2012 to 2021. The wildlife survey also captured acoustic evidence of the return of red and hoary bats (*Lasiurus borealis* and *L. cinereus*) at three locations within the AOC 2021. These bat species were not observed in 2012. Increased diversity in mammals and increased diversity in nesting birds are strong indicators of improved food sources from the base of the food chain to the bird and mammal predators that live along the shores on the River. The increase in nesting birds is a strong indicator of improved habitat quality.⁶³

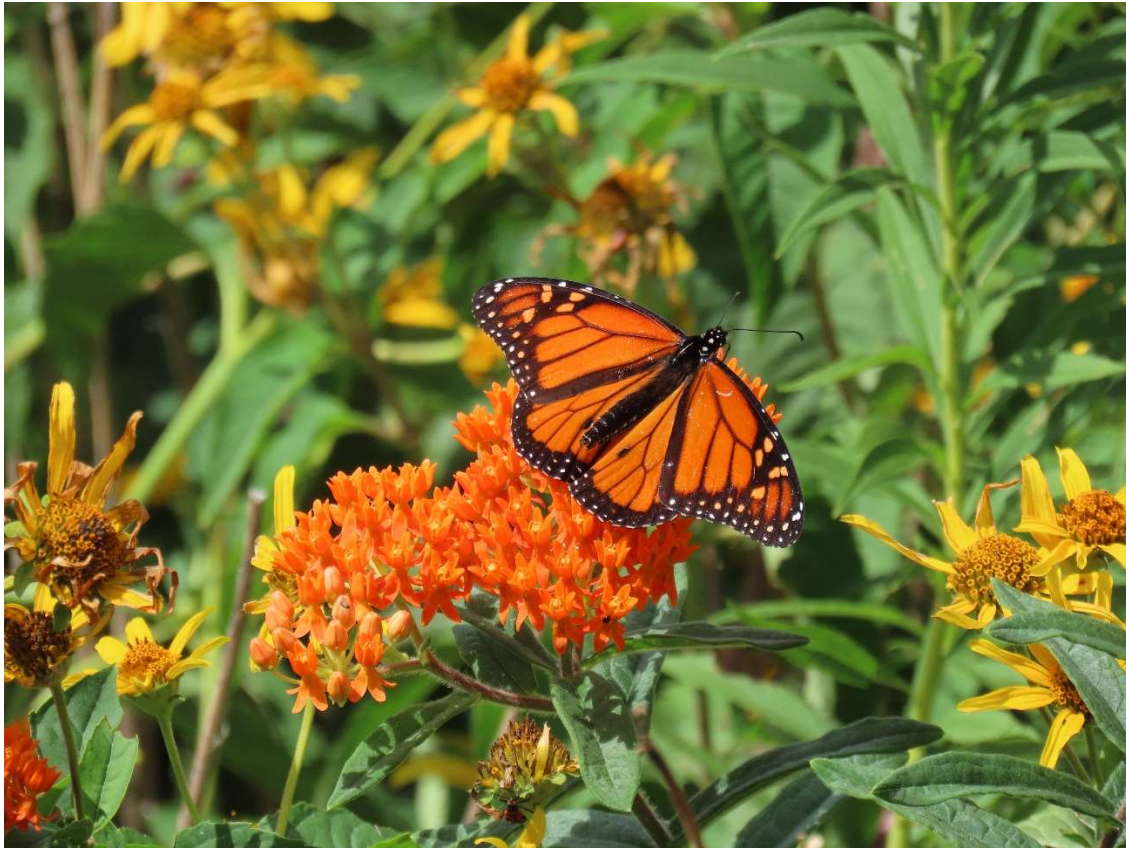
Figure 5: A Monarch butterfly on milkweed planted at Thomas Higgins Habitat Park. Photo was taken August 30th, 2020.

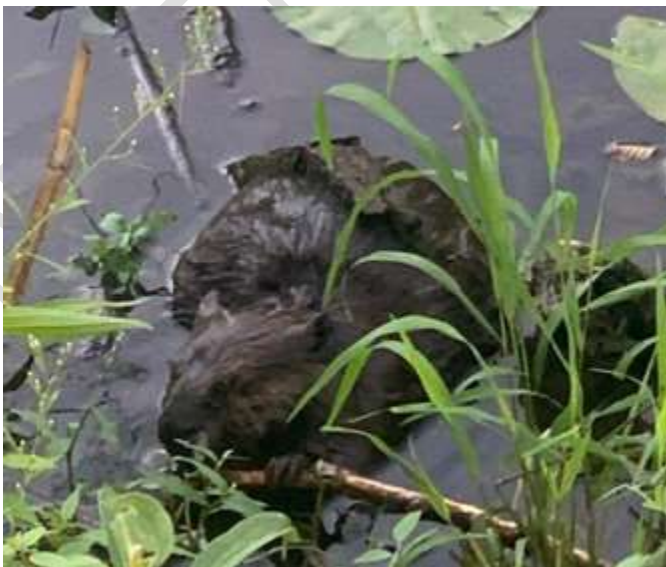
Figure 6: Beaver seen along the shores of Red Jack Habitat Park in the month of September 2021; Photo by Friends of Red Jacket

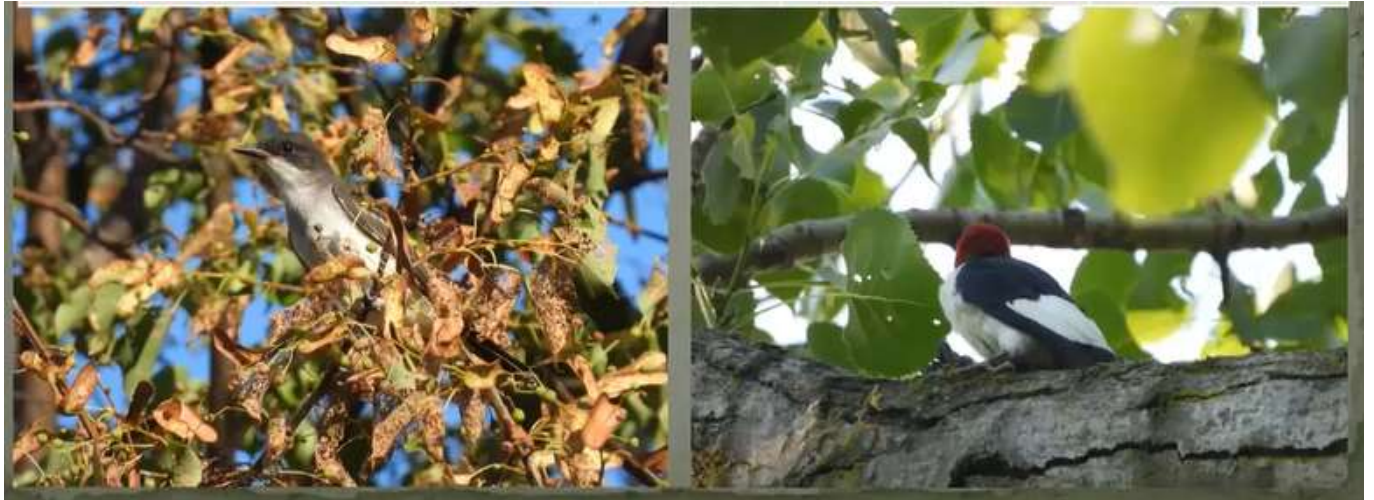
Figure 7: Breeding eastern kingbird bird (left) and red headed woodpecker (right) within the AOC and at Seneca Bluffs respectively

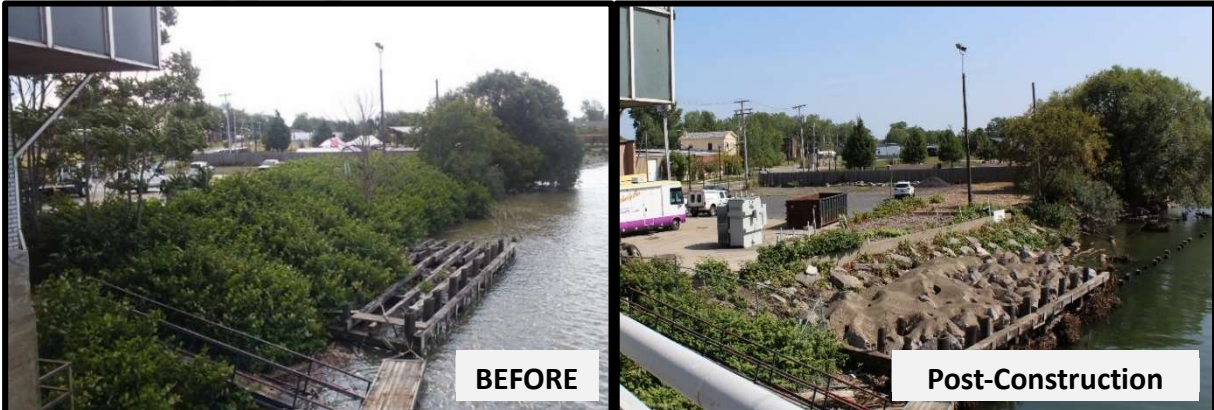
Buffalo Motor and Generator Corporation	
Site Owner	Buffalo Motor and Generator Corp. / City of Buffalo
Project Manager	BNW
Funder	GLC-NOAA/GLRI
Design Consultant	Anchor QEA
Construction Contractor	Scott Lawn Yard
Date of Completion/Success	October 2018/2020
Area Restored	331 linear feet; 0.20 Acre
Coordinates	42.871461, -78.871867
<p>Work Accomplished: This project site is one of the most visual of all the Buffalo River habitat projects due to its location in a heavily trafficked area of the City of Buffalo. This site, located in the lower section of the Buffalo River, is heavily utilized with development to the edge of the banks and a lack of Submerged Aquatic Vegetation (SAV), Emergent Vegetation (EV) and respite areas for fish and wildlife. This project aimed to remove invasive plant species from the shoreline and riparian area, plant native species, introduce SAV and EV to the nearshore area, and provide in-water fish and wildlife habitat with the alteration of an existing crib structure. Construction activities at the site began in early July 2016 with the clearing and removal of nearly 80 cubic yards of Japanese Knotweed and general debris from the riparian and shoreline areas. The upland portion of the site was then grubbed and leveled, and sediment erosion control measures and bat boxes were installed. Rootwads, boulders, and substrate were installed into the existing crib structure, - providing ideal habitat for fish and shoreline wildlife. A rootwad chain was installed in the water along the eastern portion of the project site to provide additional habitat and serve as a wave and debris deflector. In July 2018, the final work at the site began by obtaining bathymetric surveys to determine the amount the sediment settled over the course of the winter and identify the correct plant species to install. SAV and EV plants were established offsite before being installed in the project area. Over the course of the project, four rounds of invasive species treatments were conducted at the site to treat the Japanese Knotweed. As of 2020, this project has been deemed a success as the Japanese Knotweed population has been significantly reduced and replaced with thriving native plants. The SAV and EV have established in the near-shore area and the enhanced crib structure is providing habitat for fish and wildlife.</p>

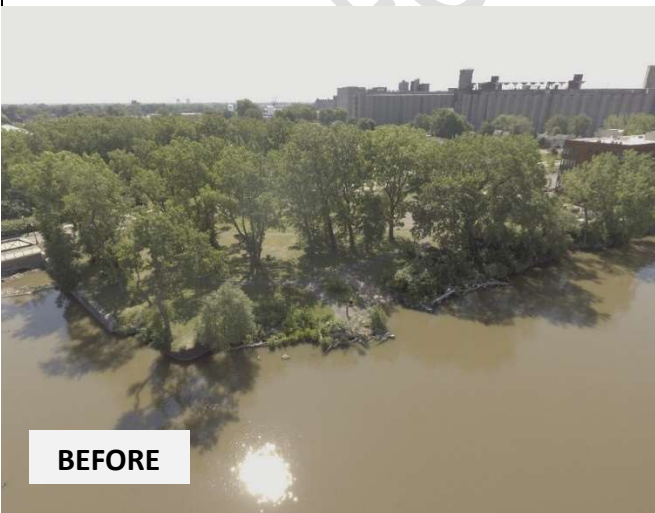
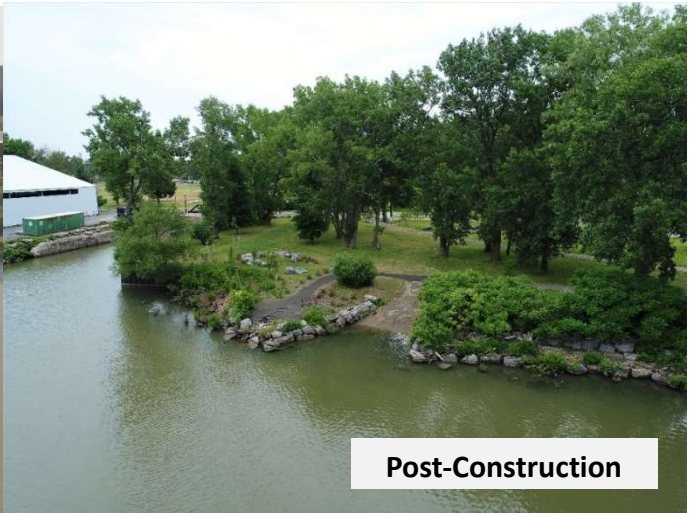
Ohio Street Boat Launch	
Site Owner	NYS Dept. of Environmental Conservation
Project Manager	BNW
Funder	GLC-NOAA/GLRI
Design Consultant	Gomez and Sullivan Engineers
Construction Contractor	Scott Lawn Yard
Date of Completion/Success	October 2018/2020
Area Restored	332 linear feet and 1.62 acres
Coordinates	42.865872, -78.868053
<p>Work Accomplished: This project site is a fishing access site, kayak, and car-top boat launch in a highly utilized section of the Buffalo River. The project goal was to remove invasive species from the shoreline and replace the flat lawn areas with critically needed meadow habitat for local pollinators and wildlife. Construction at this site began on October 3, 2017. The site was prepped by installing a fence around the project area and treating the lawn with an herbicide to aid in removal at a later date. Numerous loads of high-quality topsoil were brought onto the site which was then planted with meadow mix and approximately 100 native trees and shrubs. Large boulders were imported to the site and arranged to create berm areas for planting beds as per the design. The shoreline was cleared of invasive and nuisance vegetation. Three large bat boxes were installed in the upland area to promote use of the site by pollinators. The meadow areas were then hydroseeded with meadow seed mix during the Spring of 2018. As of 2020, this project has been deemed a success as the meadows have fully established and are providing habitat for local pollinators and upland wildlife.</p>

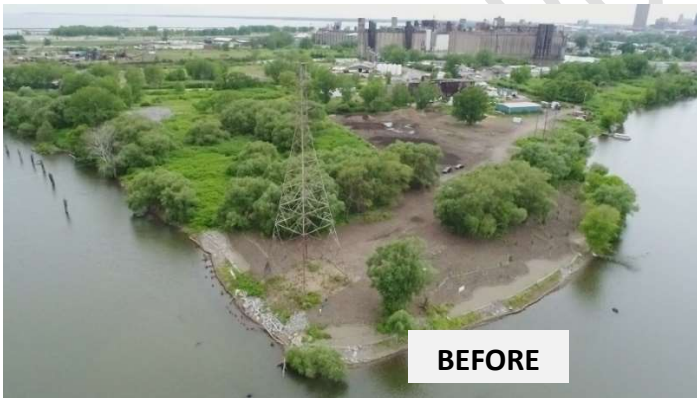
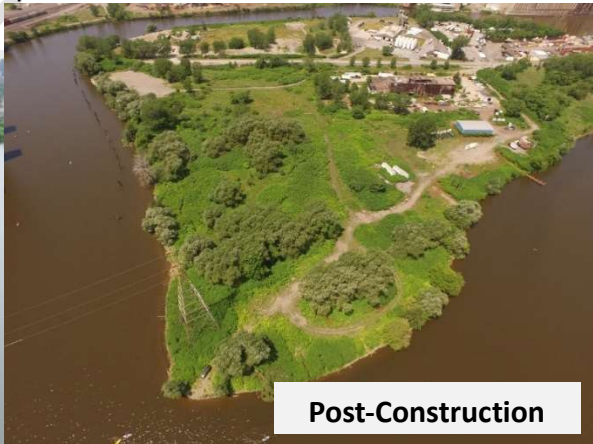
Toe of Katherine Street Peninsula	
Site Owner	City of Buffalo / Premier Towing
Project Manager	BNW
Funder	GLC-NOAA/GLRI
Primary Design Consultant	CHA
Primary Construction Contractor	Scott Lawn Yard
Date of Completion/Success	October 2018/2020
Area Restored	1693 linear feet; 7.3 Acres
Coordinates	42.857583, -78.855204
<p>Work Accomplished: This project site is landlocked and privately owned. It is located in the less congested section of the Buffalo River. The site contained a near monoculture of Japanese knotweed and had severely eroding banks. The project goal was to remove invasive plant species, soften the shoreline, plant native species, and encourage wildlife to utilize the protected site. Contractors mobilized to the site and spent nearly three weeks clearing the site of Japanese knotweed, unwanted vegetation, and general debris. The site was then rough graded and coir logs and large stone were installed along the shoreline to prevent erosion. The turtle nesting beaches were then constructed through the installation of anchored logs, medium stone fill, rock slabs (“ramps”) and special turtle nesting substrate. Final grading and the placement of coir logs occurred to provide site elevations and topography. The riparian area was planted with native trees and shrubs, live stakes were planted along the shoreline and the upland portion of the site was seeded and strawed. Over the course of the project, five rounds of invasive species treatments were conducted at the site to treat emerging Japanese knotweed. As of 2020, this project is deemed a success. The monoculture of Japanese knotweed has been nearly replaced by established native plants, the shorelines are no longer facing continuous erosion, and the turtle nesting beaches have seen signs of nesting activity.</p>

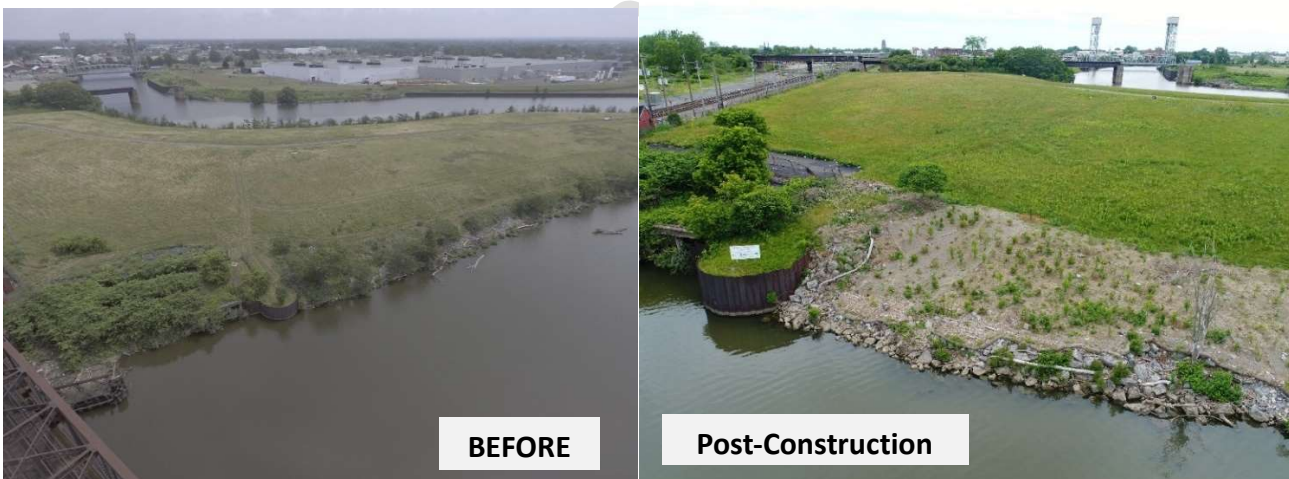
Buffalo Color Peninsula	
Site Owner	South Buffalo Development
Project Manager	BNW
Funder	GLC-NOAA/GLRI
Primary Design Consultant	Gomez and Sullivan Engineers
Primary Construction Contractor	Applied Ecological Services
Date of Completion/Success	October 2018/2020
Area Restored	2,645 Linear feet; 1.5 Acres
Coordinates	42.859986, -78.847922
Work Accomplished <p>This site is a remediated NYS Superfund site that is capped and actively maintained by the current owner. The intent of the design for this project site was to eliminate invasive species, fill voids in the existing rip-rap shoreline, and allow for native plant establishment within a 25-foot riparian buffer.</p> <p>The project began by removing invasive trees and other invasive plants from the shoreline. The shoreline work consisted of filling the large voids in the rip-rap with stone, installing coir blocks to build up planting benches, and installing coir matting and topsoil. The benches were then planted with native shrubs and seed mix. The shoreline enhancements were further bolstered by the contiguous installation of in-water plants, installed by the GLLA Project. As of 2020, this project is deemed a success. Native vegetation is filling in the voids in the rock-based shoreline and invasive plant species are limited.</p>

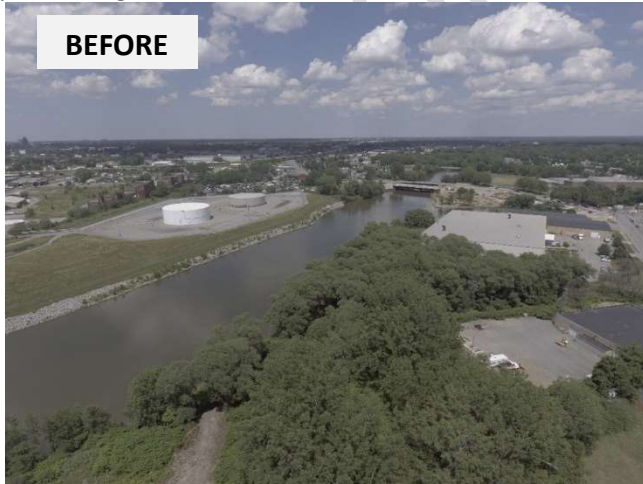
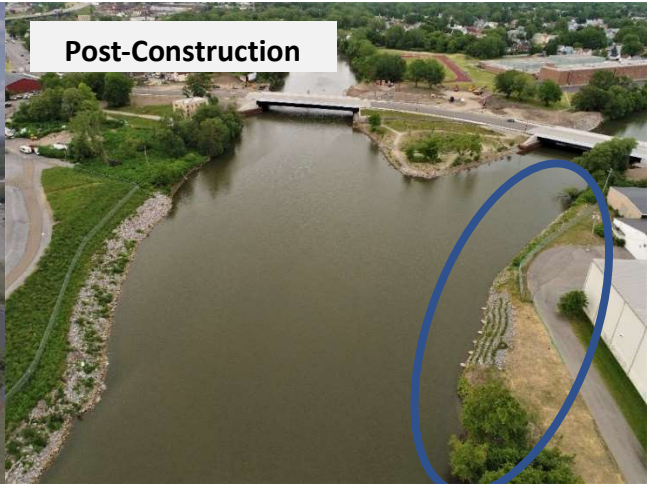
Old Bailey Woods	
Site Owner	City of Buffalo
Project Manager	BNW
Funder	GLC-NOAA/GLRI
Design Consultant	Gomez and Sullivan
Construction Contractor	LDC Construction
Date of Completion/Success	October 2018/2020
Area Restored	807 Linear Feet; 3.25 Acres
Coordinates	42.860371, -78.829117
<p>Work Accomplished. This project intended to protect and restore the last existing low-land floodplain forest in the Buffalo River AOC. The 3-acre site is owned by the City of Buffalo and was at risk due to a near monoculture of invasive plant species and significant bank erosion.</p> <p>The upland portion of the site was cleared and grubbed to manually remove invasive Japanese knotweed and allow for the removal of debris. Over the course of the project, four rounds of invasive species treatments were conducted at the site to treat Japanese knotweed. Once the invasive plants were addressed, native trees and shrubs were planted to add understory vegetation. A lawn area was converted into meadow habitat with the application of meadow seed mix and planting of native, upland vegetation. The severely eroding banks were addressed by softening the shoreline slope and removing compromised vegetation. Four alternating rows of medium stone and live stakes were installed on the shoreline to stabilize the slope and provide habitat (circled below). Six large stone weir rocks were strategically placed at the bottom of the slope to deflect ice.</p> <p>As of 2020, this project is deemed a success. The removal/treatment of invasive species and the restoration of the native understory has had significant impact on the riparian forest area and the site will now attract much needed wildlife to the area. A nesting Red Tailed Hawk and fledging were seen in 2020 (figure 4). The work that was performed in the erosion control area has already shown to be functioning as designed by preventing loss of shoreline to intense ice scour.</p>

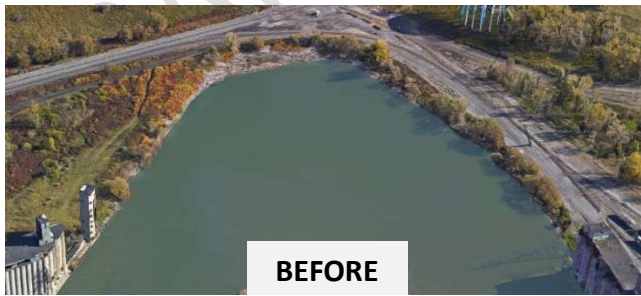
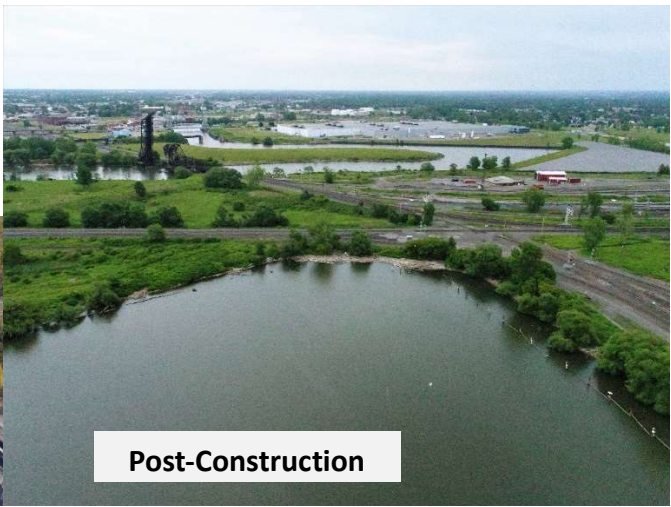
Blue Tower Turning Basin	
Site Owner	City of Buffalo
Project Manager	BNW
Funder/Source	GLC-NOAA/GLRI
Primary Design Consultant	Anchor QEA
Primary Construction Contractor	Scott Lawn Yard
Date of Completion/Success	October 2018/2020
Area Restored	1700 Linear feet; 0 upland acres
Coordinates	42.856870, -78.852694
<p>Work Accomplished: The Blue Tower Turning Basin site is located approximately 3.1 miles upstream of the mouth of the Buffalo River and it is wholly in-water. Due to its shape and location on the River, the Turning Basin routinely fills up with woody debris that had floated from upstream sources, and ice scour and cover was significant. This debris, ice, and wave action had prevented the establishment of healthy SAV and EV populations. The goal of this project was to minimize debris accumulation and ice and wave action to allow for robust SAV and EV populations which would provide fish and wildlife habitat as well as improve water quality.</p> <p>It took nearly two weeks for crane and barge equipment to remove the floating woody debris from the basin which was then brought onshore and chipped to be reused at another site. Twenty piles (made of locally sourced tulip trees) were driven into the southern portion of the basin and were connected by floating boom logs to deflect ice and waves, a novel approach that had not been implemented in the WNY area previously. A rootwad chain structure was installed in the northern part of the basin to provide a similar type of ice and wave protection. Planting substrate and SAV and EV were installed in the near-shore area behind the root wads and floating boom logs. Five duck boxes (with raccoon deterrents) were installed on the wooden piles to encourage usage by wood ducks.</p> <p>As of 2020, this project is deemed a success. The project site has seen several winters of strong ice flows as well as several intense storm surges and the elements are functioning as designed. Woody debris is no longer a concern, and the SAV and EV now have the opportunity to establish in the area providing ideal habitat for fish and wildlife.</p>

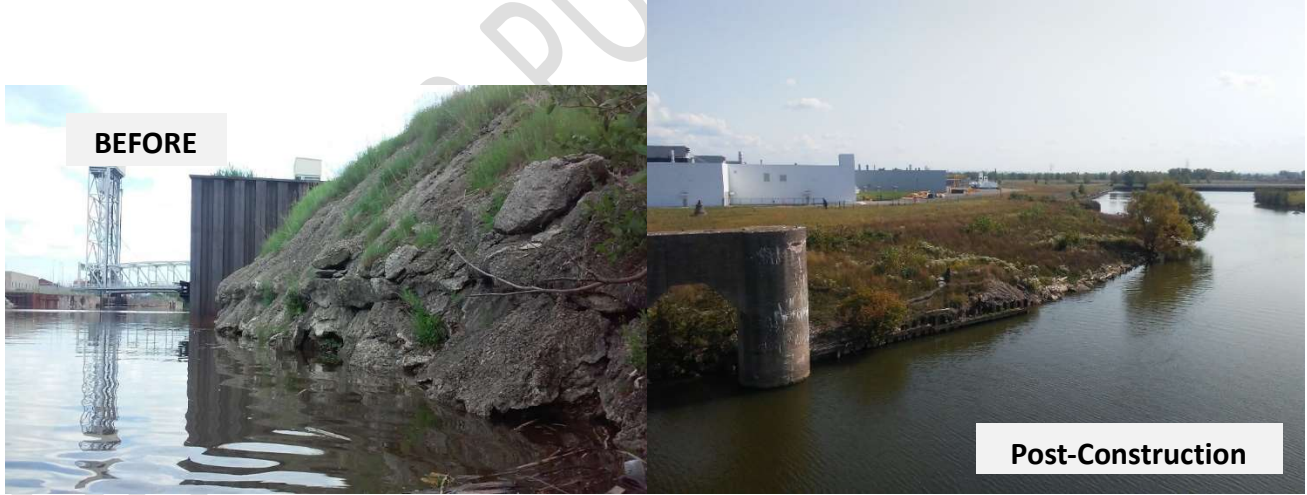
RiverBend Phase II	
Site Owner – at time of project start	Buffalo Urban Development Corporation (current owner: Tesla)
Project Manager	BNW
Funder/Source	NOAA/GLC-NOAA/GLRI
Design Consultant	Ecology and Environment / Nussbaumer and Clarke
Construction Contractor	Land Remediation
Date of Completion/Success	2015/2020
Area Restored	1,520 Linear feet; 3.5 acres
Coordinates	42.862217, -78.843086
<p>Work Accomplished: The site of a former steel plant, the RiverBend Phase II project offered the potential to restore habitat to over 1,500 linear feet of shoreline and approximately 3.5 acres of upland habitat. Work began with excavation of the banks to allow the steep slopes to be transformed into a more natural, gradual shoreline. The bank materials consisted mainly of slag which was produced during the steel making process and disposed of on-site. Excavated materials were disposed of in an appropriate manner and clean topsoil was imported and spread to the correct grades. Live branches and soil burritos were installed along the shoreline to prevent erosion and provide habitat. Nearly 100 ball and burlap native trees were planted in addition to nearly 1,000 native container trees and shrubs, all of which were protected with wildlife exclusion fencing. The upland area was shaped into planting beds and planting soil mix was installed. Coir logs were installed along the entirety of the project to prevent sheet flow of water and erosion. Standing snags and white pine clusters were installed to encourage wildlife usage and prevent damage to new vegetation. As of 2020, this project is deemed a success because it is capable of supporting a community of native vegetation and wildlife.</p>

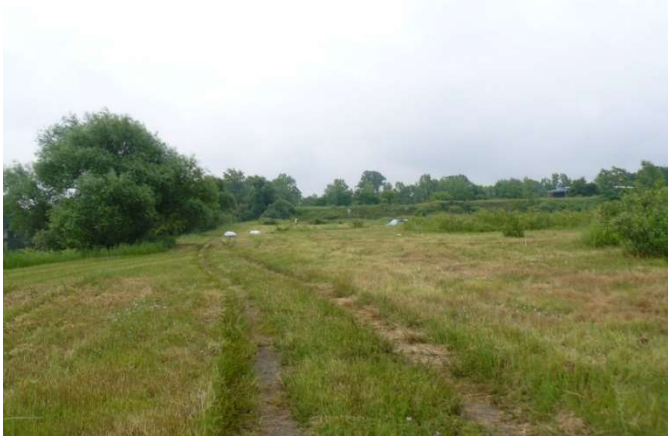
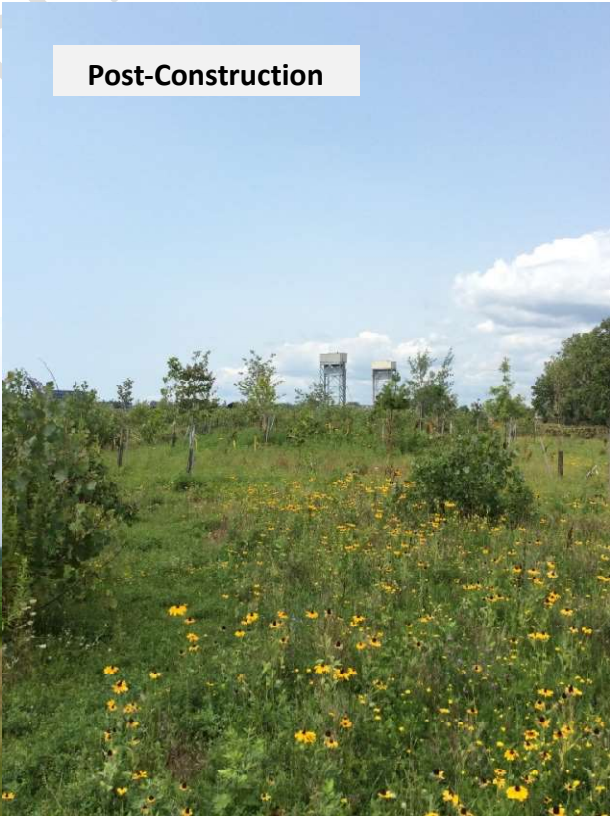
Riverbend Phase I	
Site Owner – at time of project start	Buffalo Urban Development (current Owner: Ciminelli)
Project Manager	BNW
Funder/Source	NOAA/GLC-NOAA/GLRI
Primary Design Consultant	Ecology and Environment
Primary Construction Contractor	Natural Restorations by Linda J. and Co.
Date of Completion/Success	2014/2020
Area Restored	1,200 Linear Feet; 3.5 Acres
Coordinates	42.863279, -78.840919
<p>Work Accomplished: The Riverbend Phase I site is located approximately five miles upstream of the mouth of the river and was home to a steel and coke-making facility. This project aimed to enhance habitat at the shoreline, riparian, and upland areas at a brownfield site along one of the longest naturalized stretches of the Buffalo River. This multi-phased, multi-funder project improved and created habitat by softening the banks and providing erosion protection with the installation of coir logs and planted soil burritos. Invasive plant species were addressed along the shoreline and high-quality soil and planting substrate were spread on the site. Over 2,500 native plants and shrubs were installed to provide habitat for wildlife.</p> <p>As of 2020, this project is deemed a success. Grass fields, steep shorelines, and invasive plant species have been replaced by natural shorelines and healthy native plant communities. This site provides one of the few grassland habitats along the river.</p>

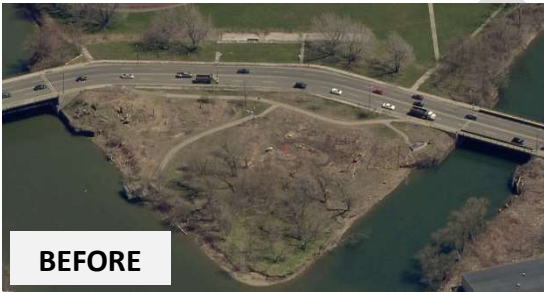
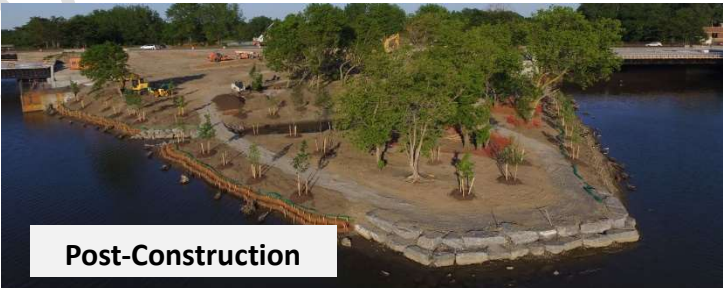
Thomas F. Higgins Natural Habitat Park (Formerly Bailey Avenue Peninsula)	
Site Owner	Erie County
Project Manager	Erie County
Funder/Source	USEPA/GLRI
Primary Design Consultant	CHA
Primary Construction Contractor	Scott Lawn Yard
Date of Completion/Success	2019
Area Restored	1,050 linear feet; 4 acres
Coordinates	42.861274, -78.825995
<p>Work Accomplished: Thomas F. Higgins Park is a natural habitat park located at the confluence of the Buffalo River and Cazenovia Creek. This park occupies approximately four acres of land on both sides of the Bailey Avenue bridge along with a parking area on the south side of Cazenovia Creek. The Bailey Bridge New York State Department of Transportation Road Reconstruction project replaced 80-year-old bridges with new single-span structures, maximizing the hydraulic openings to alleviate ice jamming and upstream flooding. Public parkland lost by relocating the bridge was replaced, invasive species were treated and replaced by native plants, and new seiche and pocket wetlands were created to enhance wildlife habitat and filter stormwater runoff. In-water restoration improved structural fish and wildlife habitat by repurposing over 50 trees from the site of the new Bailey Avenue bridge and anchoring the logs nearshore.</p>

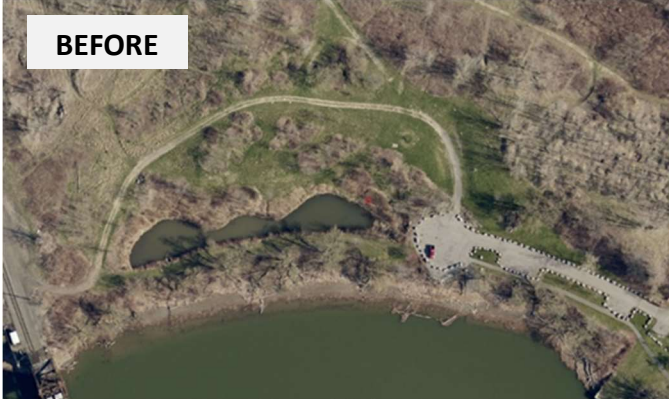
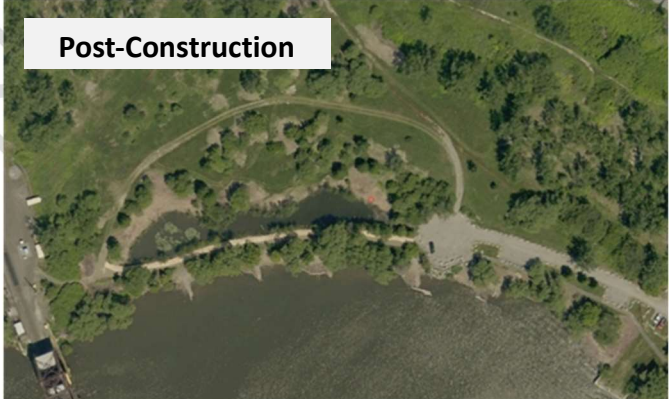
Red Jacket Riverfront Park	
Site Owner	Erie County
Project Manager	Erie County
Funder	USEPA/GLRI
Primary Design Consultant	Wendel
Primary Construction Contractor	LDC Construction
Date of Completion/Success	2019
Area Restored	745 linear feet; 7 acres
Coordinates	42.864341, -78.850585
<p>Work Accomplished: This natural habitat park is located along the north bank of the Buffalo River at the foot of Smith Street. This 7-acre site is 3.7 miles upstream of the mouth of the river and contains approximately 745 linear feet of restored shoreline.</p> <p>Restoration efforts involved re-constructing a backwater wetland similar to riparian and floodplain habitat features that were common in the lower Buffalo River watershed prior to development. Underwater log structures were placed along the shoreline to improve habitat for aquatic flora and fauna. Invasive species were treated, and native trees and shrubs were planted around the wetland and throughout the site. A riverine wetland was also constructed by placing a rock reef in the River channel to provide structural support.</p>

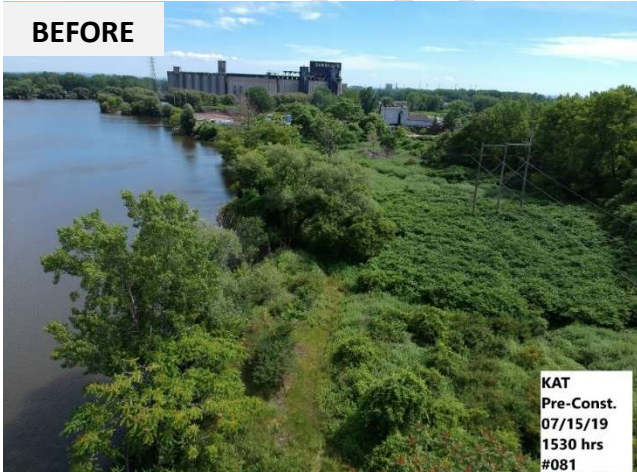
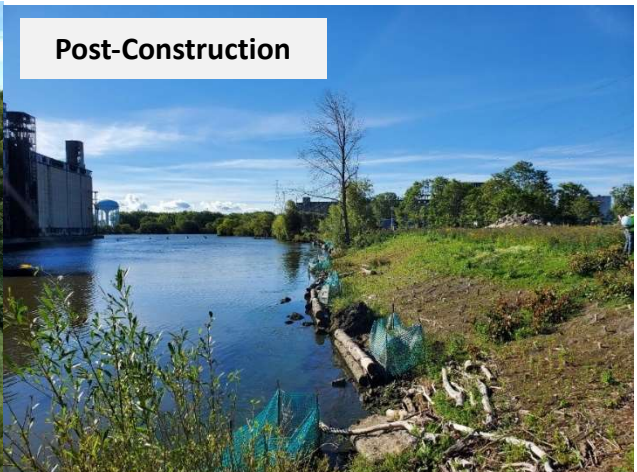
Northeast Shoreline of Katherine Street Peninsula	
Site Owner	Linde, LLC (now Messer)
Project Manager	USEPA
Funder/Source	USEPA/GLRI
Design Consultant	CH2M (prime)/Ecology and Environment (sub)
Construction Contractor	Scott Lawn Yard
Date of Completion/Success	September 2019/Monitoring process ongoing
Area Restored	1775 linear feet; 3.7 acres
Coordinates	42.861723, -78.857409
<p>Work Accomplished: The northeast shoreline of Katherine Street Peninsula site is located on private property between the Red Jacket Riverfront Park and Toe of Katherine Street habitat restoration projects. The objectives of the restoration are to improve nearshore, shoreline, and shallow-water habitat; control and manage invasive species; and naturalize, restore, and stabilize the riverbank. Tree of heaven, Japanese knotweed, mugwort, and bush honeysuckle are the predominant invasive species on site.</p> <p>Restoration features include root wads and bendway weirs to dissipate shoreline wave energy and redirect stream velocity and debris away from the shoreline and encourage sedimentation and the establishment of EV/SAV; cabled logs to protect the shoreline and serve as downslope walls for planting troughs; reef balls and pilings to provide fish habitat; and rock sills to dissipate nearshore wave energy and/or create planting troughs, which will support plant growth along the shoreline. Invasive species treatment occurred in the upland areas using a combination of mechanical and chemical control. In addition, a barrier trench was dug six feet deep and lined with 60 mm HDPE liner to prevent re-establishment of invasive species through root growth. Lastly, native species of plants were installed across four planting zones (submerged/emergent, shoreline, riparian slope, and upland slope).</p> <p>Construction activities took place between mid-July and the end of September 2019. Monitoring and maintenance activities, such as installing additional plants and conducting invasive species treatments, will be implemented during the restoration establishment period which runs through 2023.</p>

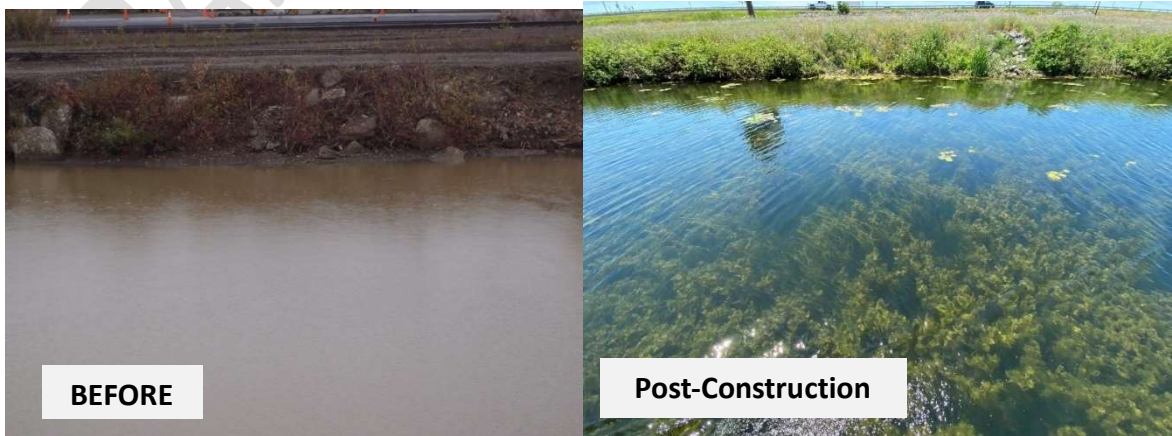
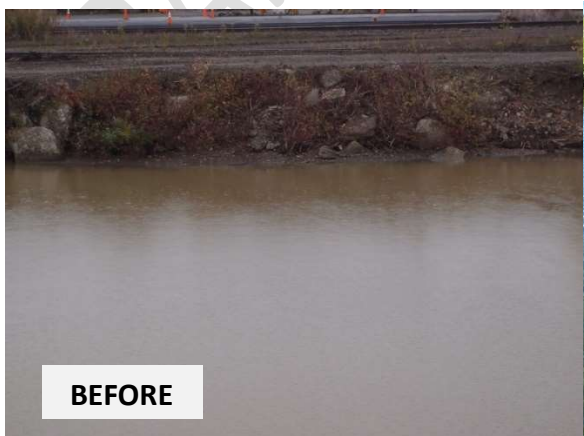
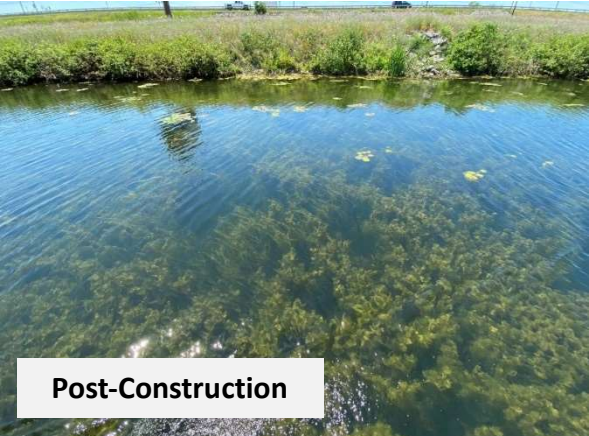
Great Lakes Legacy Act (GLLA) Aquatic Habitat Restoration	
Site Owner	City of Buffalo (owner of river bottom)
Project Manager	Honeywell
Funder/Source	Honeywell
Primary Design Consultant	CH2M Hill (original) and Anchor QEA (revision)
Primary Construction Contractor	Sevenson (prime)/Cardno JFNew (sub)
Date of Completion/Success	2015/2020
Area Restored	9,095 linear feet
Coordinates	Multiple locations in the Buffalo River AOC
<p>Work Accomplished: As part of the GLLA cost-shared project, in-water habitat restoration was conducted at five sites in the Buffalo River AOC: Riverbend, Buffalo Color Peninsula, Ohio Street Shoreline, Katherine Street Peninsula, and the City Ship Canal. The sites were restored by replacing and augmenting aquatic habitat impacted by dredging or capping as well as enhancing site aquatic zones. The habitat restoration efforts at the City Ship Canal and Katherine Street sites were specifically used to mitigate environmental impacts from the sediment dredging activities.</p> <p>In 2014, primary activities for habitat restoration focused on fill placement, habitat structure installation, and base installation work. Approximately 26,500 tons of habitat subgrade material (gravel) were placed at the Katherine Street Peninsula habitat restoration area in order to construct an extended bench of suitable planting elevations for EV and SAV planting beds. A minimum six-inch habitat substrate layer was placed at all five habitat restoration areas to provide suitable, consolidated substrate material for EV and SAV plants. In addition, rock vanes were installed at three locations at Katherine Street Peninsula, three locations at Riverbend, and 12 locations at Buffalo Color Peninsula to dissipate wave energy and encourage sediment deposition. Bedding material and rip rap were placed at three locations at Riverbend and two locations at the City Ship Canal to provide outfall scour protection. 53 anchored rootwads and eight log poles were installed in the habitat restoration areas to provide fish habitat and sheltered planting areas for EV and SAV plants. Four gravel spawning beds and 12 porcupine cribs were installed for use as fish spawning habitat and shelter in the City Ship Canal.</p> <p>The 2015 restoration activities focused on in-water planting of EV and SAV species. An empty building on site was used as a temporary nursery to provide shade and ventilation for the EV and SAV plant stock while waiting for installation. For all five habitat restoration areas combined, approximately 29,500 EV plants and approximately 47,500 SAV plants were installed. Monitoring and maintenance activities, such as supplemental planting and herbicide treatments, were implemented over a five-year timeframe and concluded in 2020.</p>

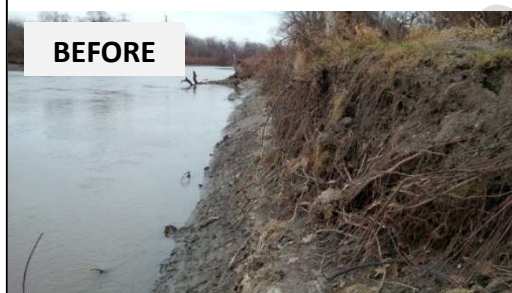
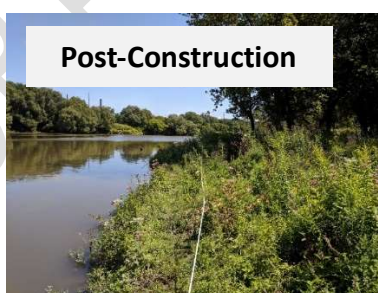
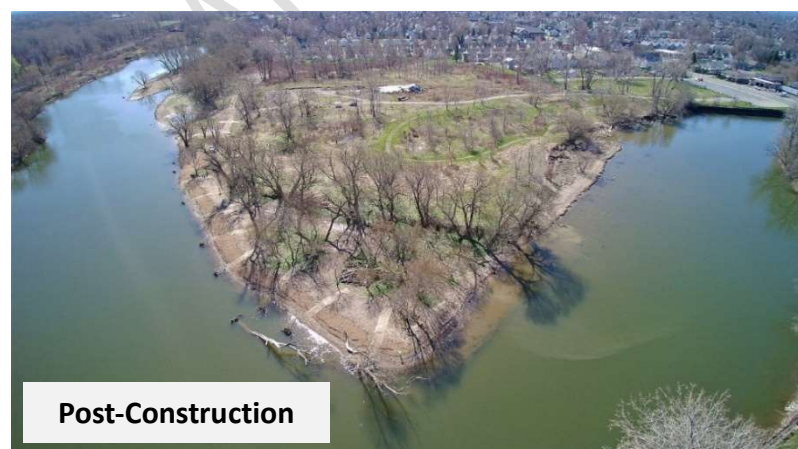
Invasive plant species were treated using mechanical removal and chemical application during the first three years, and spot chemical treatments in the fourth and fifth years of the project. Native dominated floodplain and riparian habitats were established through seeding and shrub/tree planting. The project stabilized eroding riverbanks, created in-channel aquatic habitat, reduced invasive species, and restored native riparian vegetation communities.

Project monitoring began in 2016 after completion of earthwork, initial invasive species removal, and initial planting and was carried out over a period of five years. Monitoring data documented the successful reduction of invasive species (< 5% of total cover) and establishment of native plant communities.

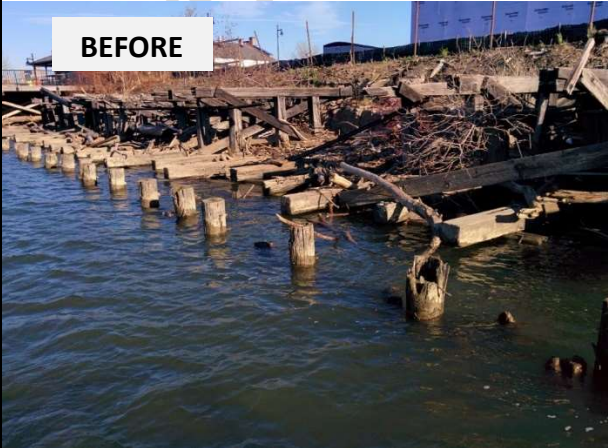
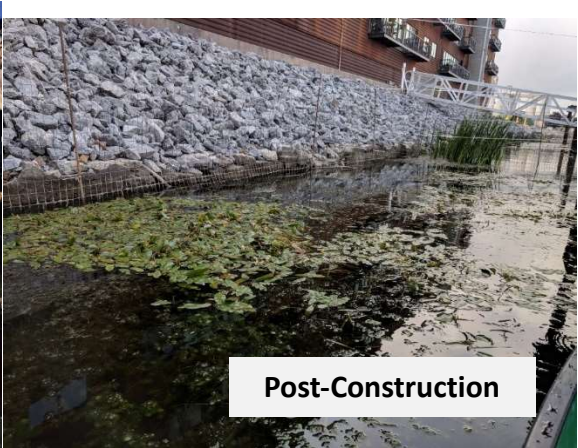
Buffalo River Aquatic Habitat Restoration - 1 South St., 70 Katherine St.; and 301 Ohio St.	
Site Owner	City of Buffalo (In water). Adjacent property owners Savarino Companies (1 South Street), Ellicott Development Co. (301 Ohio Street), Irish Propane (70 Katherine Street).
Project Manager	USACE
Funder/Source	USEPA/GLRI
Primary Design Consultant	USACE
Primary Construction Contractor	1 South Street: BIDCO Marine Group 70 Katherine Street: BIDCO Marine Group 301 Ohio Street: LDC (Prime), Sienna (QA/QC), AES (Sub)
Date of Completion/Success	1 South Street & 70 Katherine Street: 2019 301 Ohio Street: 2020 Monitoring process of success ongoing
Linear Feet Restored	1 South Street: 550' 70 Katherine Street: 820' 301 Ohio Street: 920' Total: 2,290'
Coordinates	Multiple locations within the Buffalo River AOC
<p>Work Accomplished: The Buffalo River Aquatic Habitat Restoration project included restoration of aquatic habitat at three sites along the Buffalo River. The sites are in-water, adjacent to the following properties: 1 South Street (Savarino Companies), 70 Katherine Street (Irish Propane), and 301 Ohio Street (Ellicott Development).</p> <p>The project consisted of construction of structural habitat in the form of submerged locked logs and rootwads, and the establishment of native aquatic SAV and EV vegetation communities. Additionally, work at the 301 Ohio Street site removed decrepit wooden infrastructure (wooden bulkheads) from the riverbank, installation of terraced planting areas using locked logs, and establishment of riparian vegetation and shrubs in front of an existing concrete retaining wall.</p> <p>Monitoring since 2016 indicates a successful establishment of diverse SAV, EV, and riparian communities. Structural habitat reduces nearshore wave energy, and provides refuge habitat for fish, waterfowl, American mink, and migratory birds. Monitoring continued through 2021.</p>
