### **Stream Assessments in the Niagara River Greenway**

Prepared by: Dr. Kelly M. Frothingham  
Prepared for: Buffalo Niagara Riverkeeper

January 2014

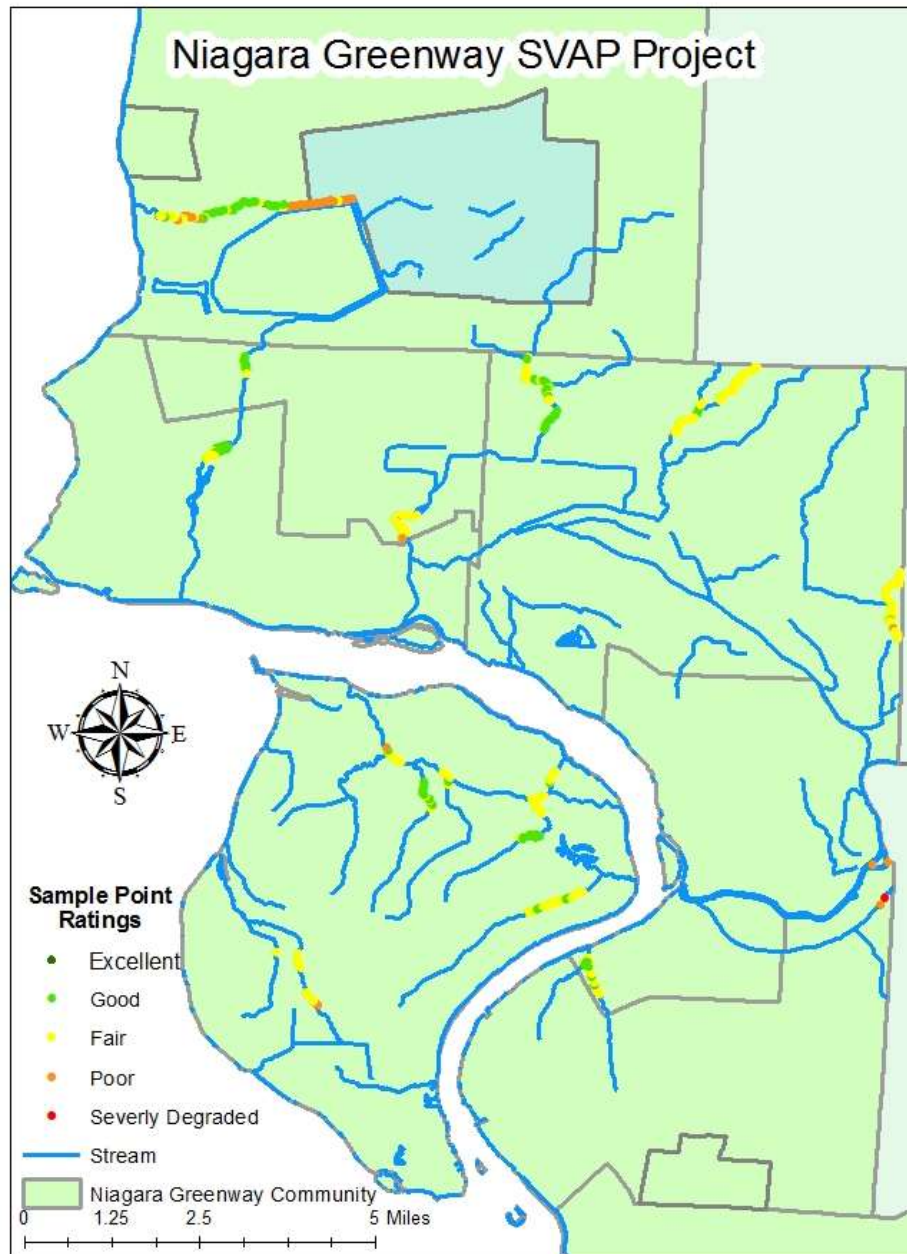
Figure 2 Overall SVAP scores in reaches of Niagara River Greenway streams.

The majority of assessed reaches (57%; 200 reaches) had overall SVAP scores in the Fair rating range (Figure 2). There were 109 reaches (31%) with Good overall scores, one reach was rated Severely Degraded (Ellicott Creek Reach 1), and there were not any reaches with an Excellent overall rating (Figure 2).

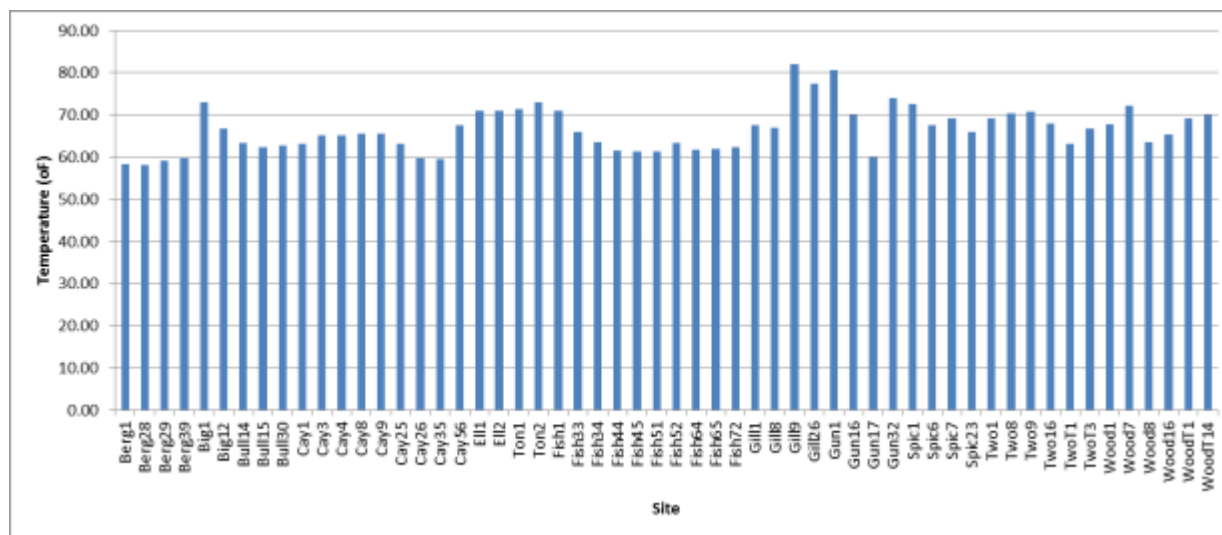
Figure 14 Reach-averaged temperatures at each site.

Reach-averaged temperature values ranged from 58.12 to 81.96°F (Figure 14). Temperature values were within normal ranges for tributaries to the Niagara River during summer months (URS and Gomez and Sullivan, 2005).

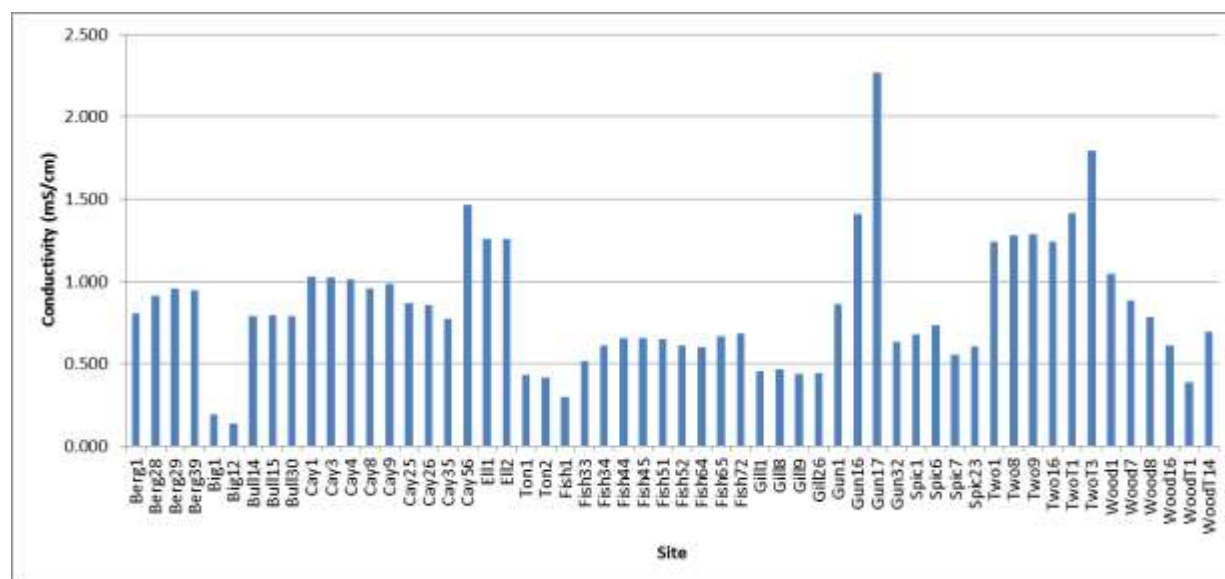
Figure 15 Reach-averaged conductivity values at each site.

high conductivity indicates high dissolved ions. Conductivity in freshwater streams will vary based on factors like soil and bedrock material and groundwater versus precipitation inputs and most streams have conductivity values that range between 0.500 to 1.5 mS/cm (Behar, 1997). The optimal range of conductivity values to support a diverse aquatic community is 0.150 to 0.500 mS/cm (Behar, 1997). Conductivity values for this study ranged from 0.136 to 2.268 mS/cm (Figure 15) and values measured during this study were similar to those reported previously in Niagara River tributaries (URS and Gomez and Sullivan, 2005). Moreover, 80% of the reaches (45 reaches) had conductivity values within the normal range of freshwater streams (i.e., 0.500 to 1.5 mS/cm) (Behar, 1997). Only 20% of the reaches (11 reaches) had conductivity values in the optimal range to support a diverse aquatic community (i.e., 0.150 to 0.500 mS/cm) (Behar, 1997).

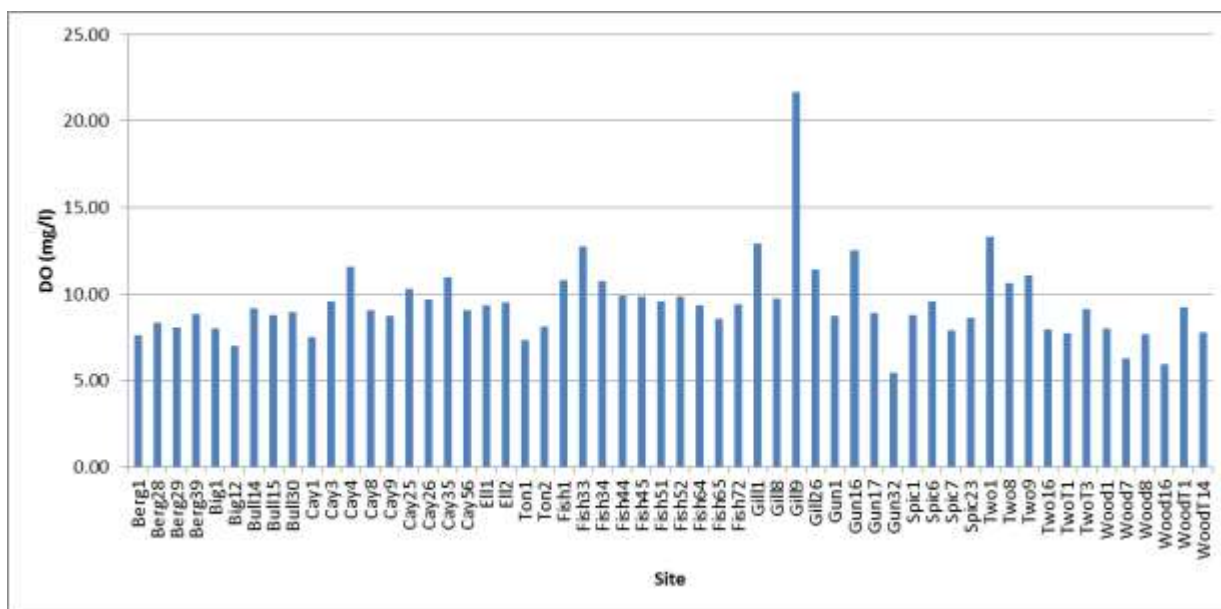
Figure 16 Reach-averaged DO concentrations at each site.

Dissolved oxygen concentrations ranged from 5.44 to 21.64 mg/l, although the 21.64 mg/l concentration from Gill Creek Reach 9 may have been an erroneous reading (Figure 16). Excluding Gill Creek Reach 9, DO concentrations ranged from 5.44 to 13.31 mg/l. The NYSDEC DO water quality standards for Class B and C streams are in Table 26. DO concentrations at all 37 sites were greater than 5.0 mg/l, which is the minimum DO concentration for trout waters. Generally, DO concentrations between 4 and 7 mg/l are good for many aquatic animals, although low for coldwater fish and concentrations between 7 and 11 mg/l are very good for most stream fish (Behar, 1997). DO concentrations were between 5 and 11 mg/l in 91% of the reaches (51 reaches). DO concentrations measured during this study were similar to those measured previously in Niagara River tributaries (URS and Gomez and Sullivan, 2005).

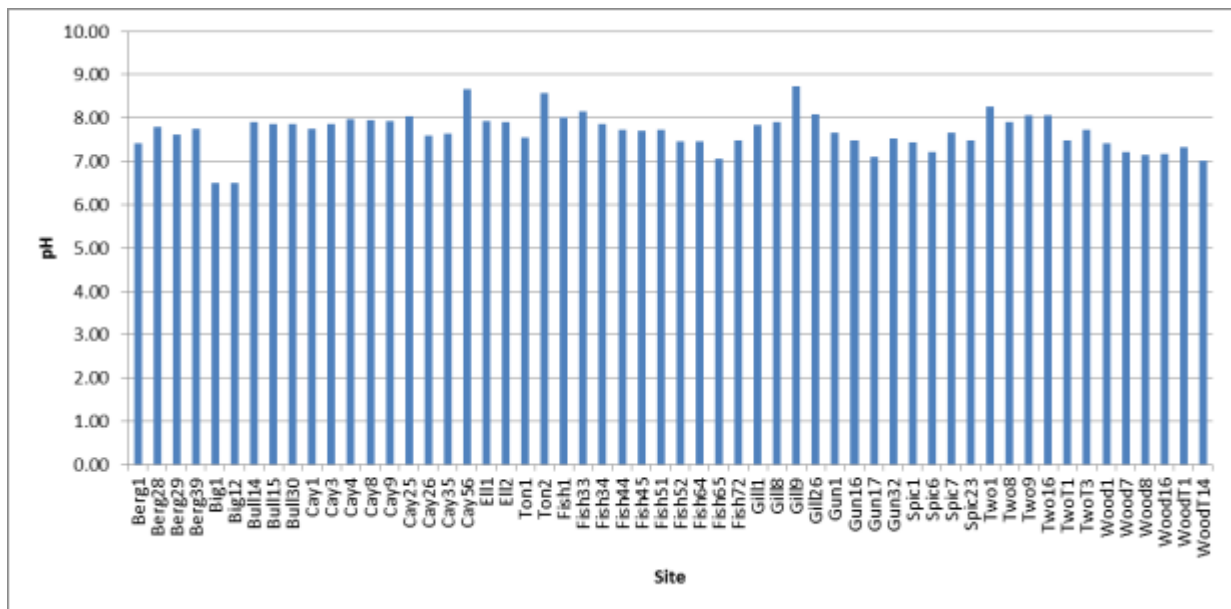
Figure 17 Reach-averaged pH values at each site.

pH values ranged from 6.5 to 8.72, indicating that all the creeks were near neutral (7.0) to slightly alkaline (Figure 17). The NYSDEC water quality standard for pH says that for Class B and C streams pH should be between 6.5 and 8.5. pH was only above 8.5 in three reaches: Tonawanda Creek Reach 2 (pH 8.57), Cayuga Creek Reach 56 (pH 8.66), and Gill Creek Reach 9 (pH 8.72). pH values measured during this study were similar to those measured previously in Niagara River tributaries (URS and Gomez and Sullivan, 2005).

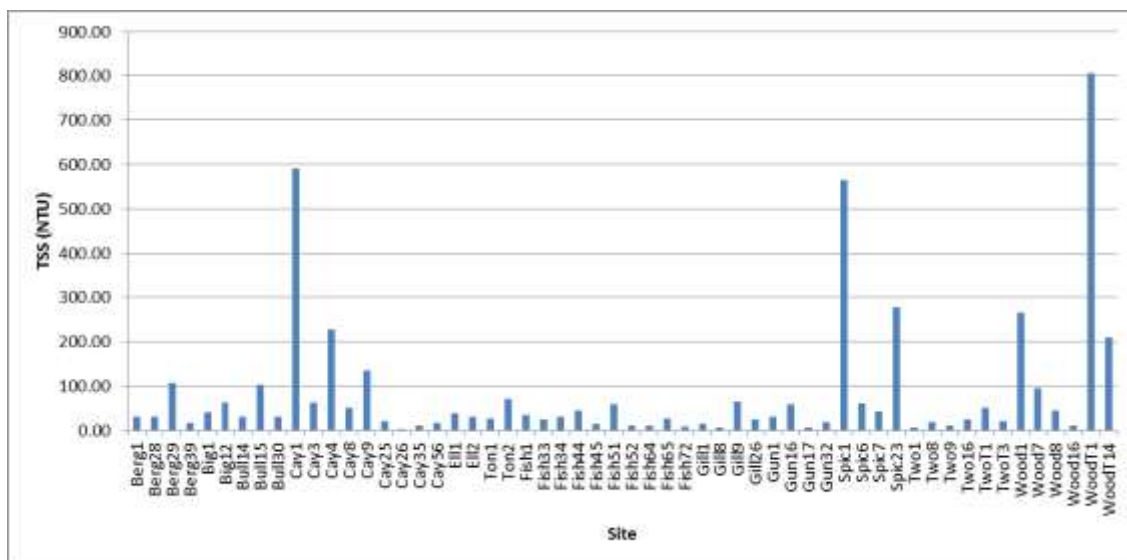
Figure 18 Reach-averaged turbidity values at each site.

Turbidity ranged from 2.93 to 806.10 NTU, although field notes indicate that many high turbidity readings were a result of bed sediment being disturbed by the field crew (see Appendix E; Figure 18). The 2005 study by URS and Gomez and Sullivan reported turbidity results for sites on nine Niagara River streams (Fish, Gill, Cayuga, Tonawanda, Ellicott, Woods, Gun, Big Six Mile, and Spicer Creeks). Average dry weather turbidity results from URS and Gomez and Sullivan (2005) ranged from 1.88 NTU for a site on Gill Creek and 45.73 NTU for a site on Woods Creek. Results from this study fall within that range of turbidity readings in 64% of the reaches (36 reaches).
