ECOLOGICAL CONDITION OF GILL, FISH, AND CAYUGA CREEKS

Niagara Power Project (FERC No. 2216)

New York Power Authority

May 2004

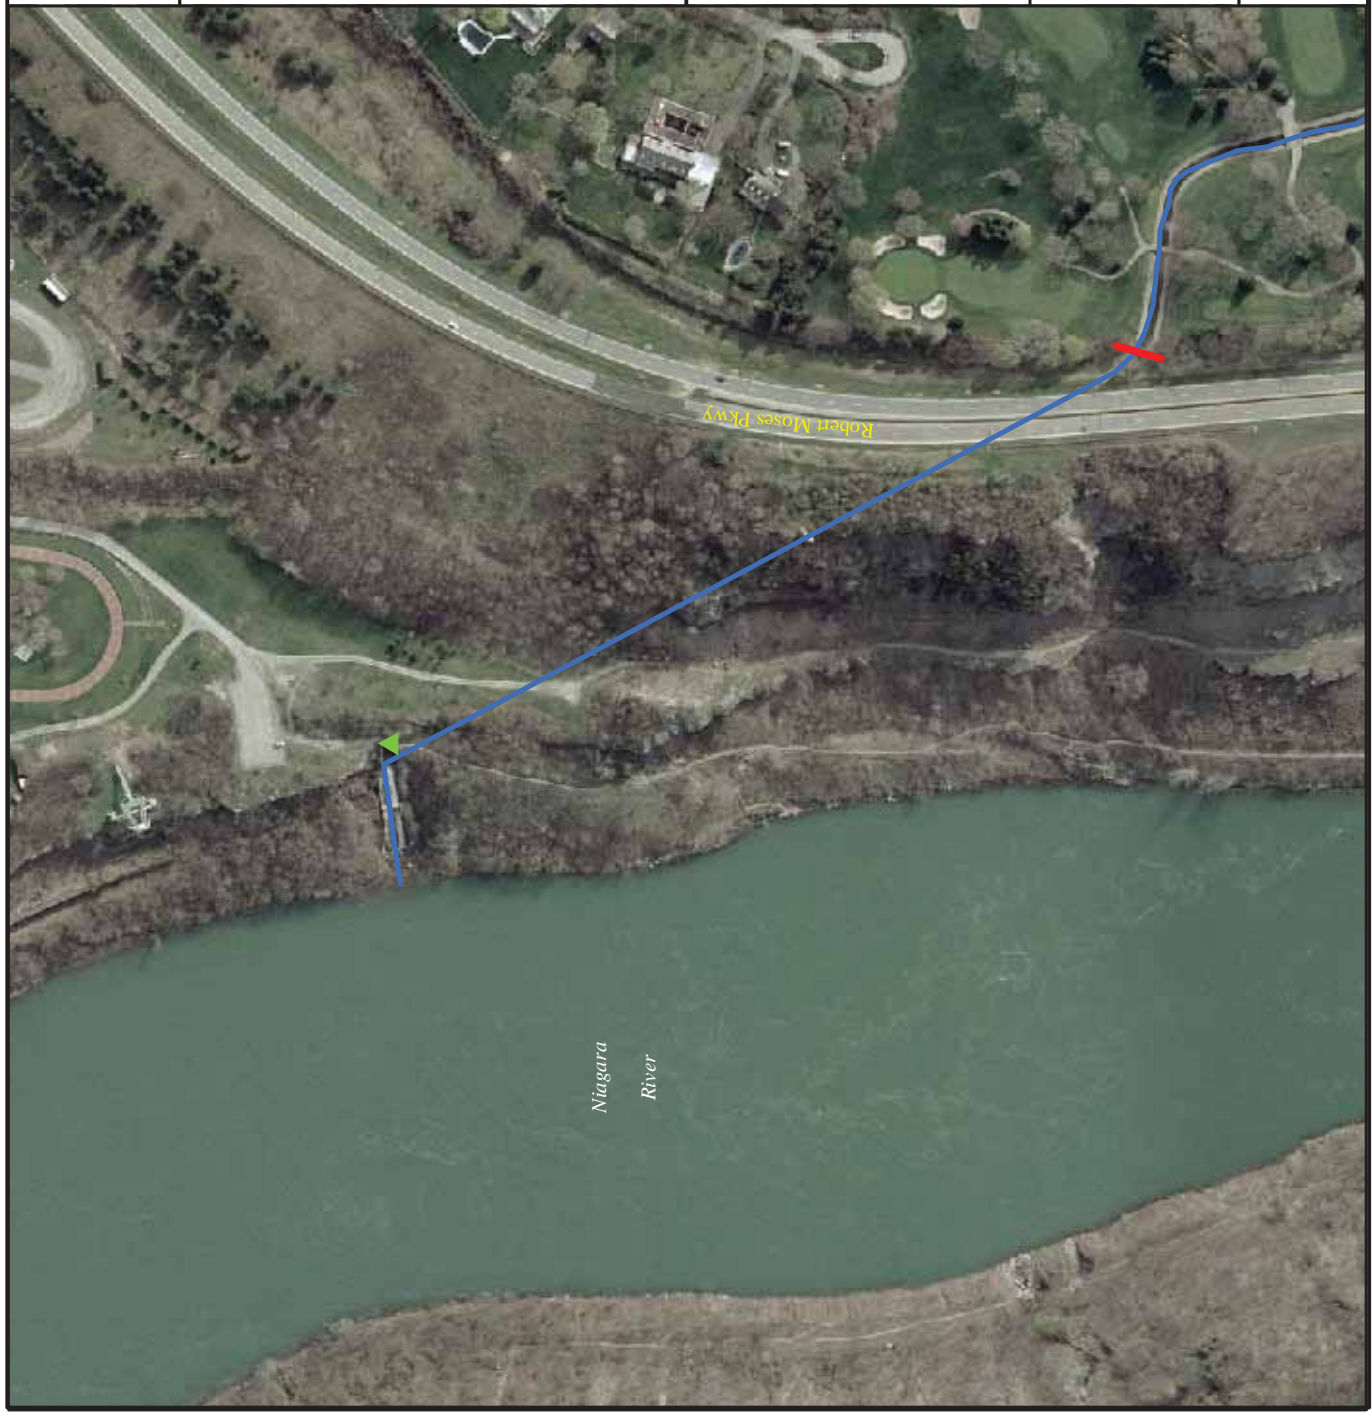
FIGURE 2.5.1-2
SLIME CHUTE AT THE MOUTH OF FISH CREEK

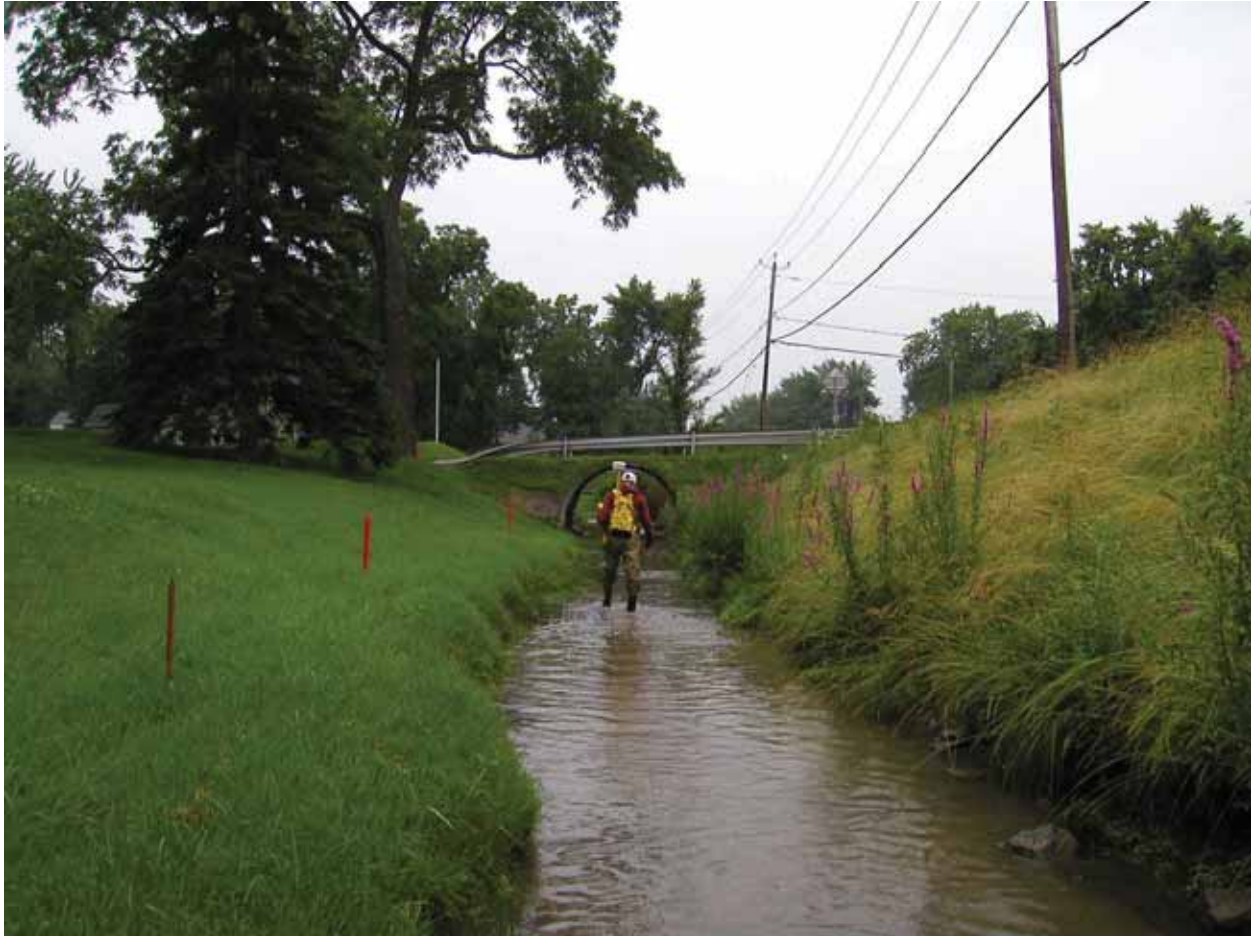
FIGURE 2.5.1-5
CONCRETE LINED STREAM CHANNEL THROUGH THE NIAGARA FALLS COUNTRY CLUB IN REACH F1

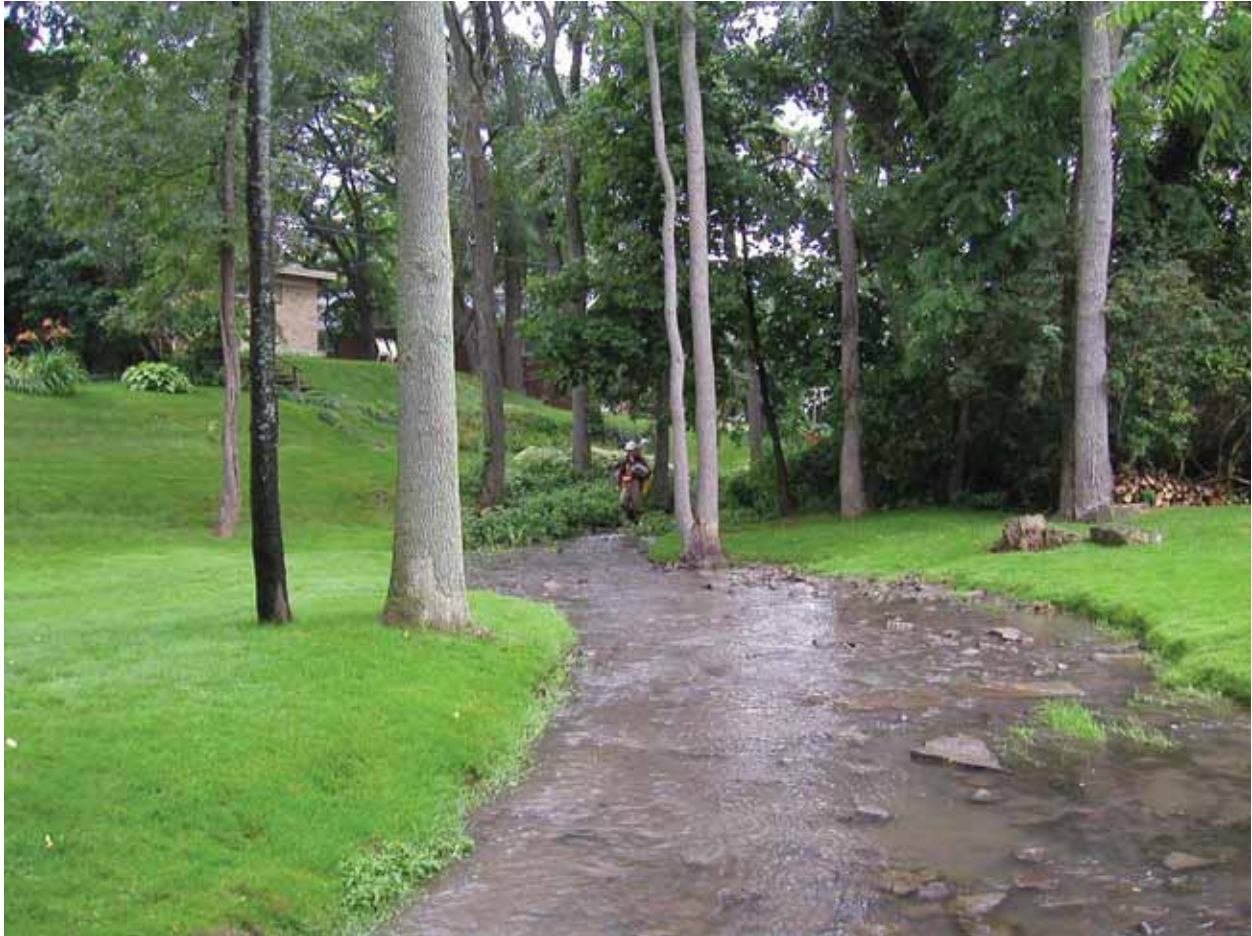
**FIGURE 2.5.1-7
REACH F2 BEHIND RESIDENTIAL PROPERTIES ON MEADOW BROOK ROAD**

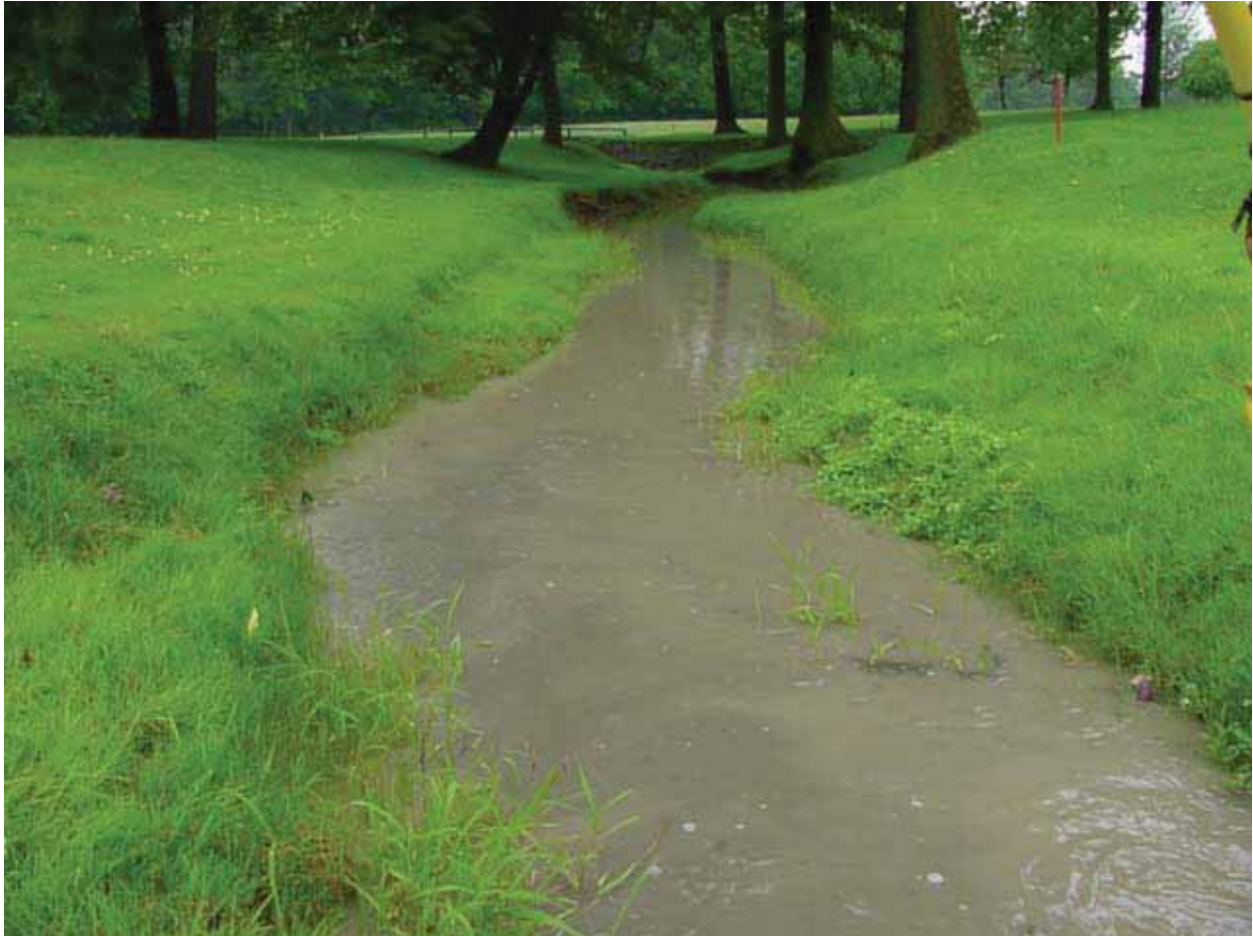
FIGURE 2.5.1-9

FISH CREEK THROUGH NIAGARA FALLS COUNTRY CLUB GOLF COURSE IN REACH F3

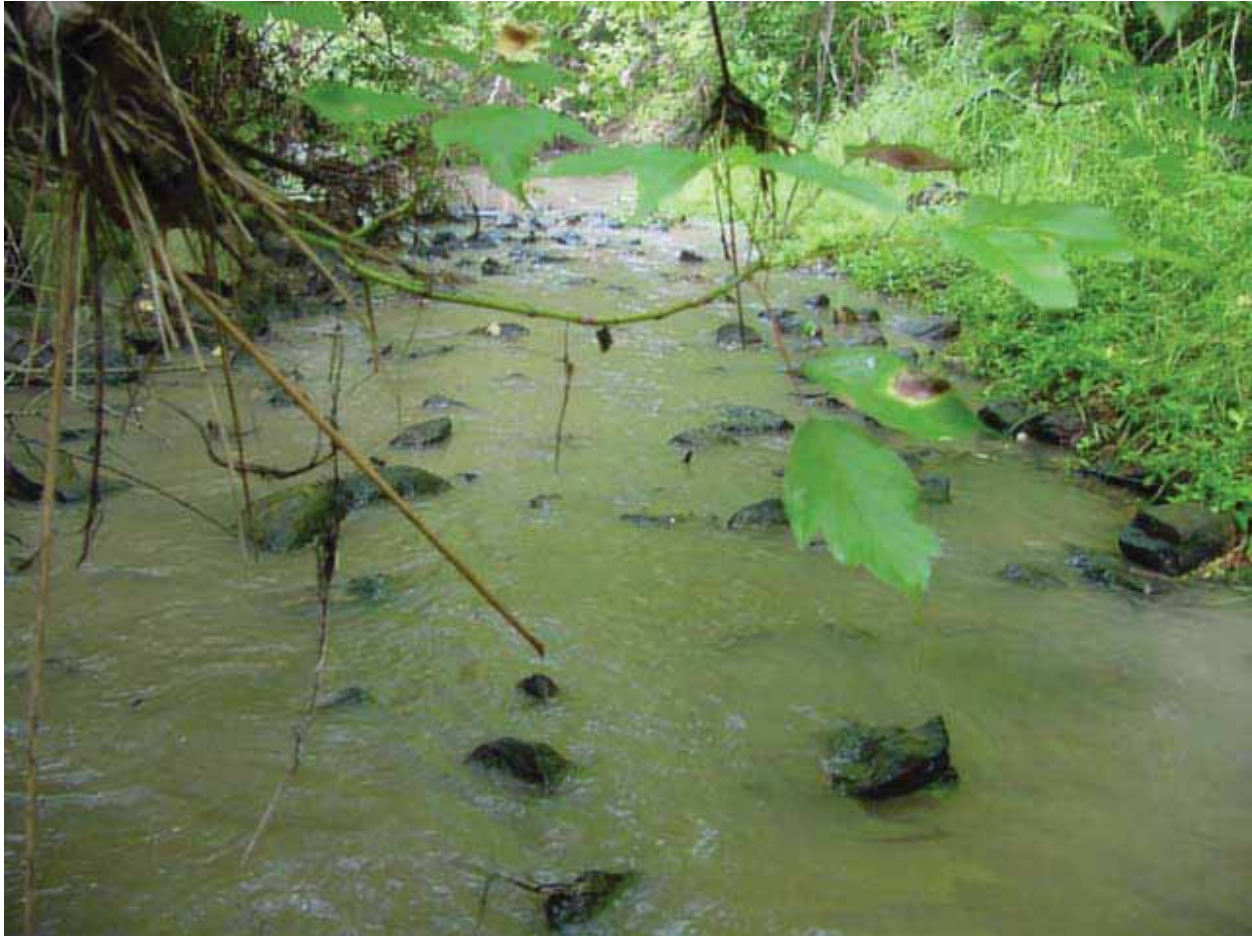
FIGURE 2.5.1-11
A REPRESENTATIVE PORTION OF REACH F4

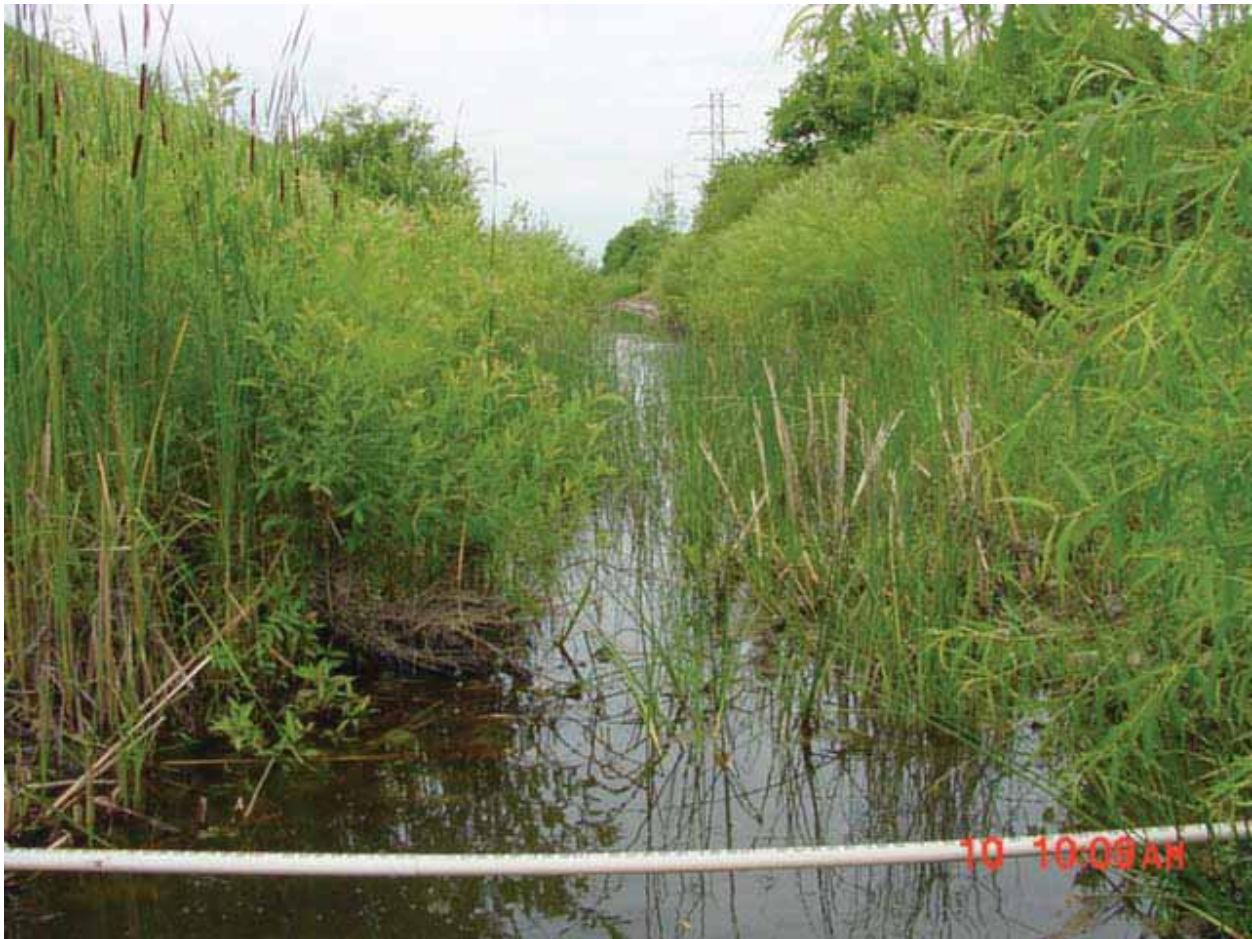
FIGURE 2.5.1-13

A CHANNELIZED SECTION OF FISH CREEK ALONG THE LEWISTON RESERVOIR

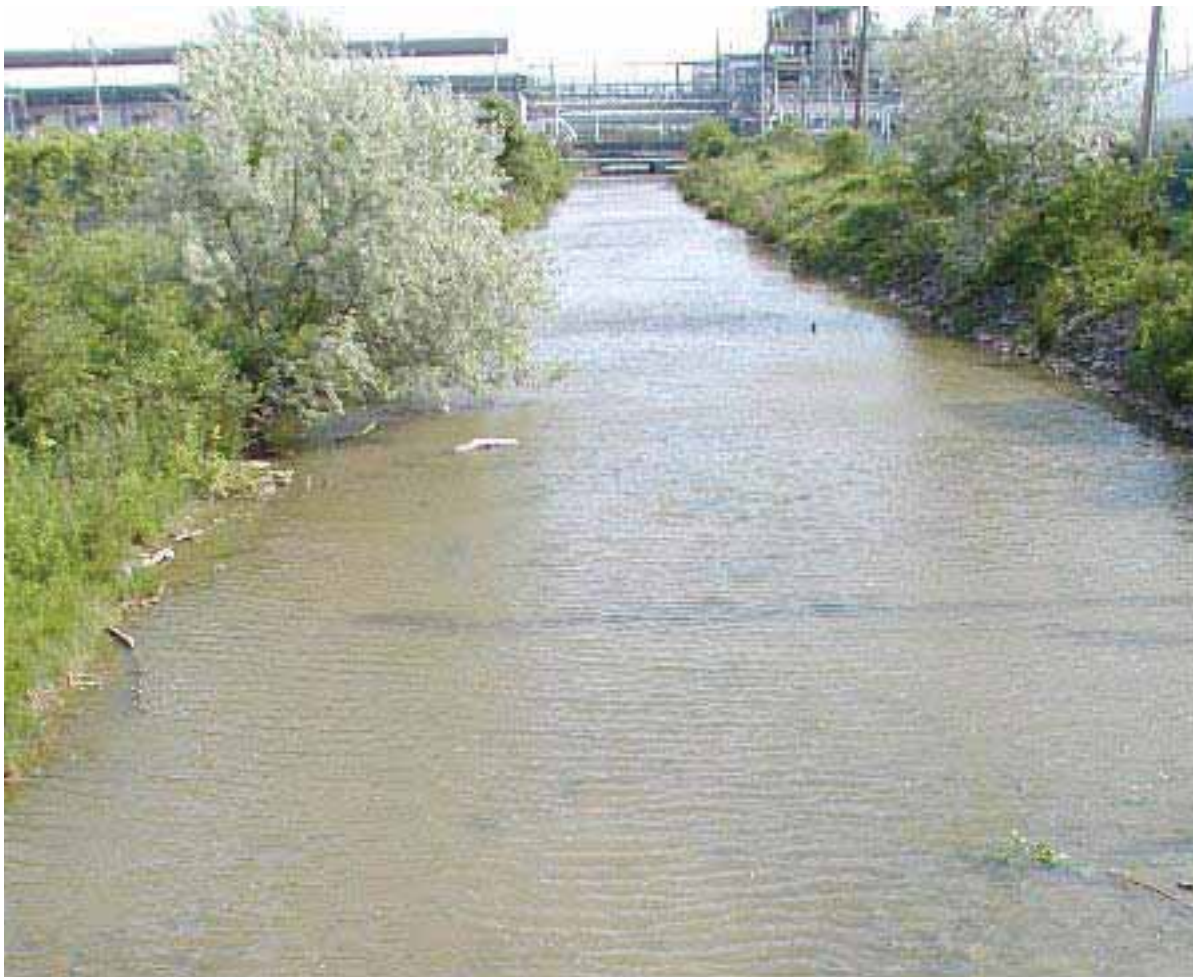
FIGURE 2.5.2-2
INDUSTRIAL FACILITIES ALONG GILL CREEK IN REACH G1

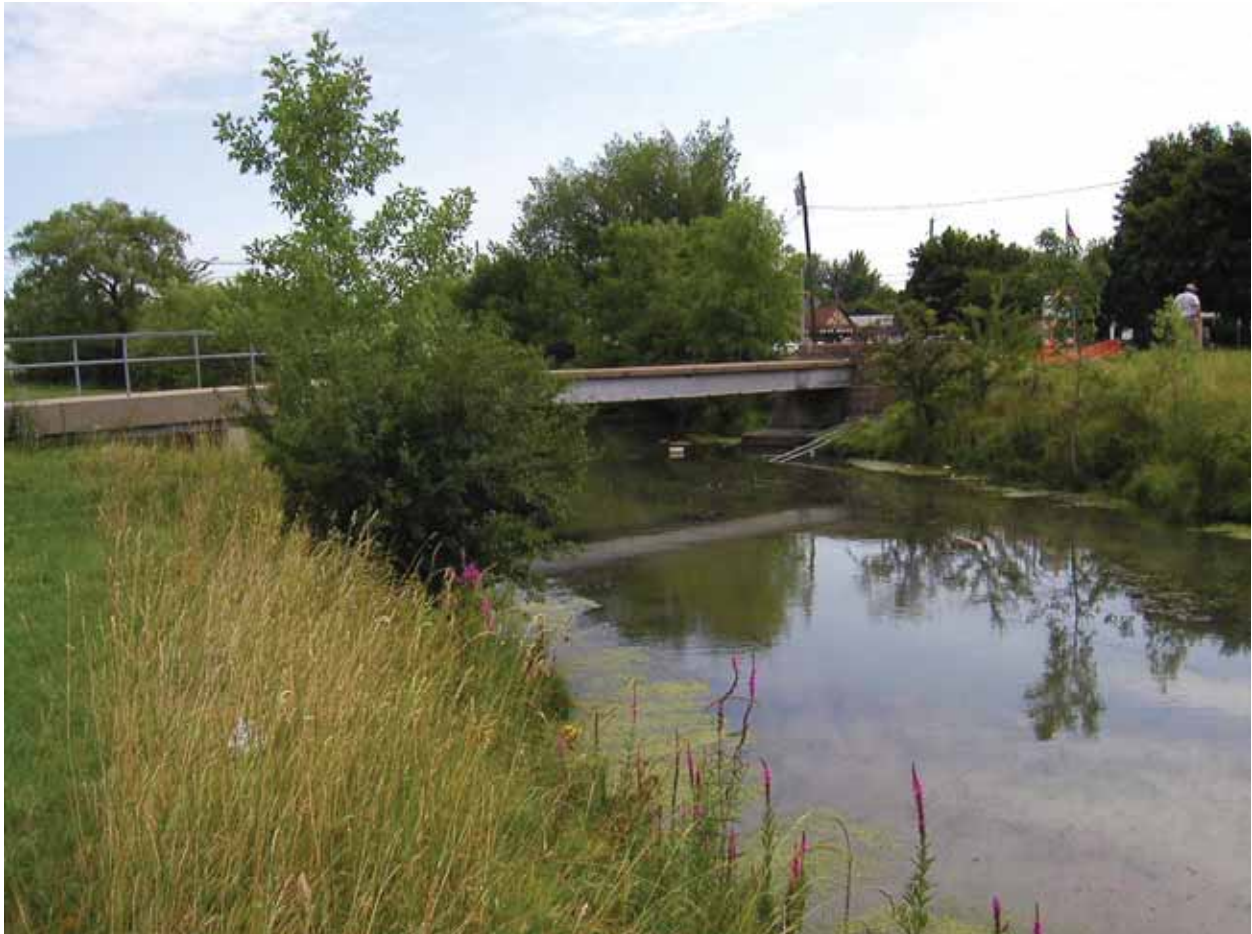
**FIGURE 2.5.2-4
GILL CREEK THROUGH REACH G2**

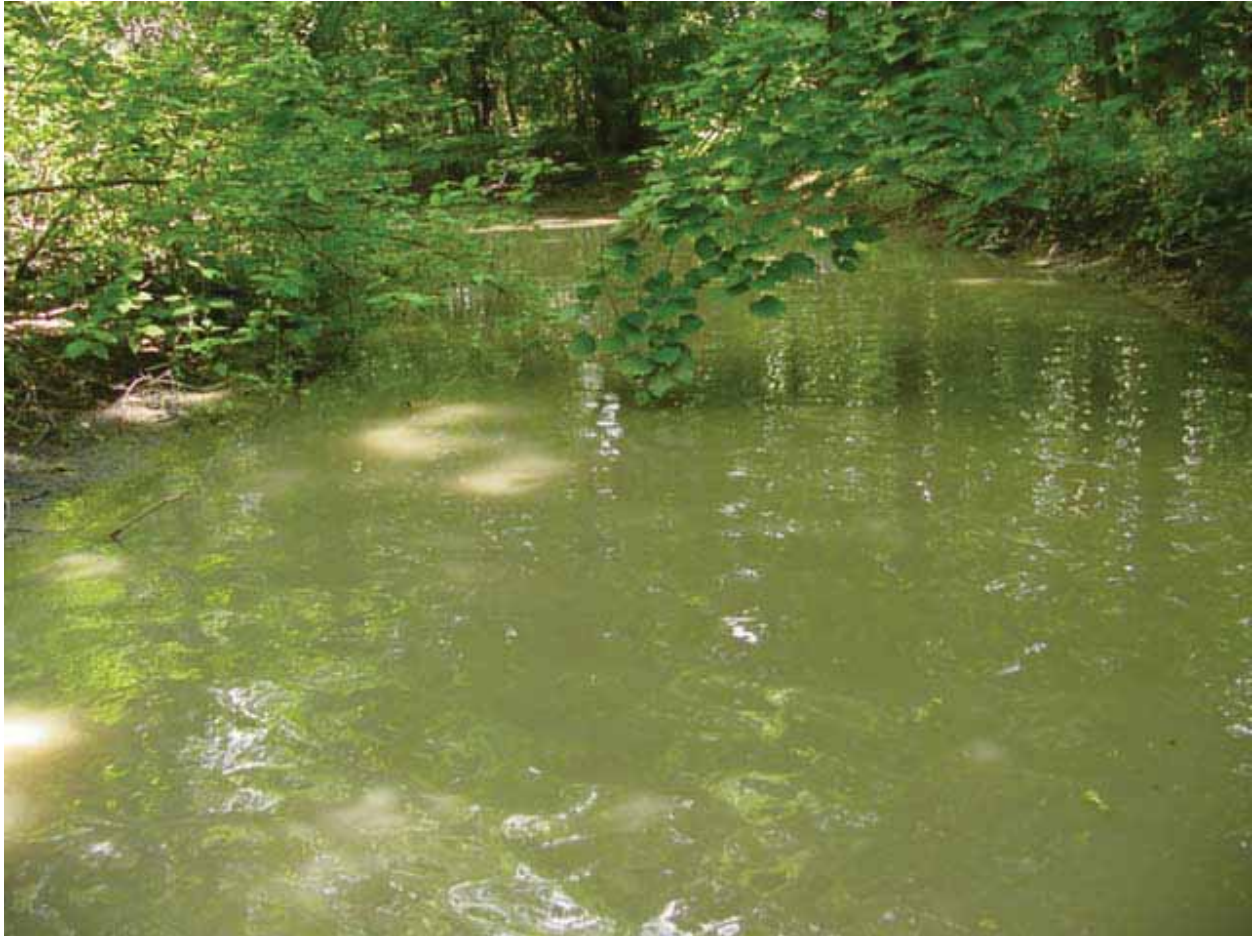
FIGURE 2.5.2-9
FORESTED RIPARIAN BUFFERS ALONG GILL CREEK IN REACH G4

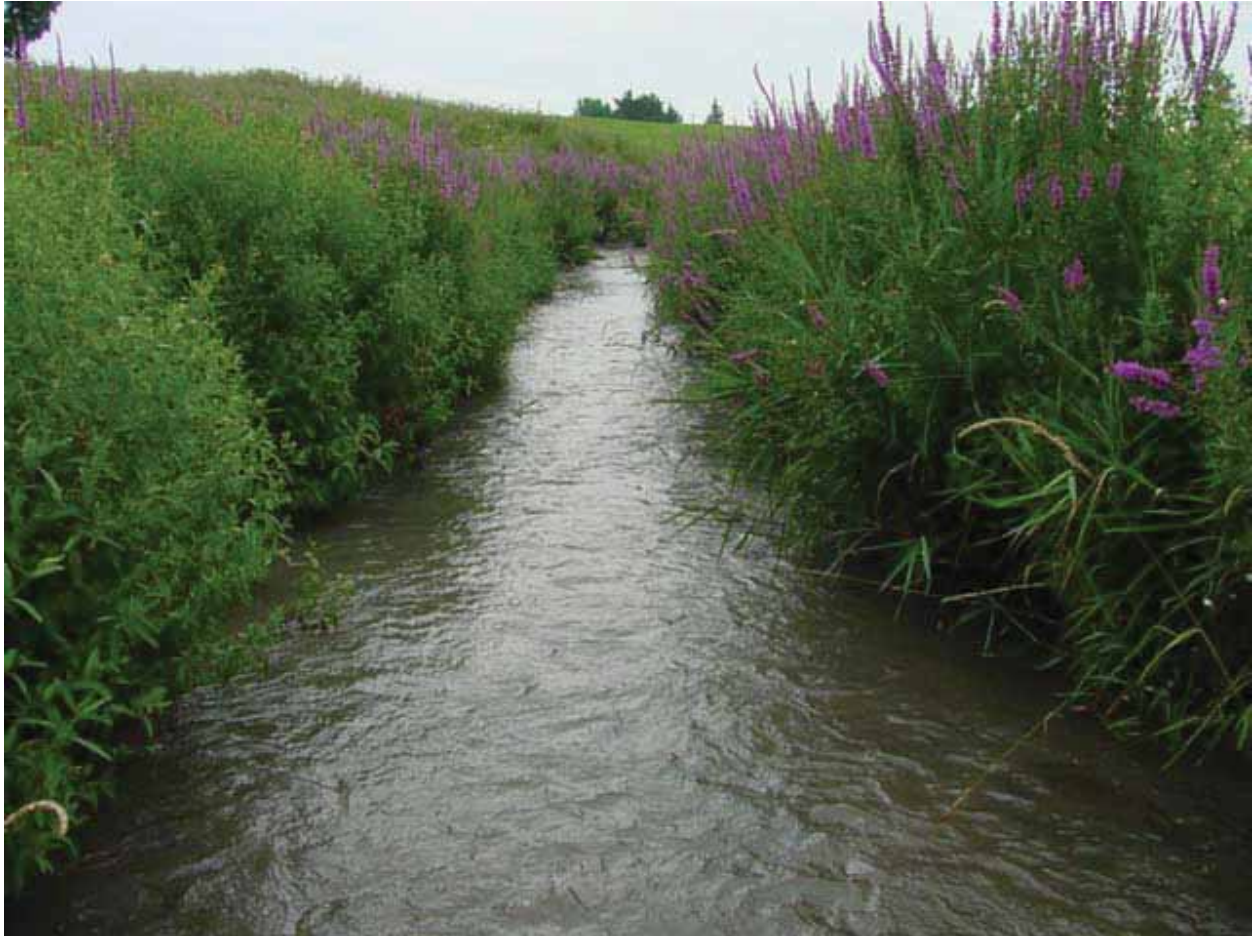
FIGURE 2.5.2-12

HERBACEOUS RIPARIAN BUFFERS ALONG PORTIONS OF GILL CREEK IN REACH G5

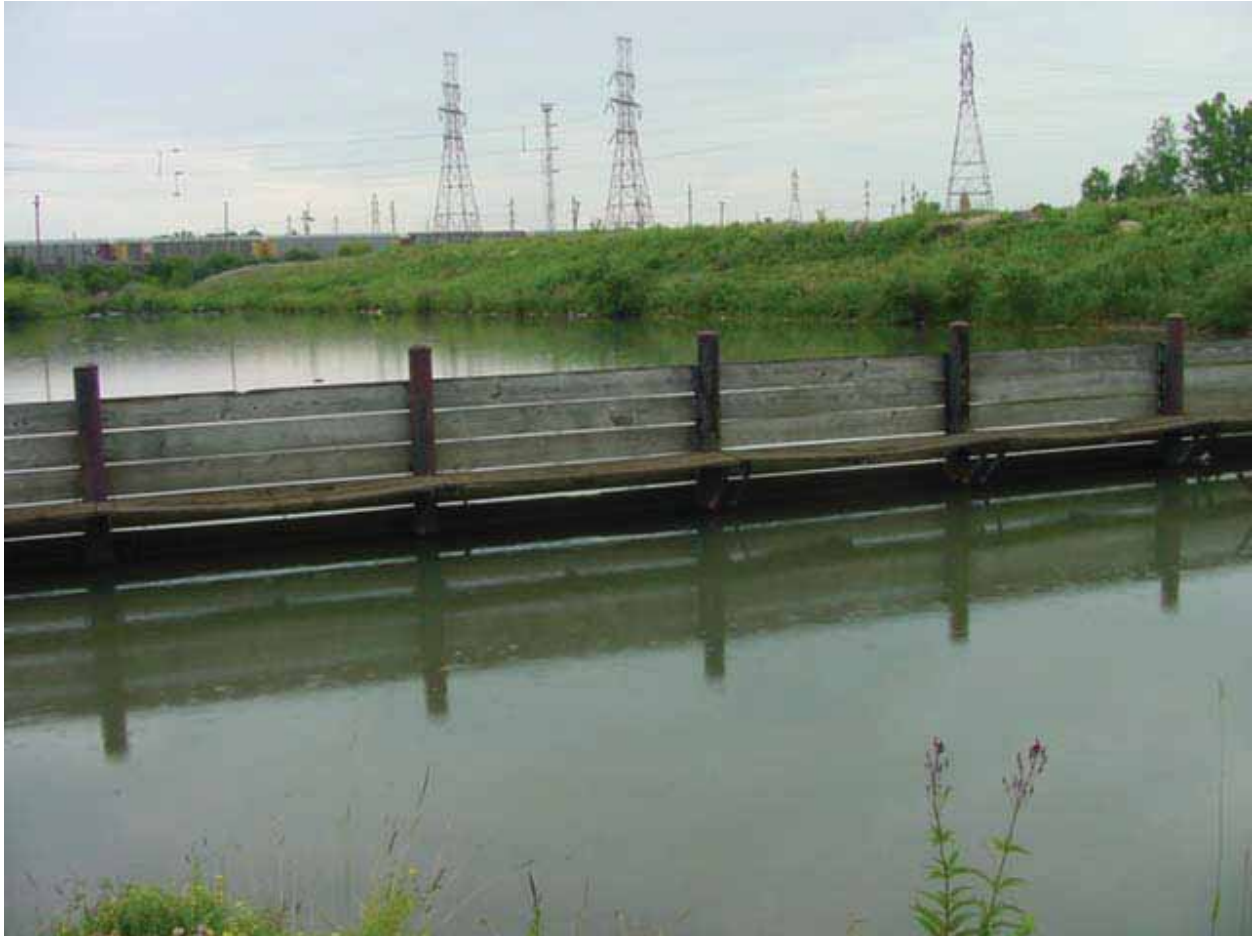
FIGURE 2.5.2-14

SMALL POND ON GILL CREEK LOCATED JUST DOWNSTREAM OF THE RAIL YARD

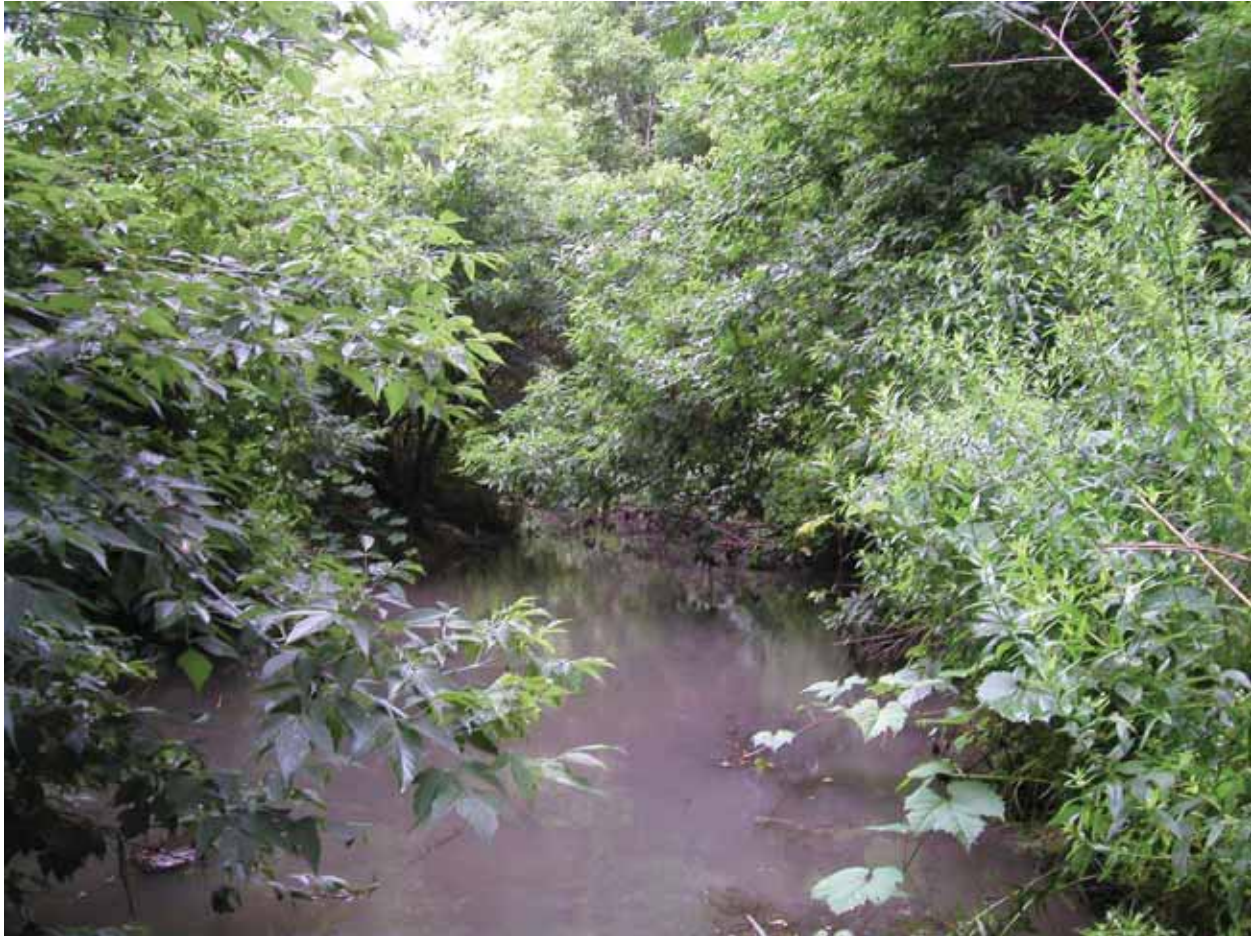
**FIGURE 2.5.2-17
OVERHANGING COVER ALONG GILL CREEK IN REACH G8**

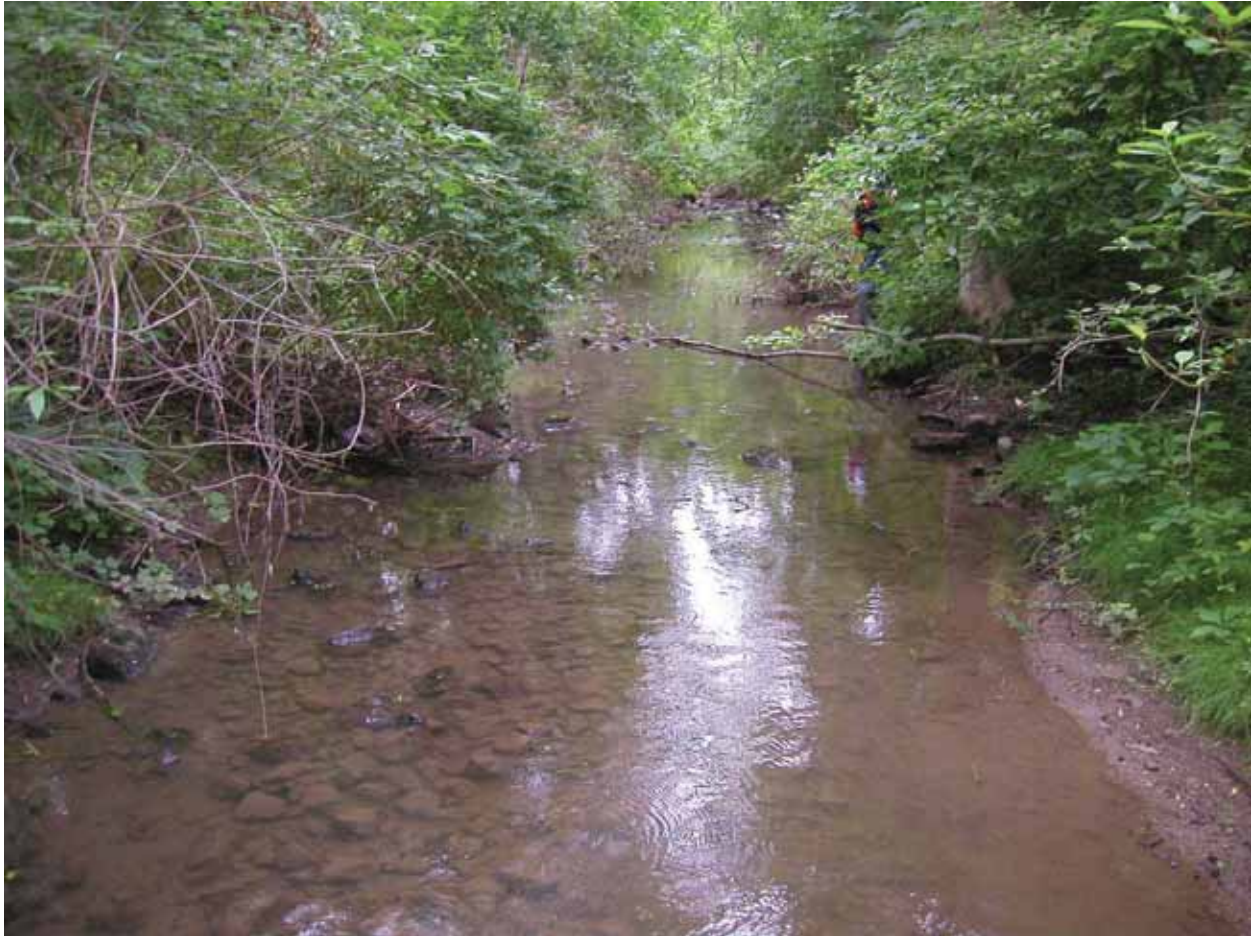
**FIGURE 2.5.2-21
FORESTED RIPARIAN BUFFERS ALONG GILL CREEK IN REACH G10**

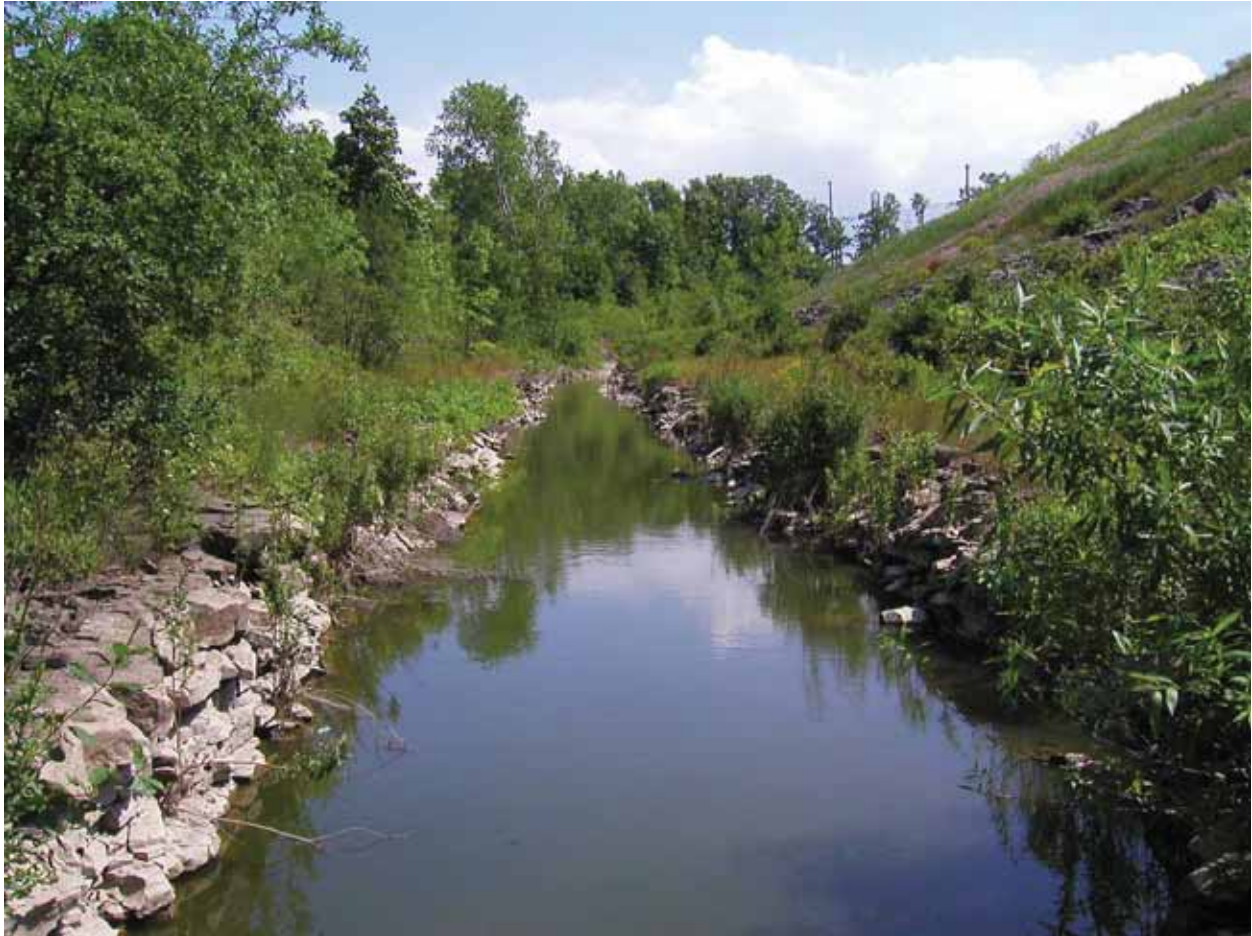
FIGURE 2.5.2-23
CHANNELIZED SECTION OF GILL CREEK ALONG THE LEWISTON RESERVOIR

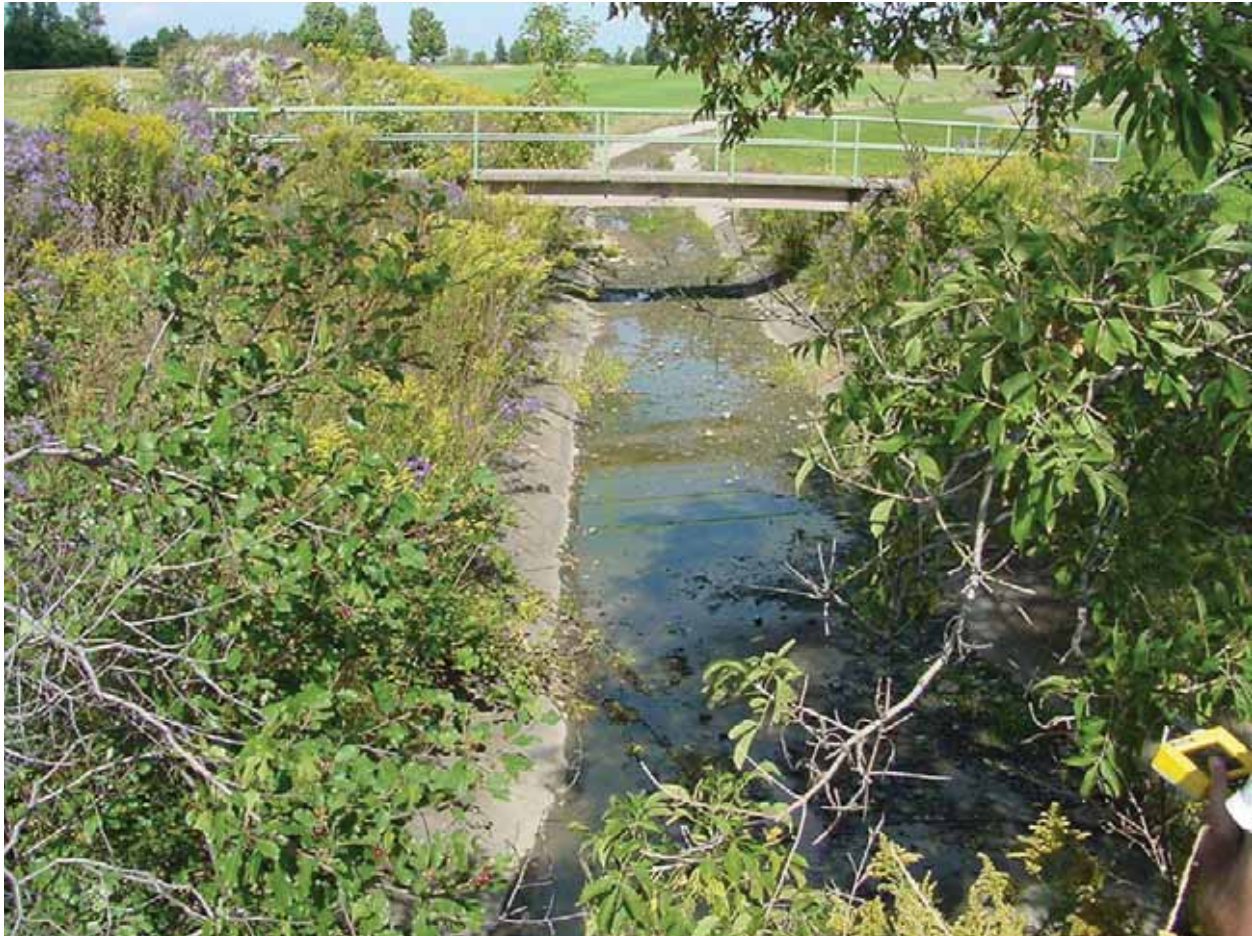
FIGURE 2.5.2-29
CONCRETE LINED STREAM CHANNEL THROUGH THE HYDE PARK GOLF COURSE IN
REACH GT1

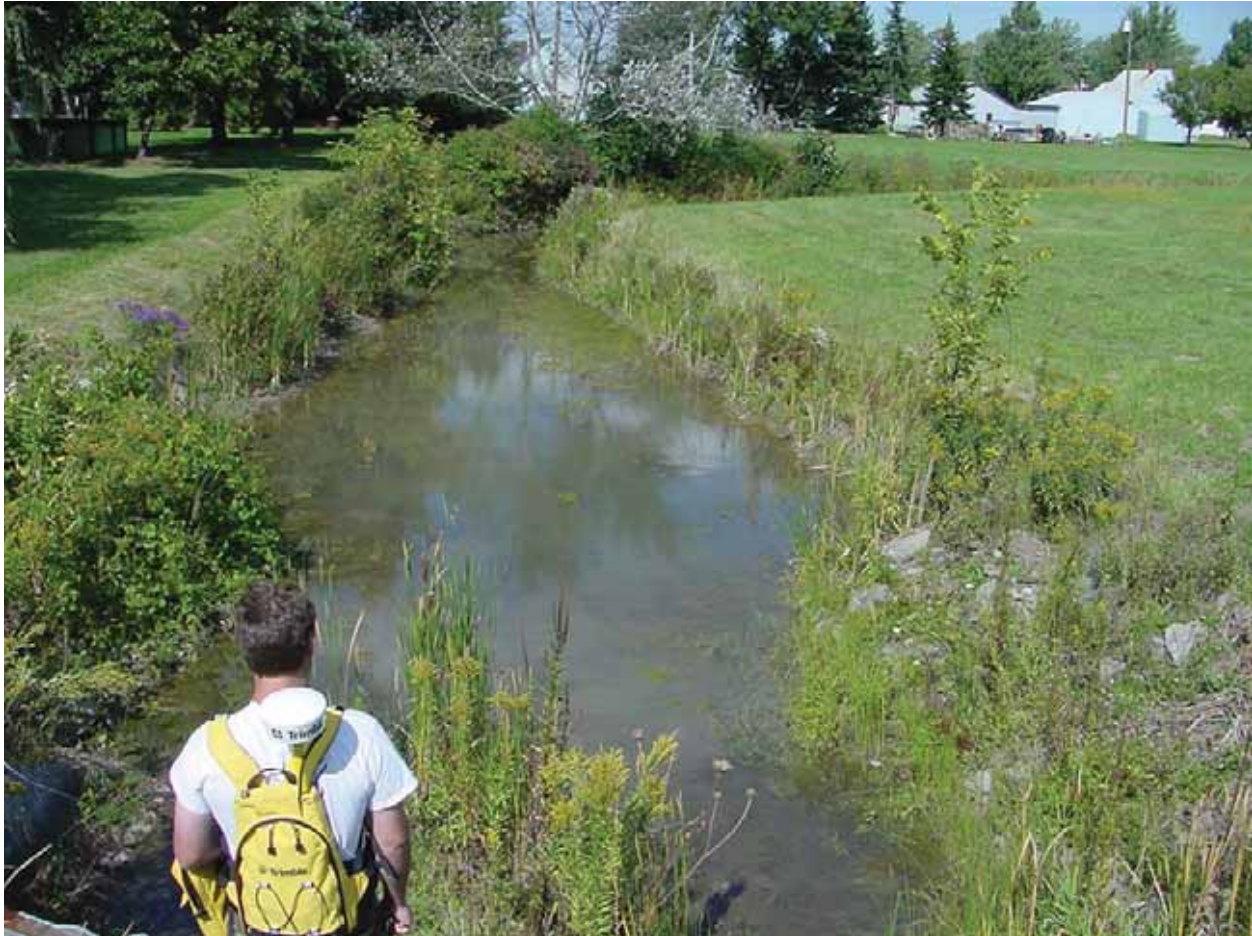
FIGURE 2.5.2-33

NARROW RIPARIAN BUFFERS ALONG THE GILL CREEK TRIBUTARY IN REACH GT3

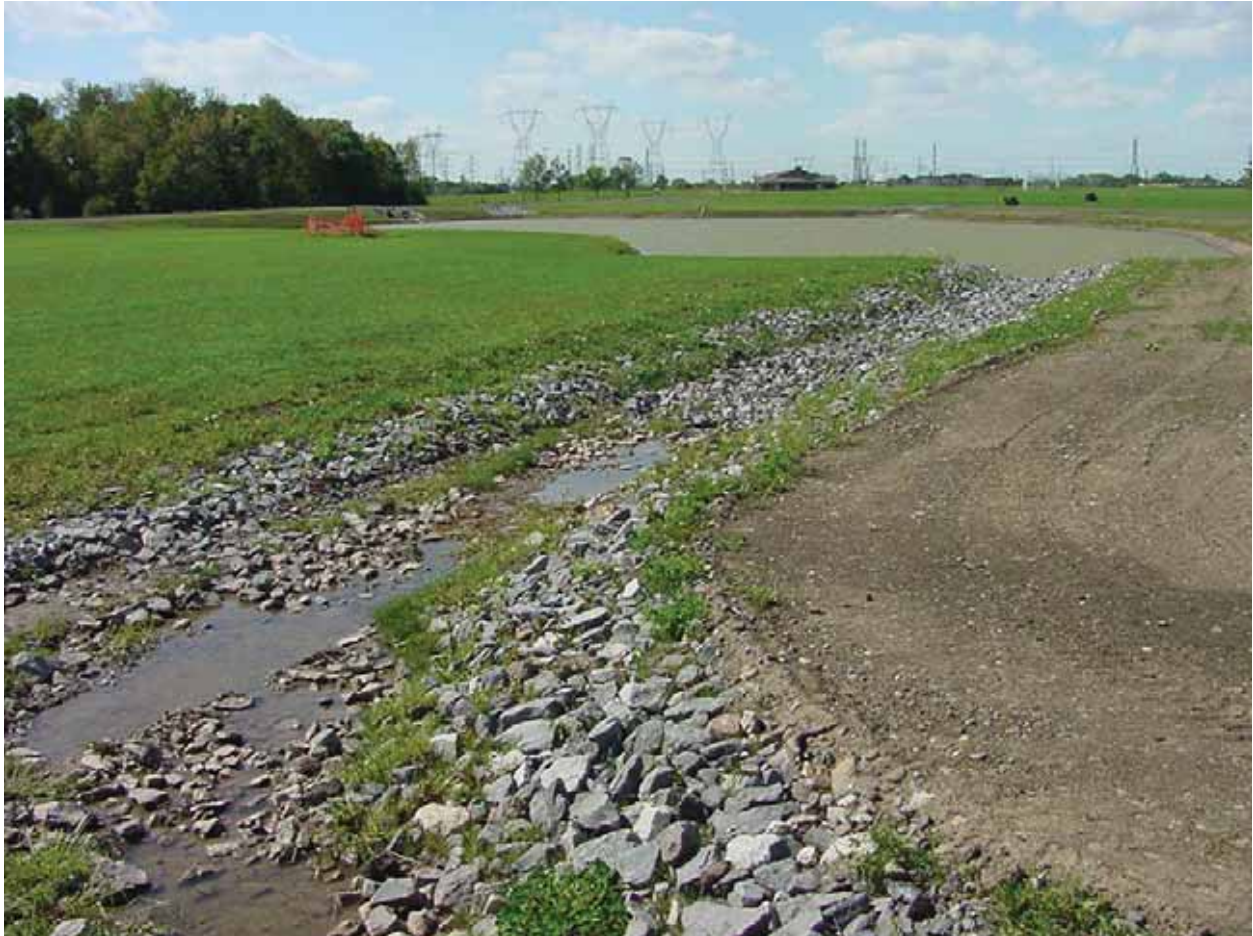
FIGURE 2.5.2-35

NEWLY CREATED POND ON THE HEADWATERS OF THE GILL CREEK TRIBUTARY

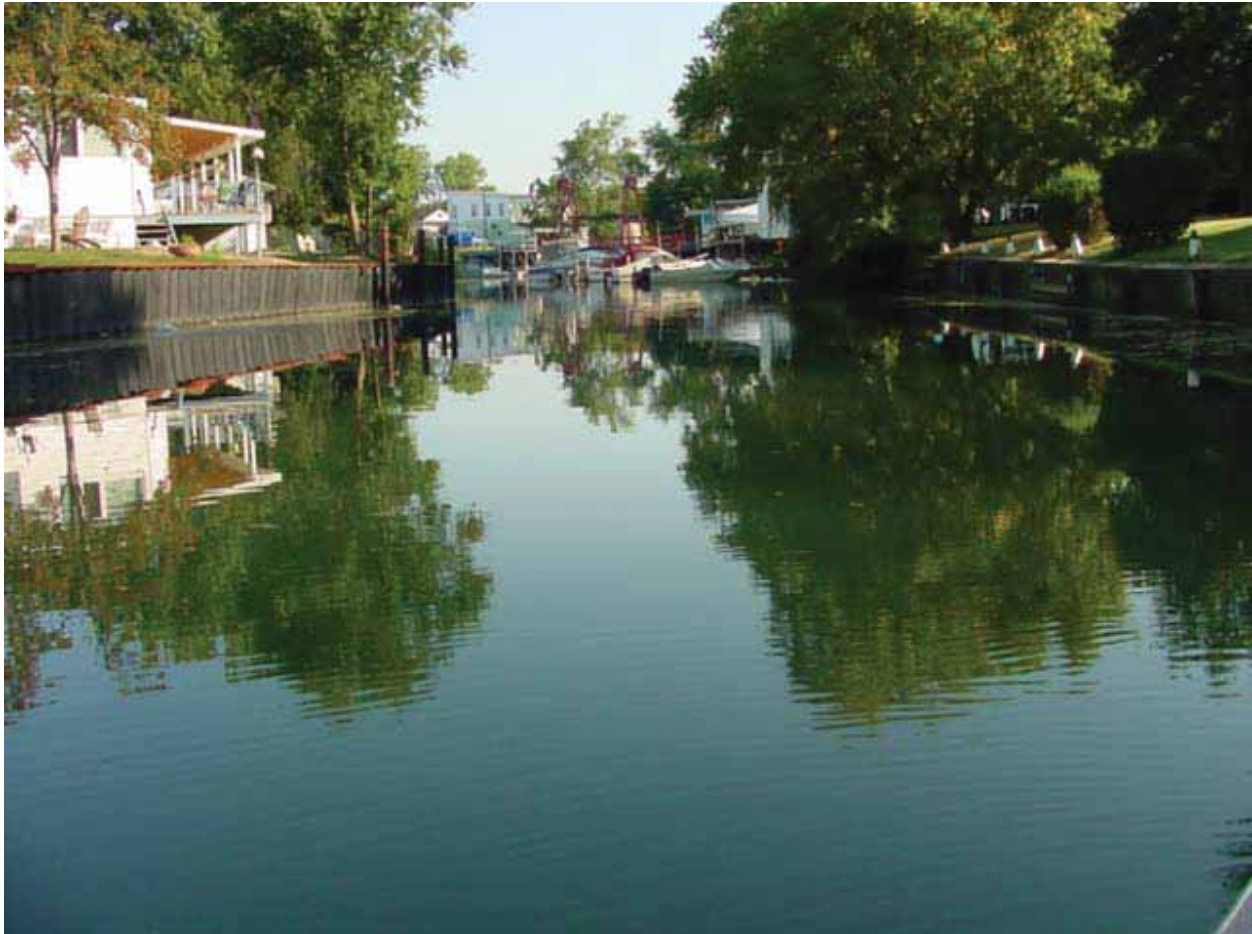
**FIGURE 2.5.3-2
HOUSES AND BOAT DOCKS ALONG CAYUGA CREEK IN REACH C1**
