ECOLOGICAL CONDITION OF GILL, FISH, AND CAYUGA CREEKS

Niagara Power Project (FERC No. 2216)

New York Power Authority

May 2004

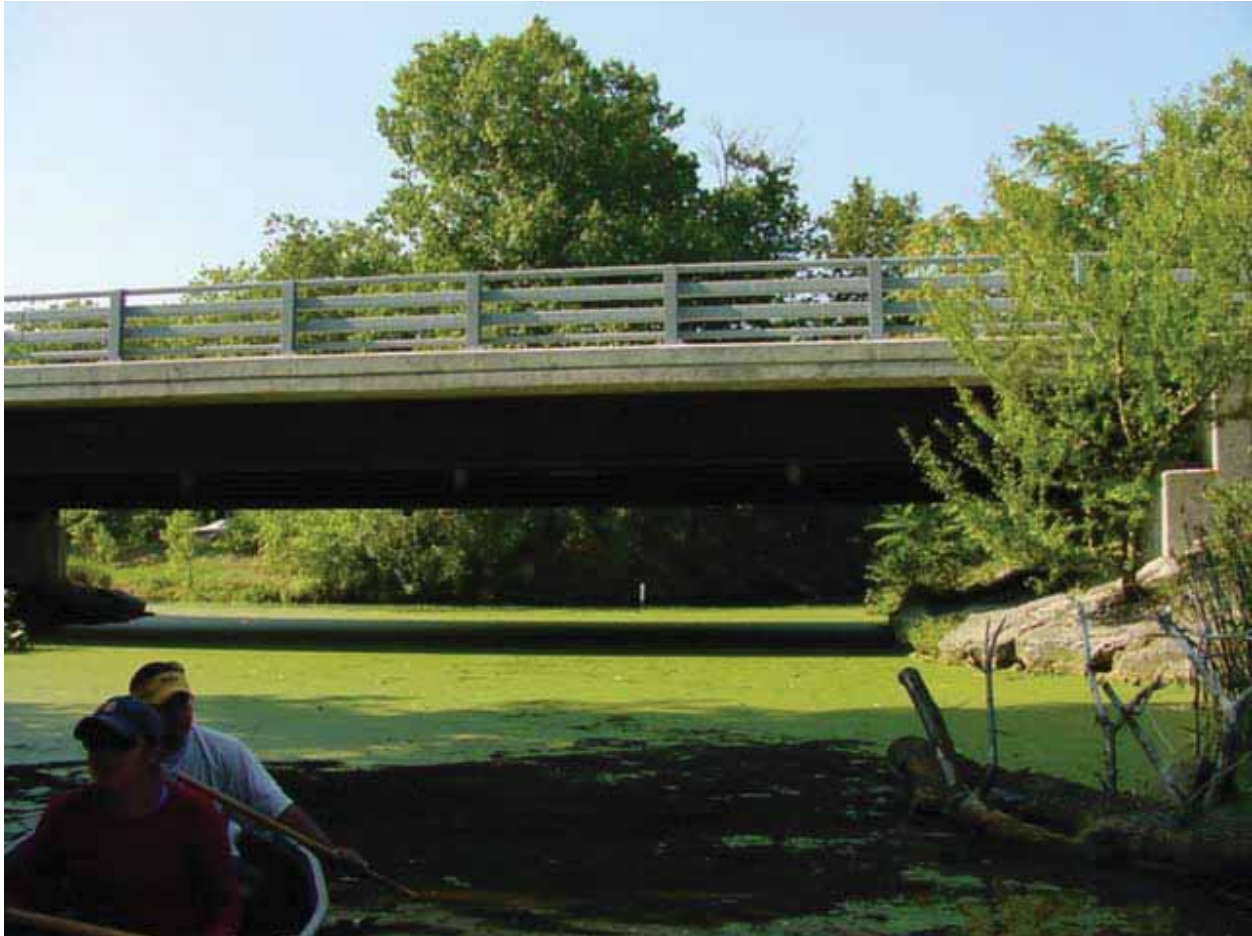
FIGURE 2.5.3-3
TYPICAL ROAD CROSSING OVER CAYUGA CREEK IN REACH C1

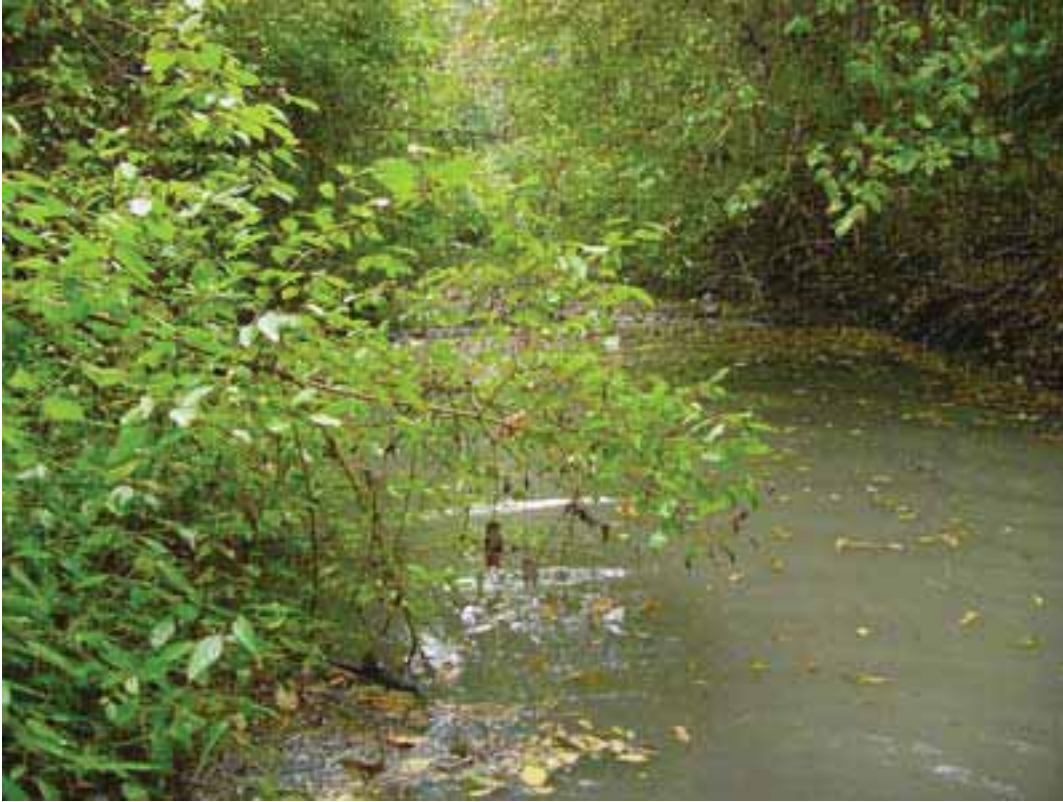
FIGURE 2.5.3-8
CAYUGA CREEK THROUGH A CHANNELIZED SECTION IN REACH C3

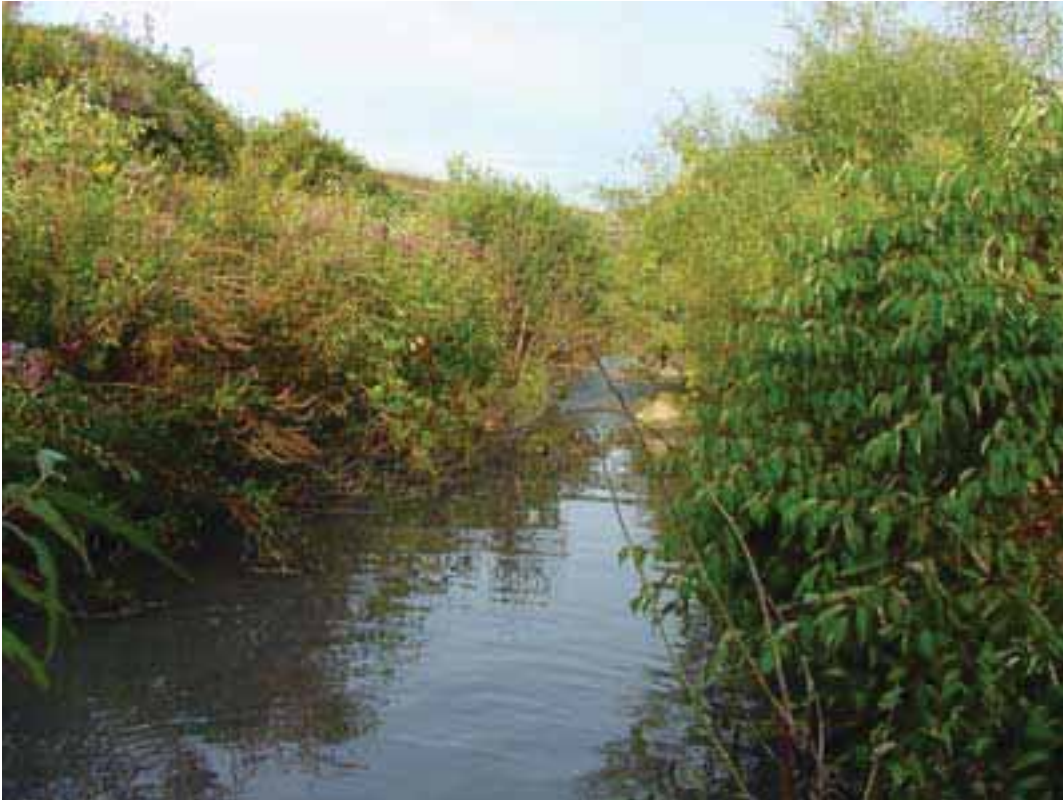
FIGURE 2.5.3-10
RIPARIAN BUFFERS ALONG CAYUGA CREEK IN REACH C4

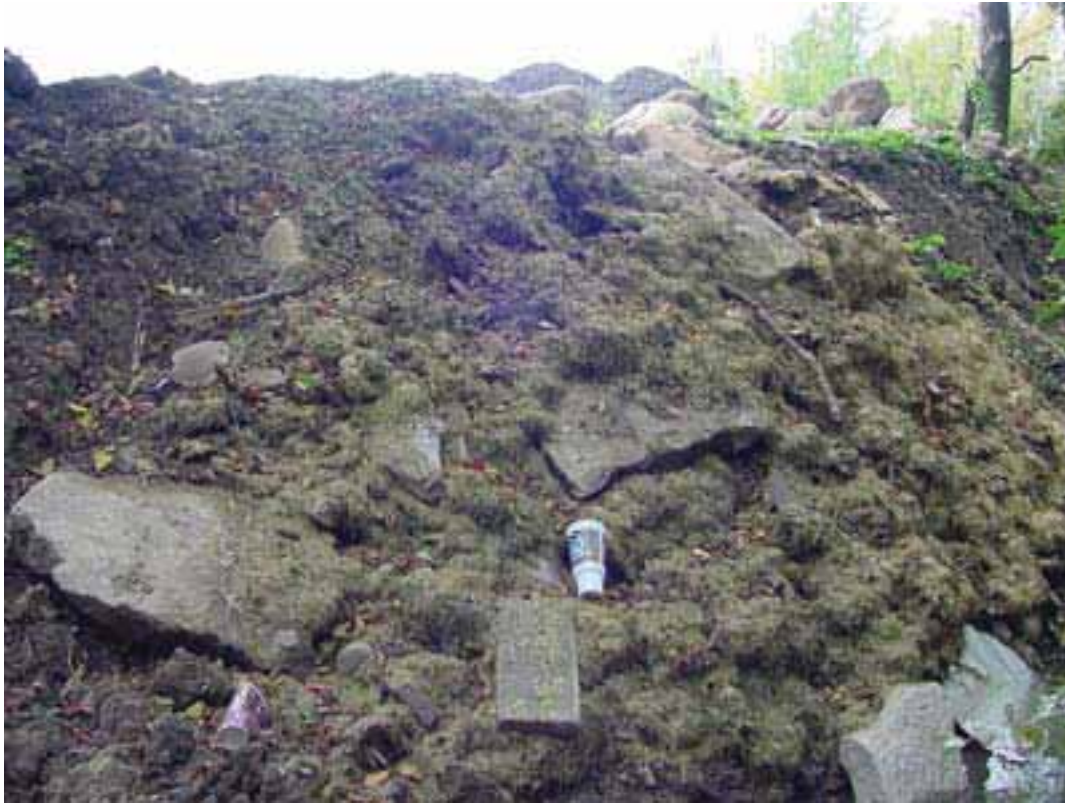
FIGURE 2.5.3-11
LANDSCAPING MATERIAL DUMPED ALONG CAYUGA CREEK IN REACH C4

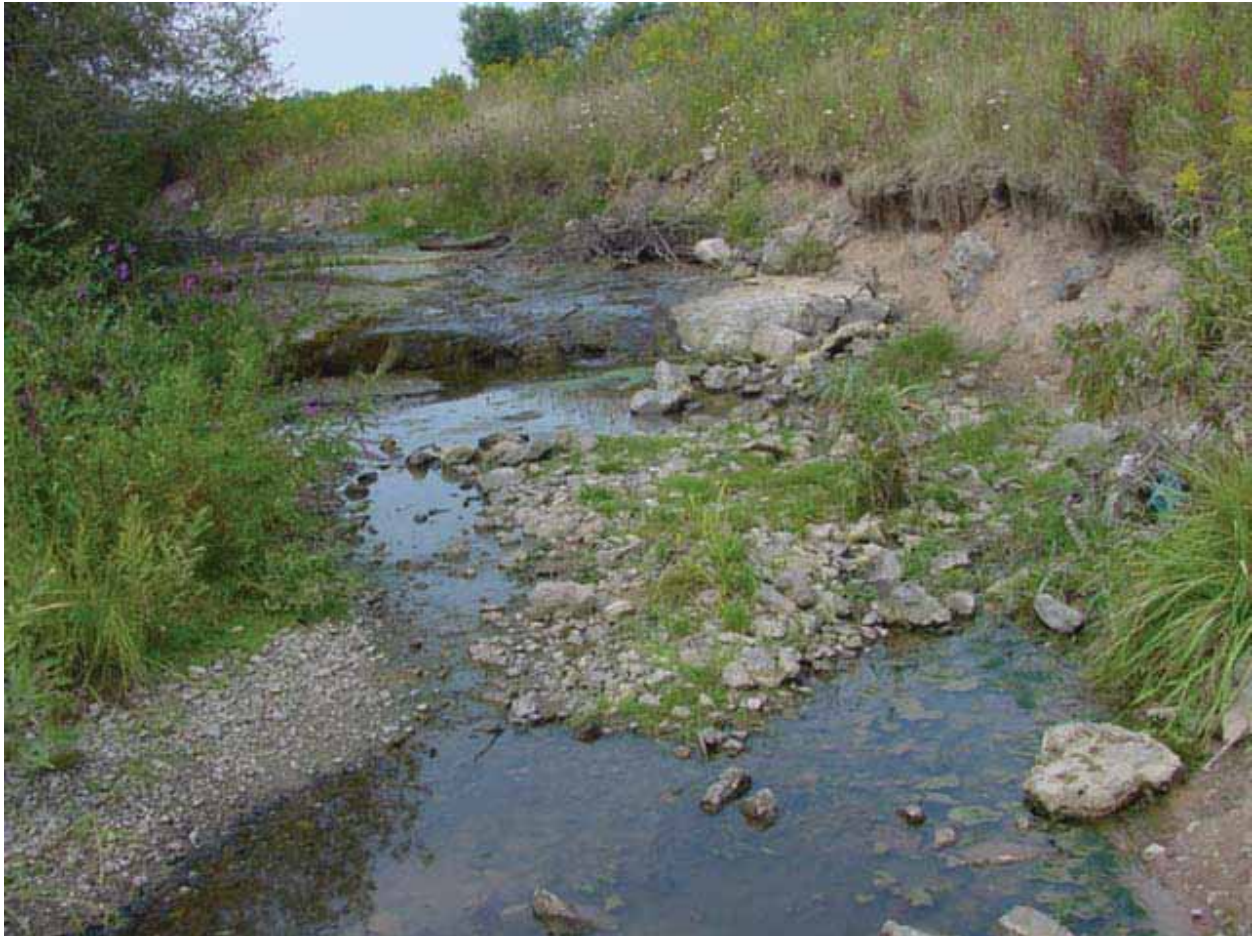
FIGURE 2.5.3-14
A SMALL BEDROCK LEDGE ON CAYUGA CREEK IN REACH C5

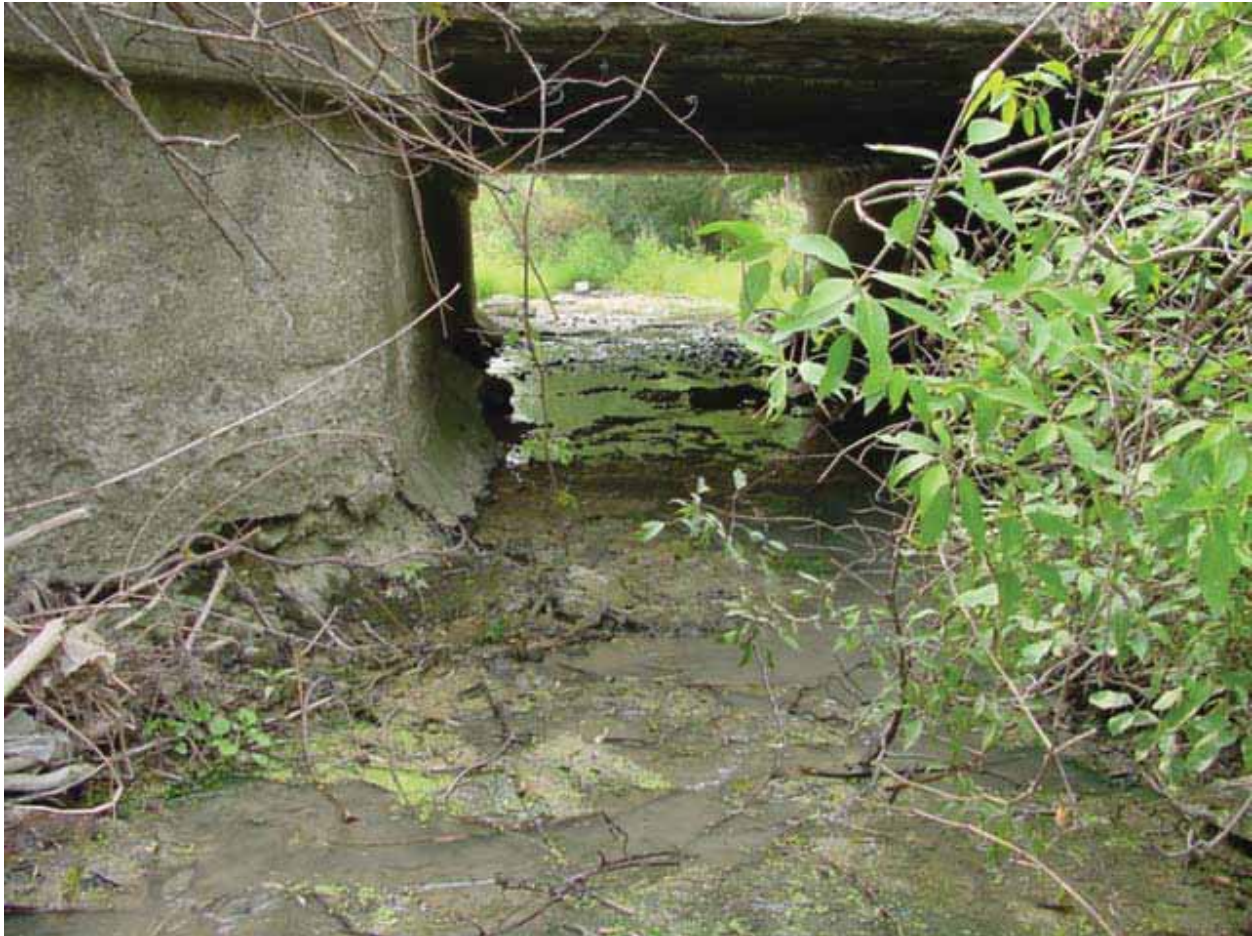
FIGURE 2.5.3-17
THE RAILROAD BRIDGE OVER CAYUGA CREEK IN REACH C6

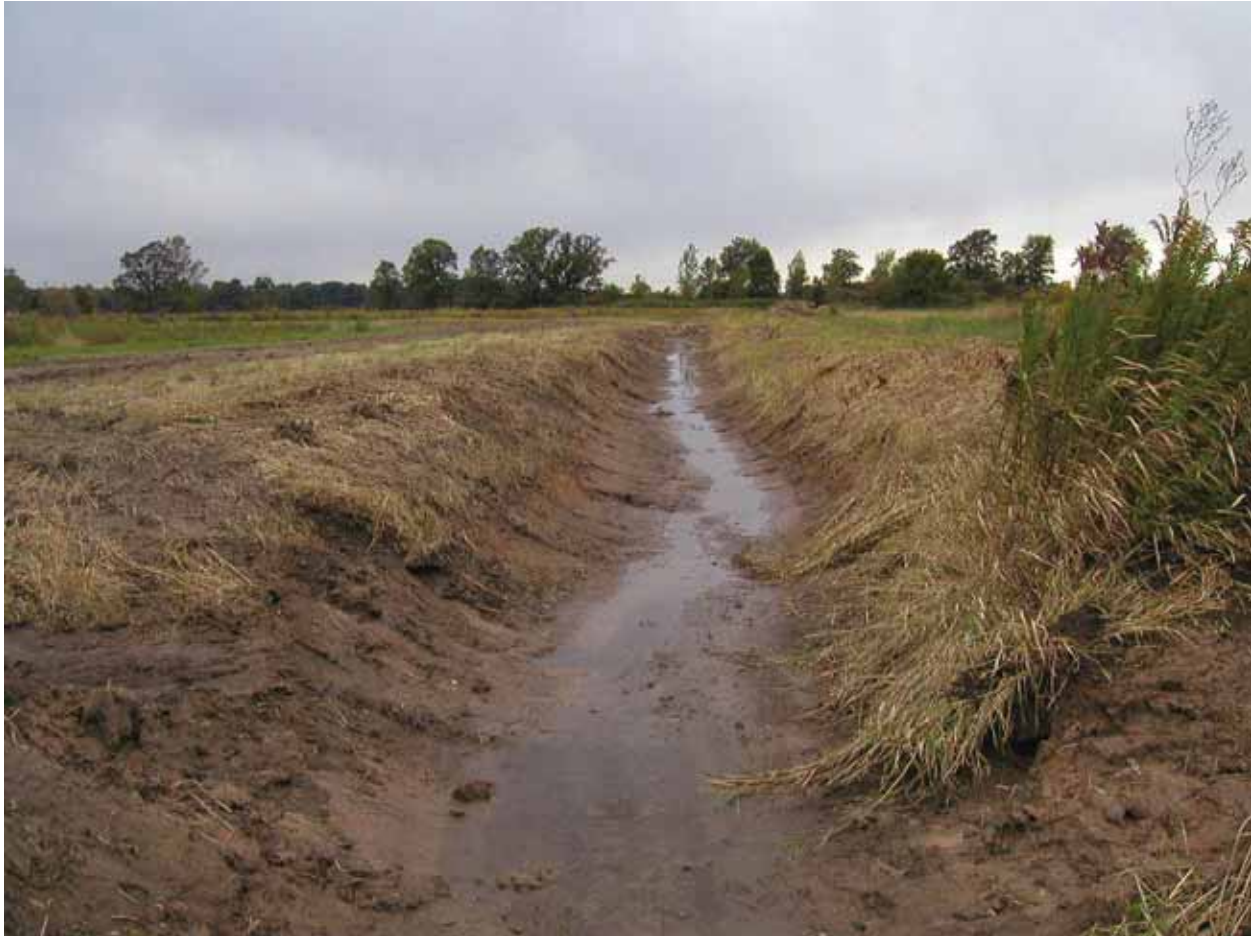
**FIGURE 2.5.3-23
A NEWLY DREDGED SECTION OF REACH CET1**

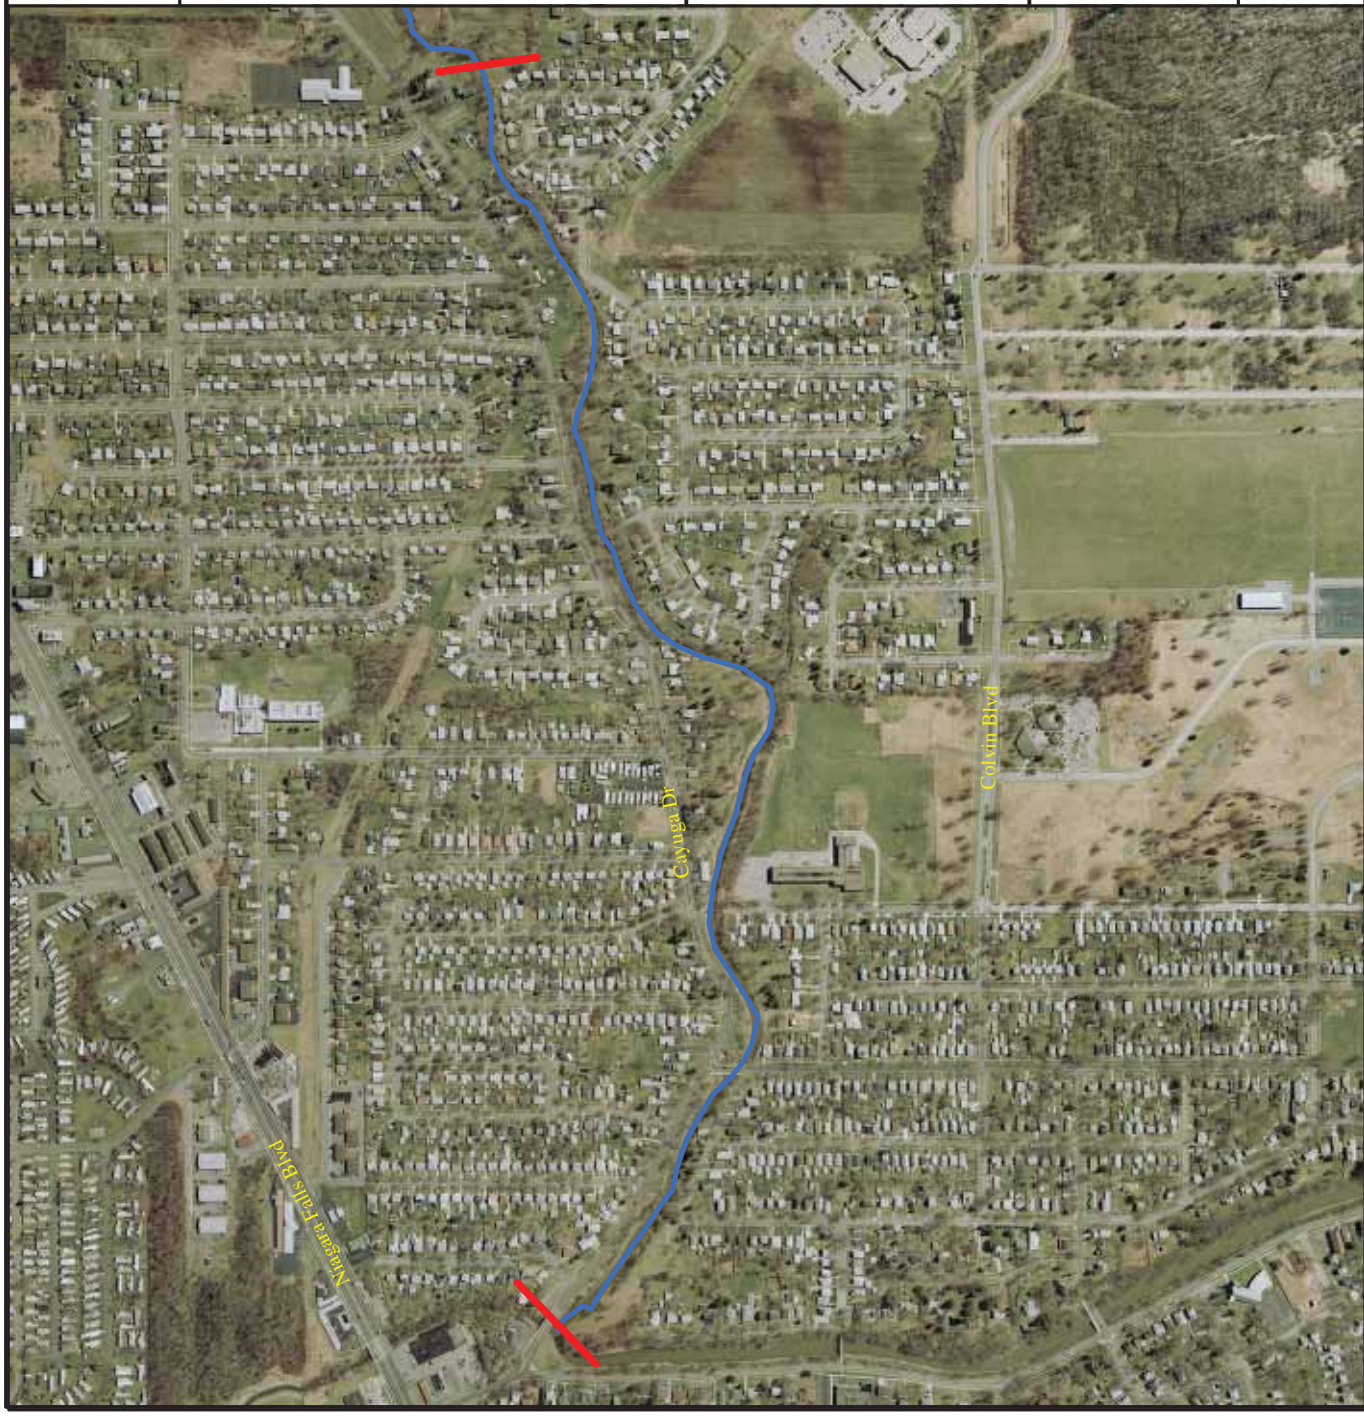
Aerial View of Reach BZ1, and the Location
of Fish Barriers within the Reach

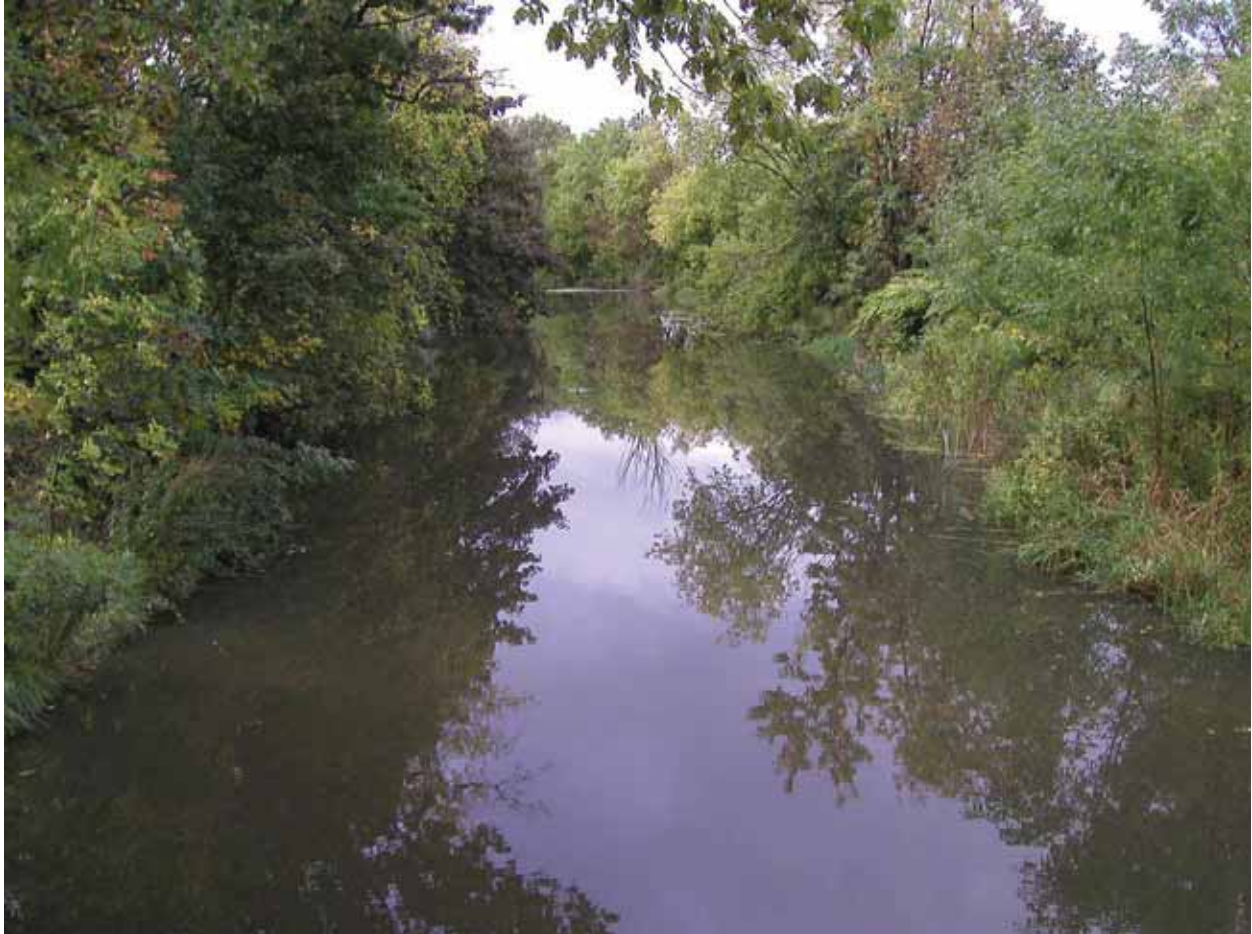
FIGURE 2.5.3-28
BERGHOLTZ CREEK IN REACH BZ1

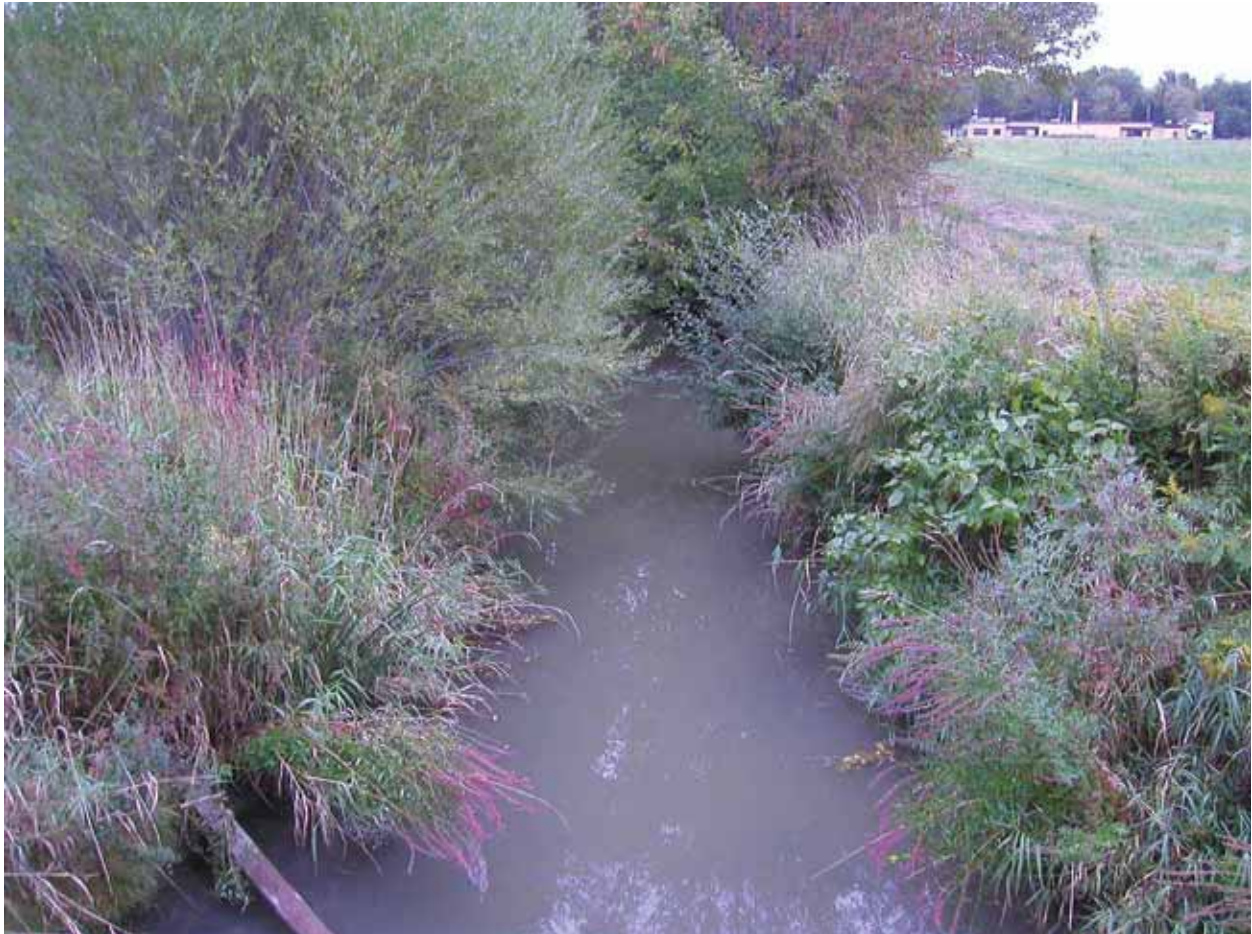
FIGURE 2.5.3-30
BERGHOLTZ CREEK IN REACH BZ2

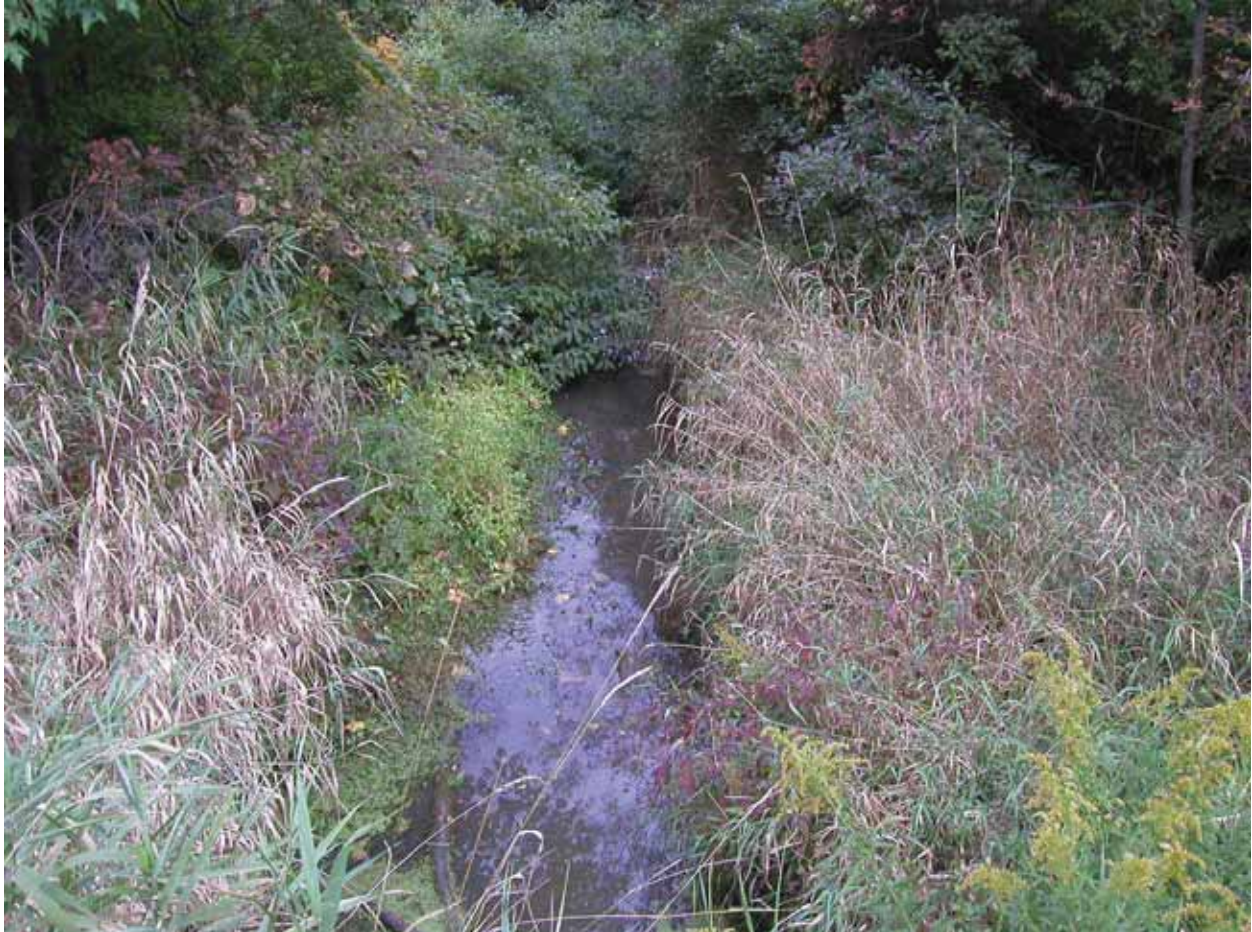
FIGURE 2.5.3-32
NARROW STREAM CHANNEL AND SLOW MOVING WATER IN THE DOWNSTREAM
SECTION OF REACH BZ3
